# Four Seasons Condominium

## Condition Survey Report Buildings 1, 2, 3, 4, 5, 6, & 7

# **Four Seasons Condominium Condition Survey Report**

Re: Buildings 1-7 Structural Condition Survey Report

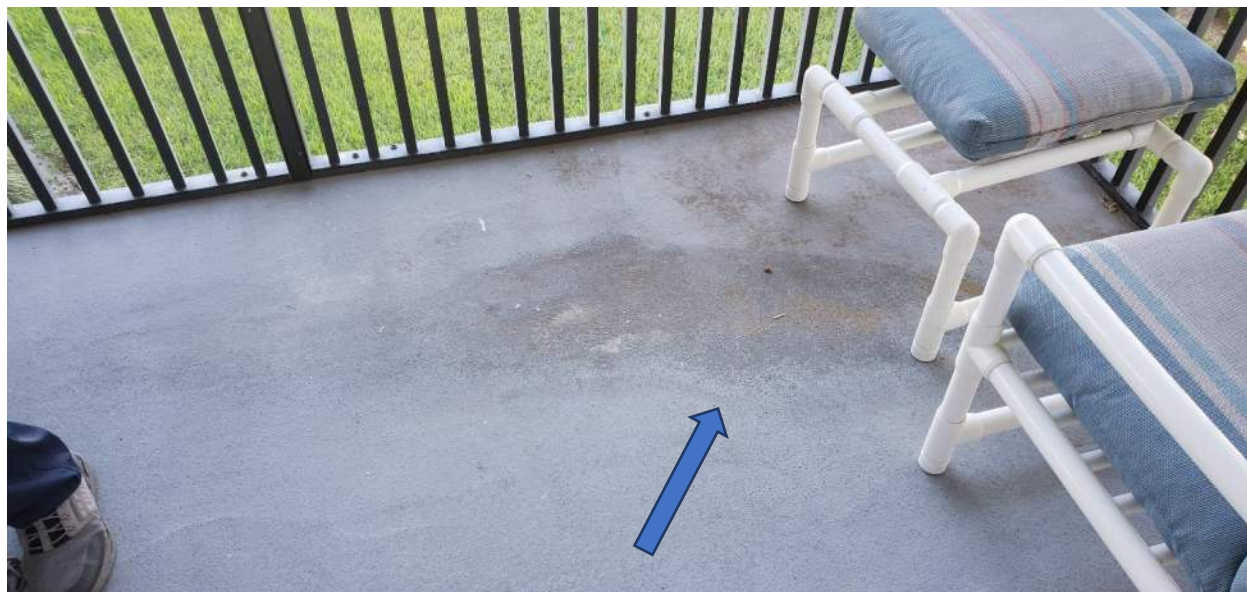
**Example view of stained balcony floor coatings**

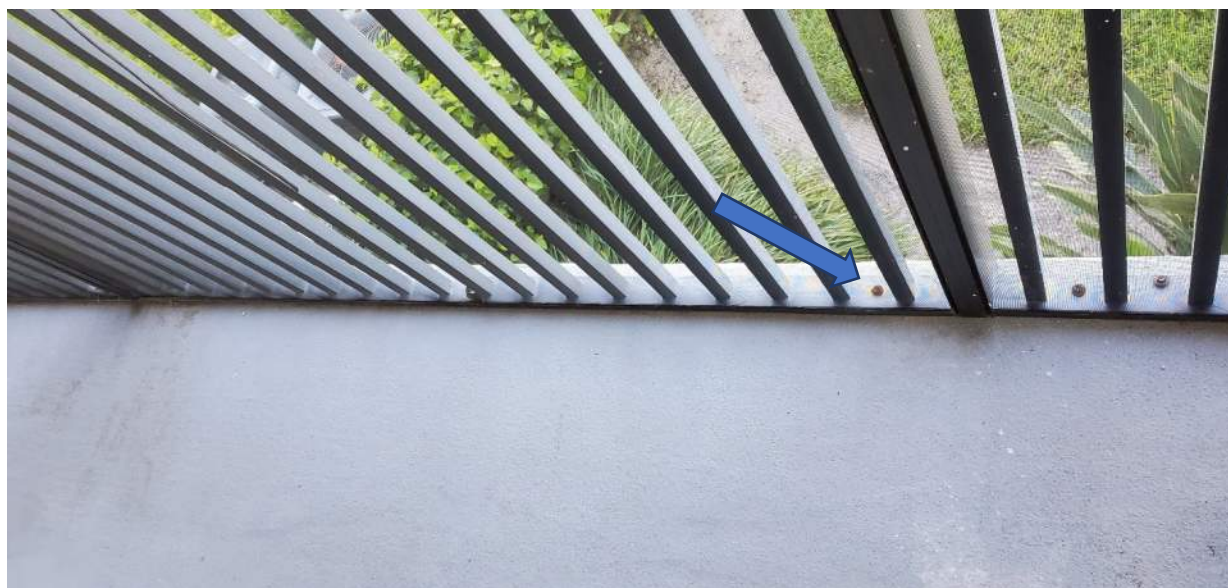
**Example view of rusting fasteners of screen railing**

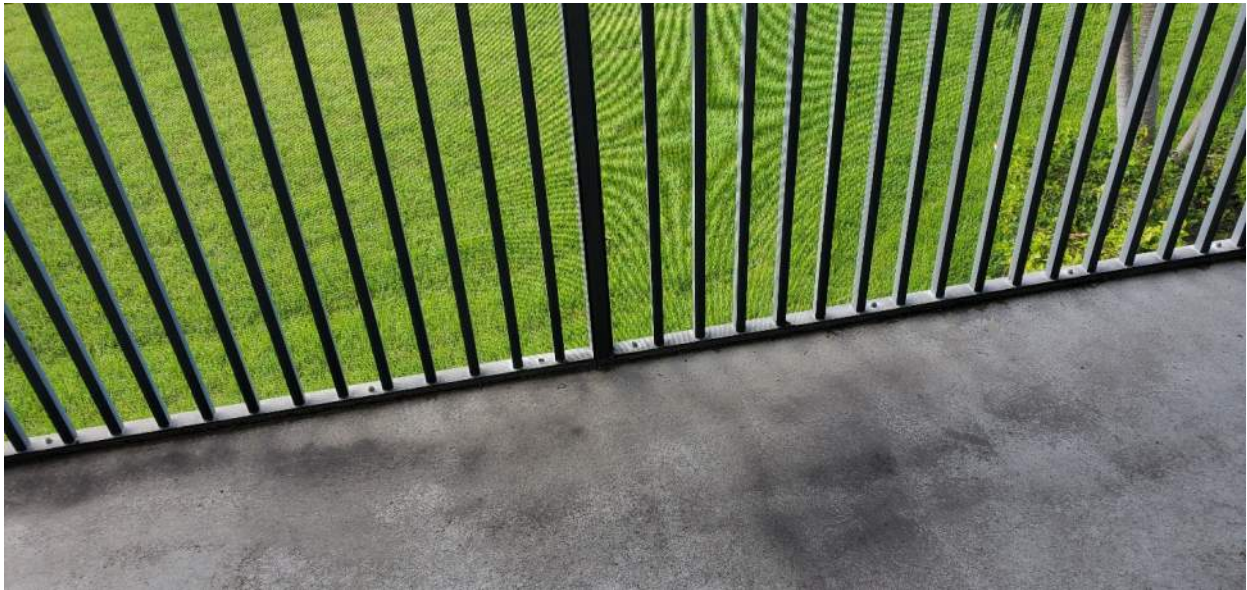
**Example view of worn floor coatings**

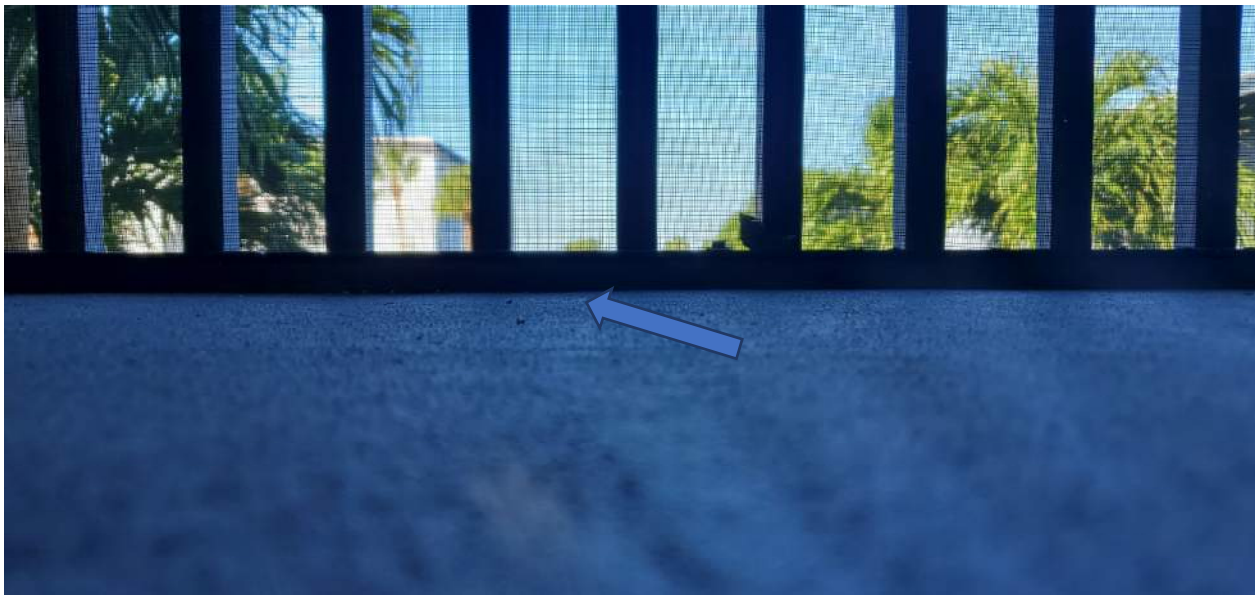
**Example view of no shims under screen which prevents positive drainage**

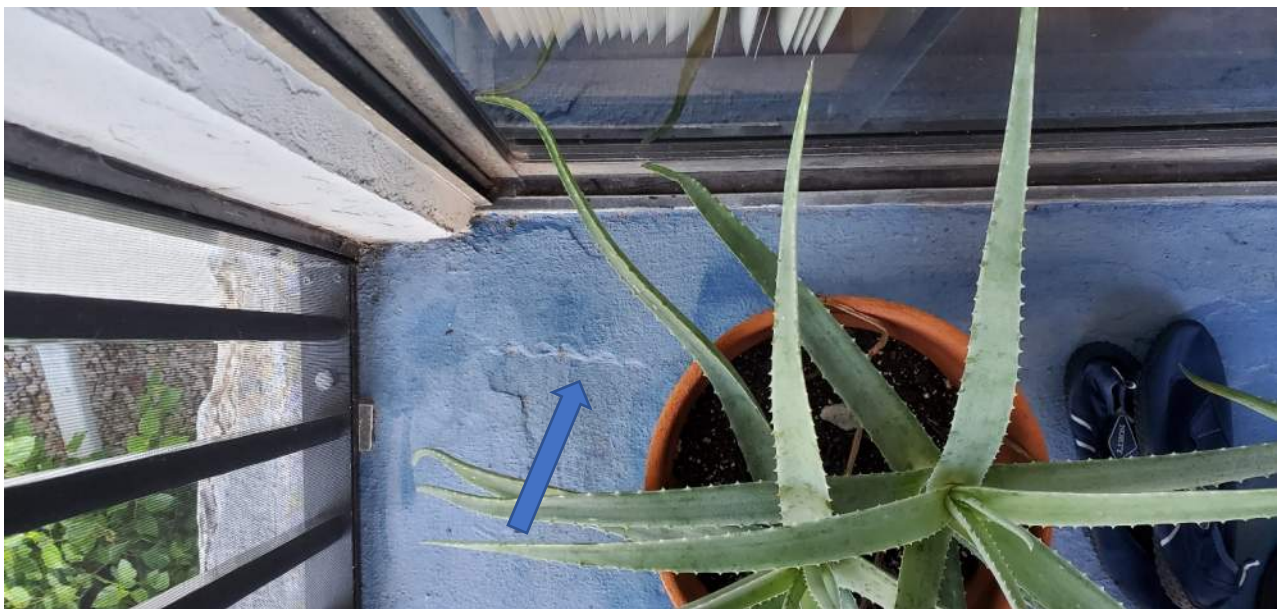
**Example view of spalled concrete surface due to corroding reinforcing bars**

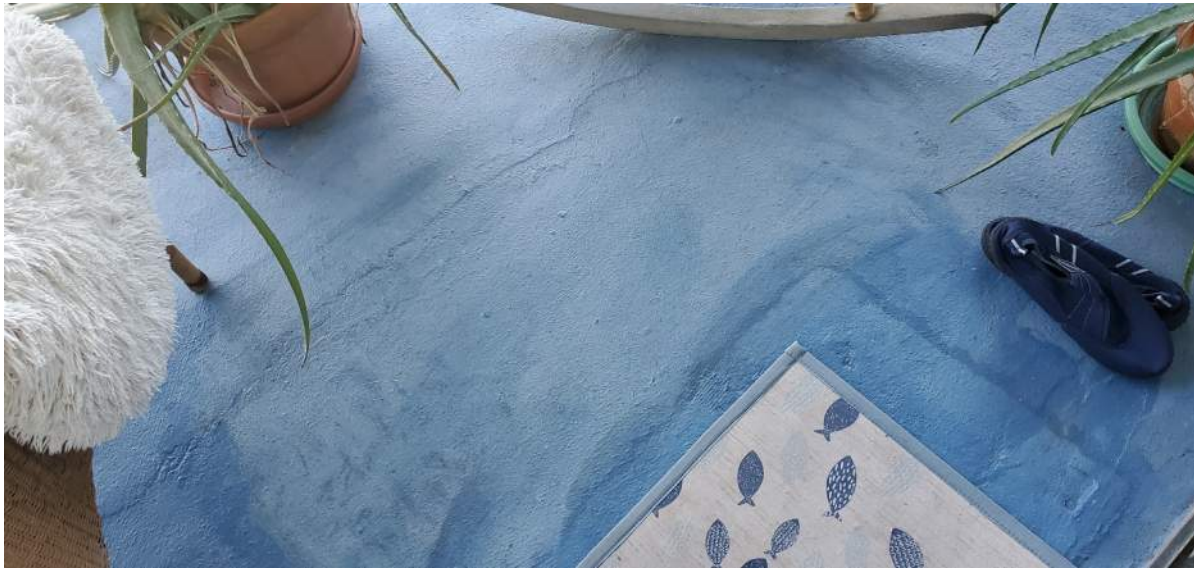
**Example view of poor floor coatings**

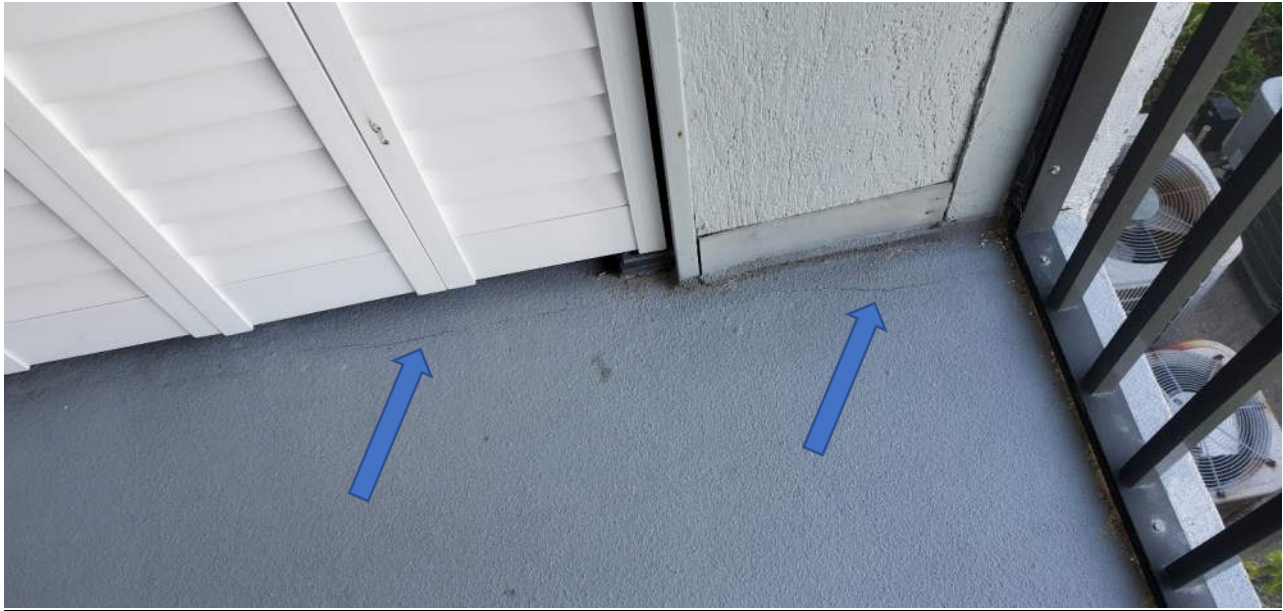
**Example view of spalled concrete surface due to corroding reinforcing bars**

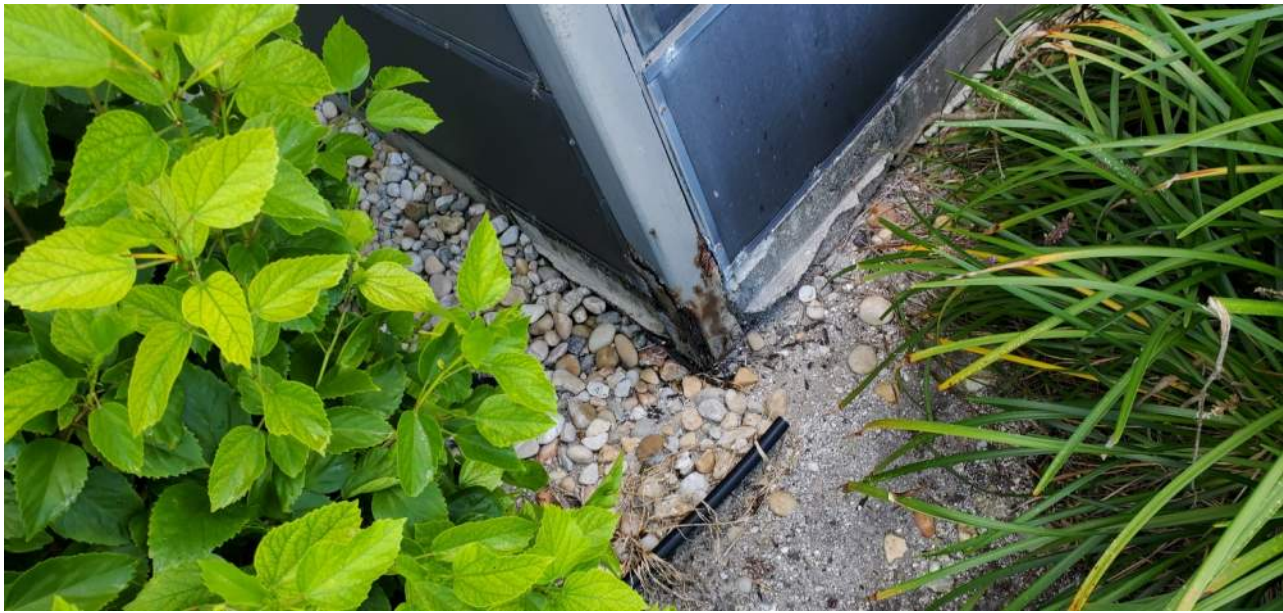
**Example view of corroded corner column of screened porch**

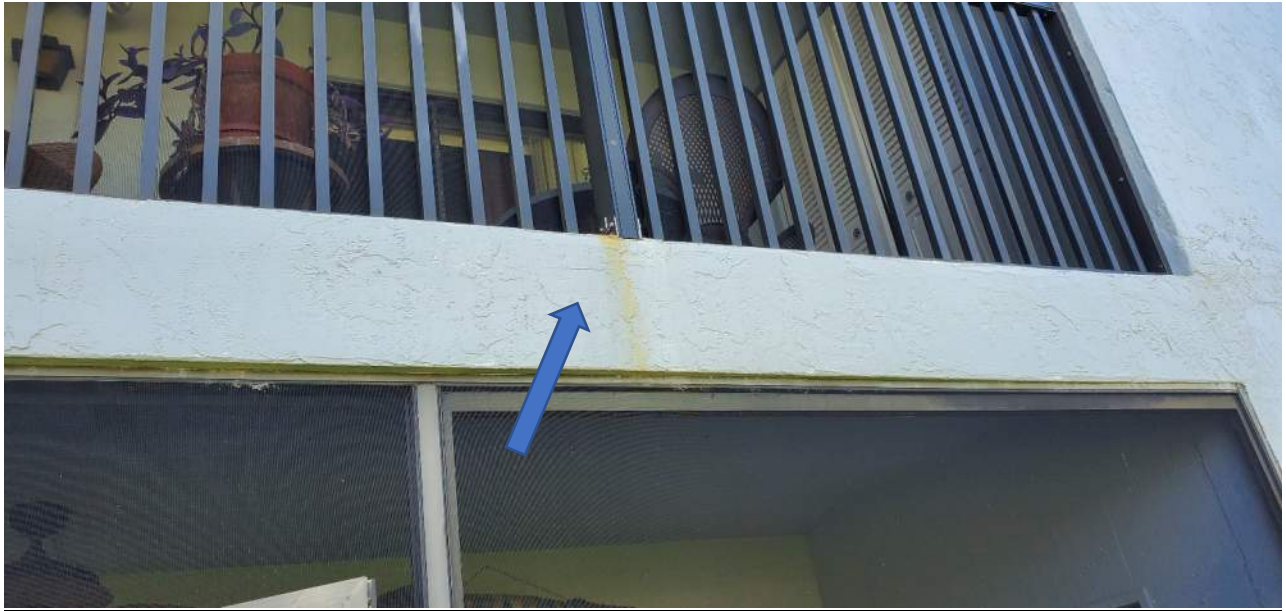
**Example view of rust stains coming from screen posts**

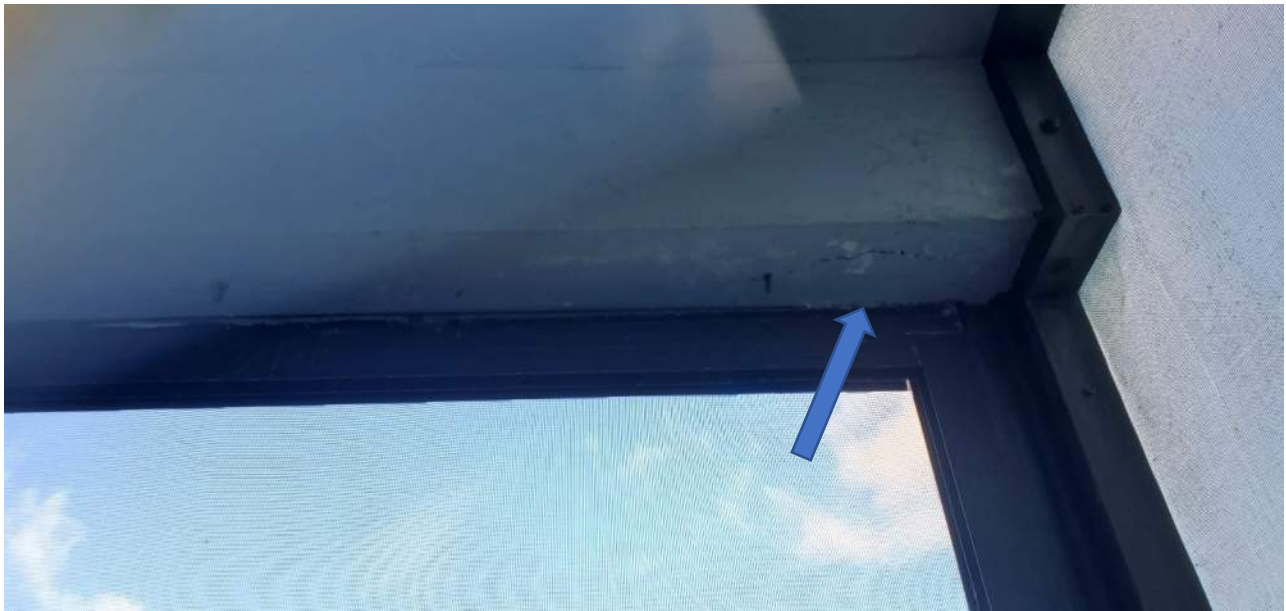
**Example view of concrete beam spalling**

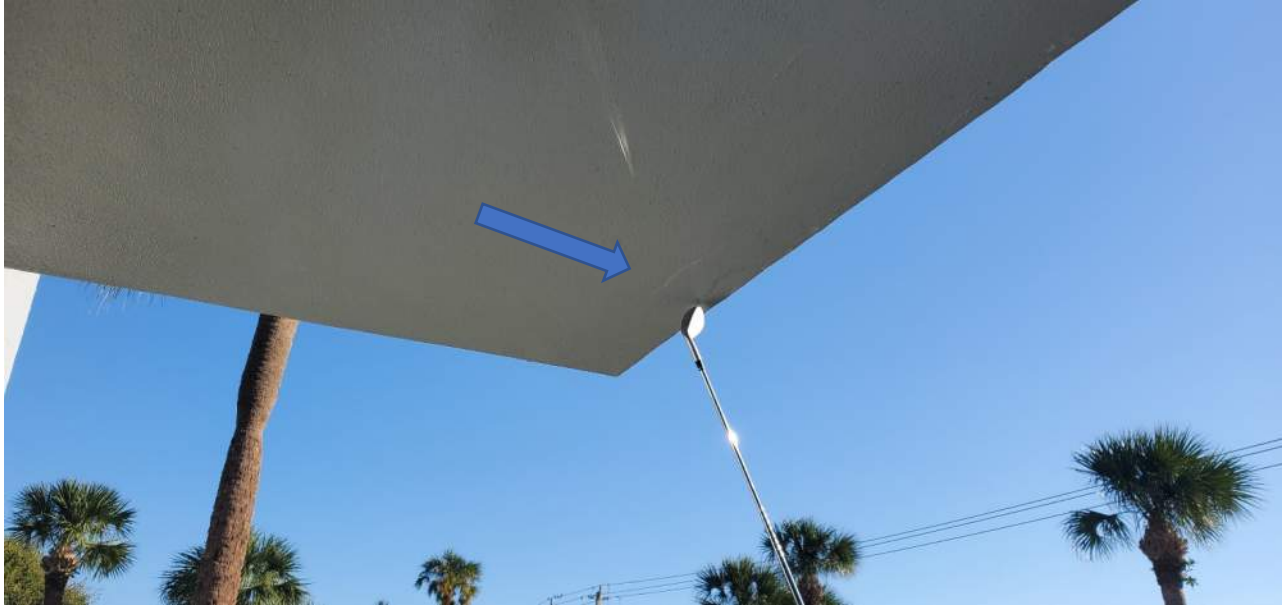
**Example view of spalling concrete slab ceiling**

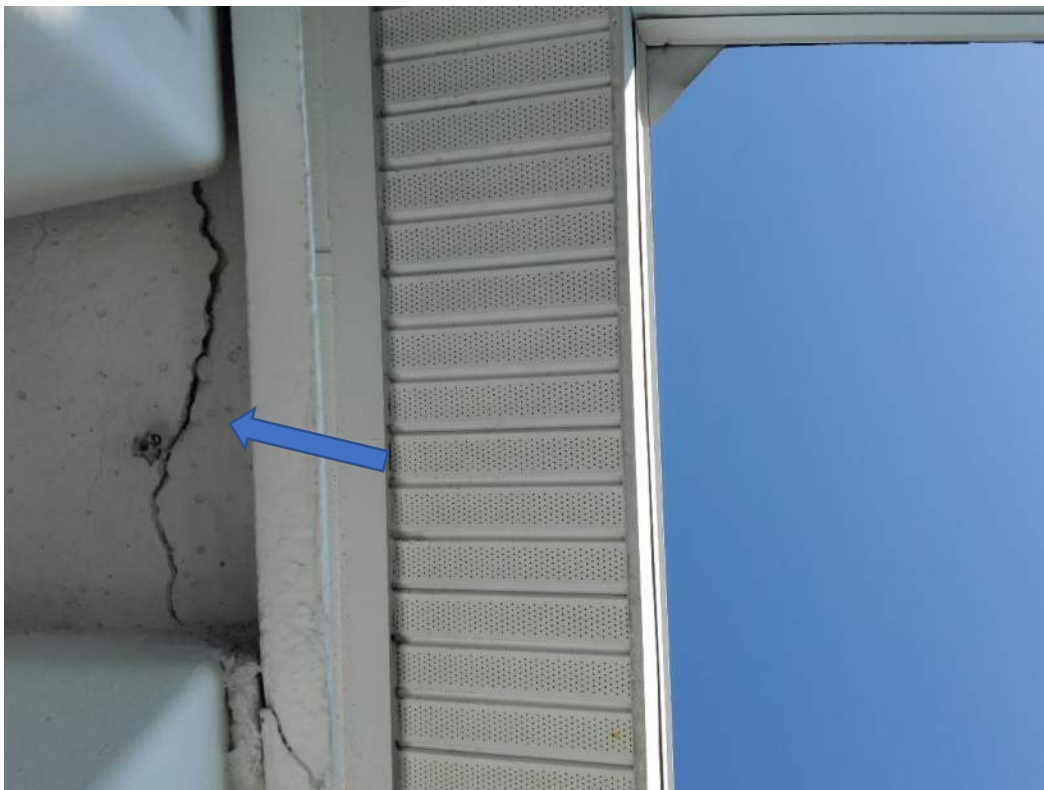
**Example view of concrete ceiling spalling**

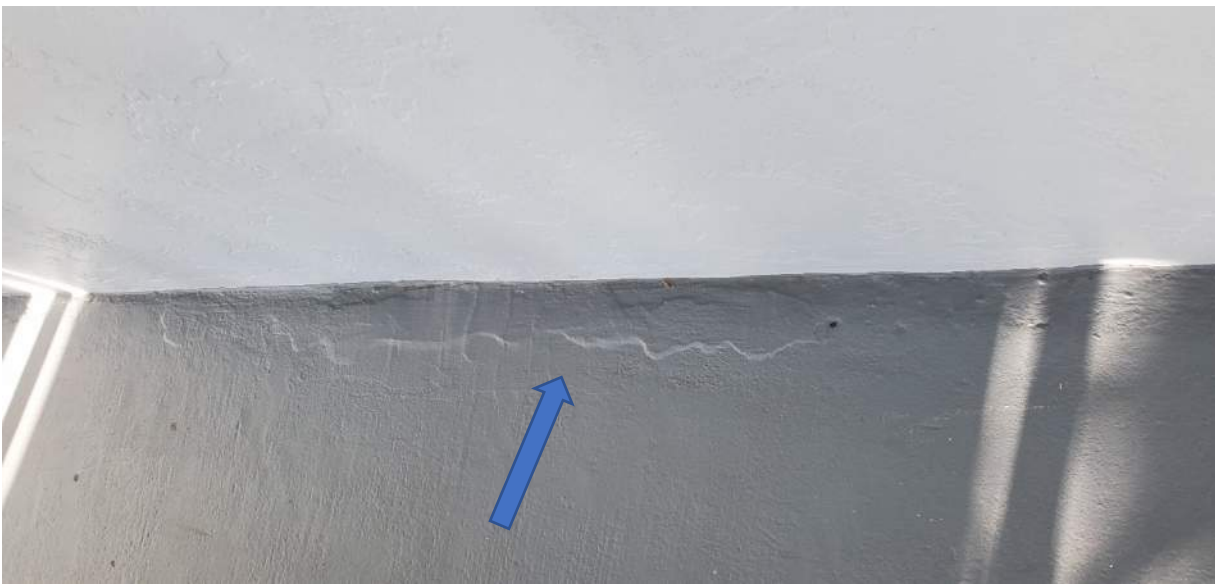
**Example view of spalling concrete on walkway**

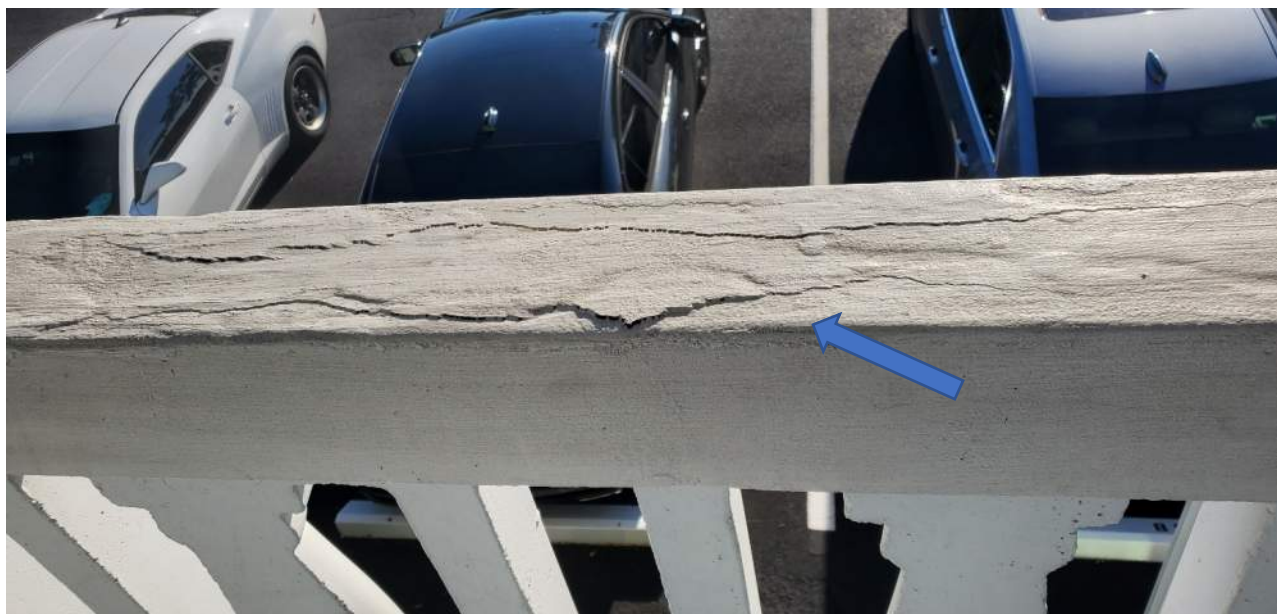
**Example view of concrete walkway railing spalling**

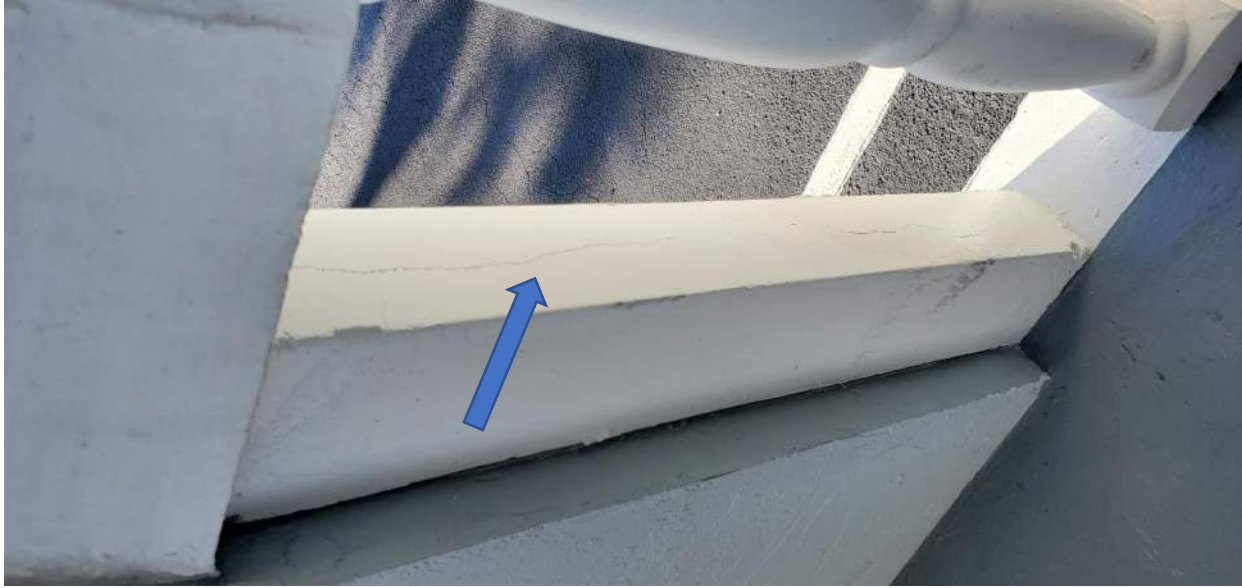
**Example view of spalling concrete walkway railing picket**

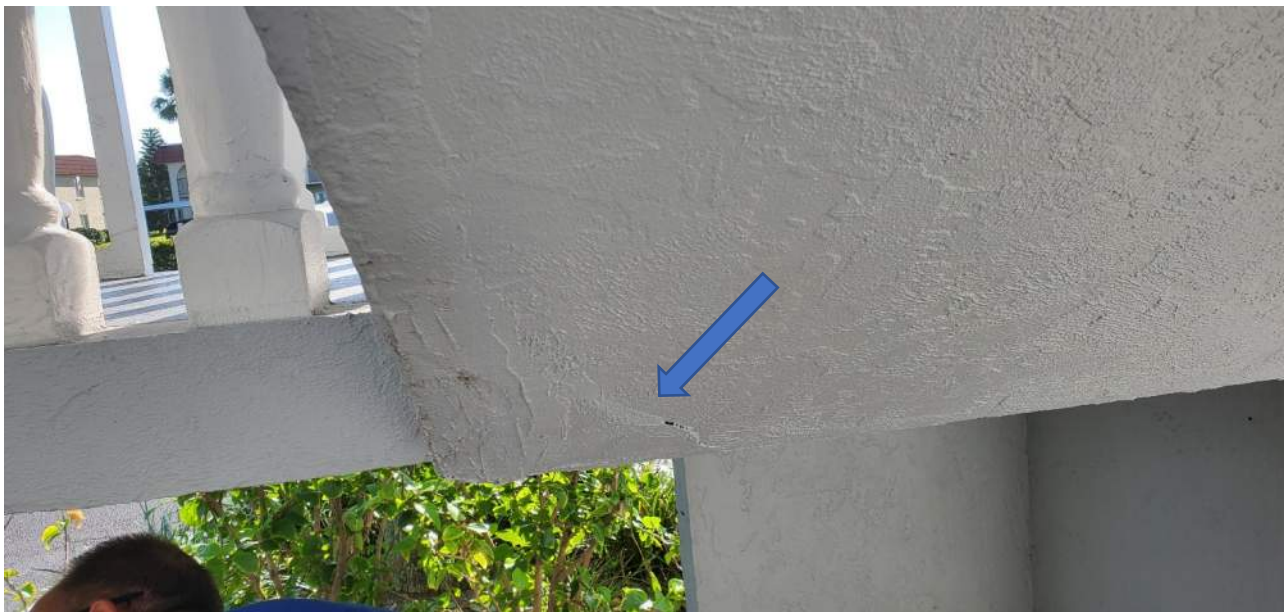
**Example view of concrete stairs spalling**

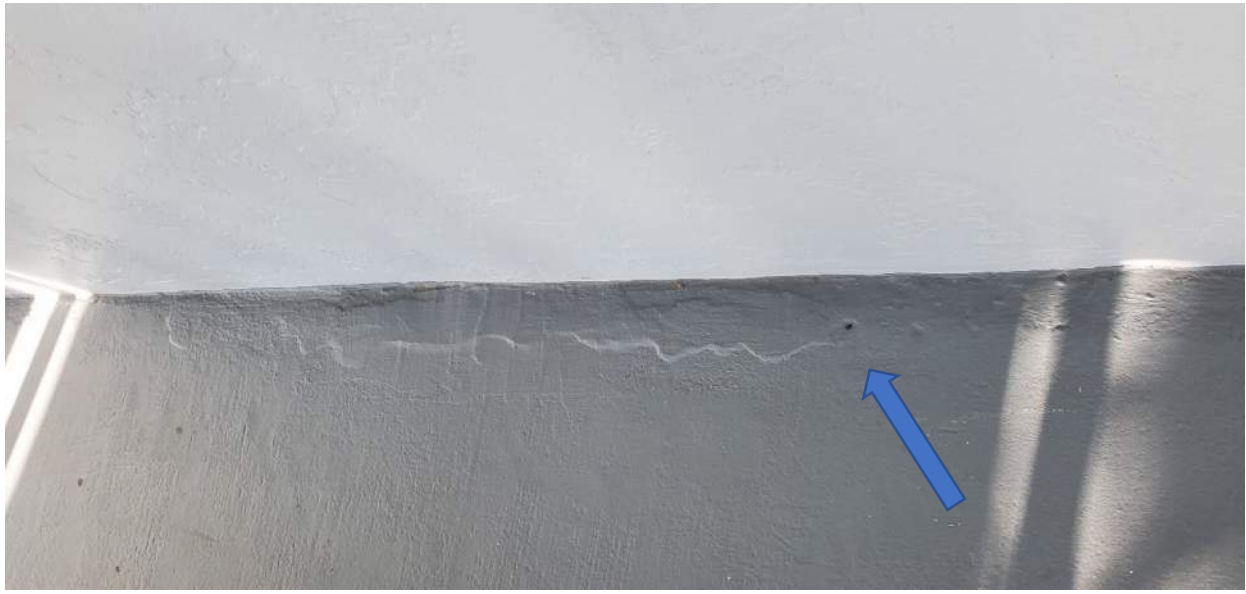
**Example view of concrete walkway spalling and rust spots**

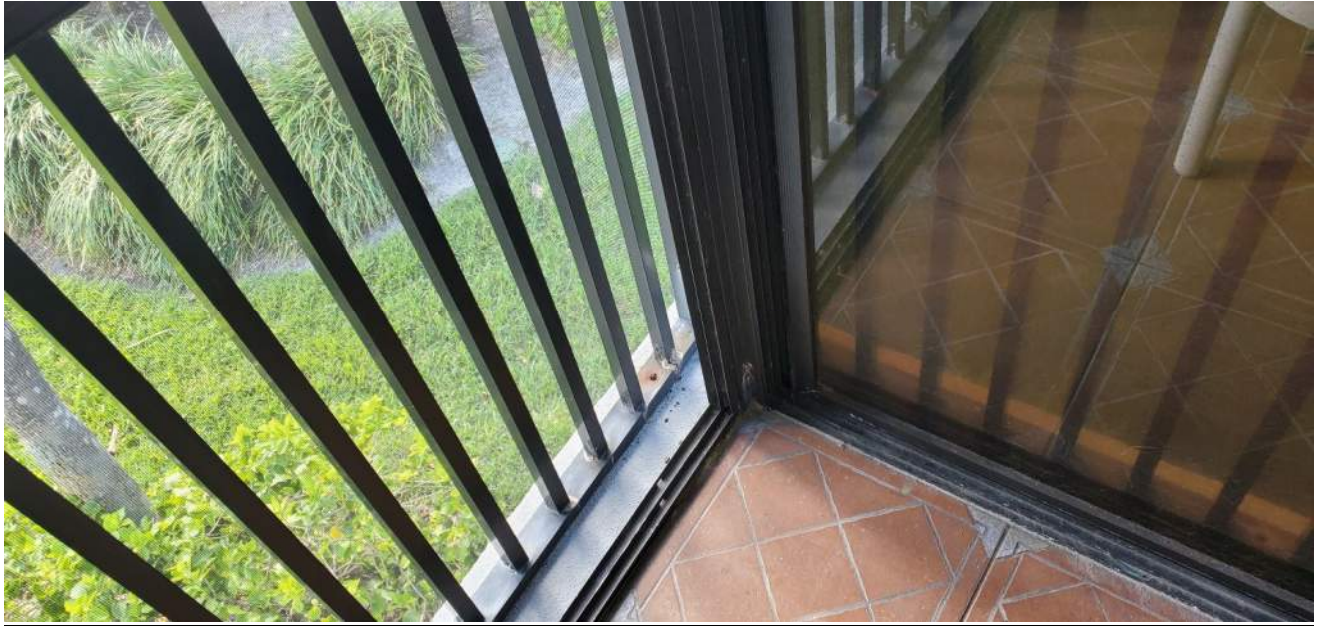
**Example view of rusting railing fastener.**  
**Note there is tile on the balcony surface.**

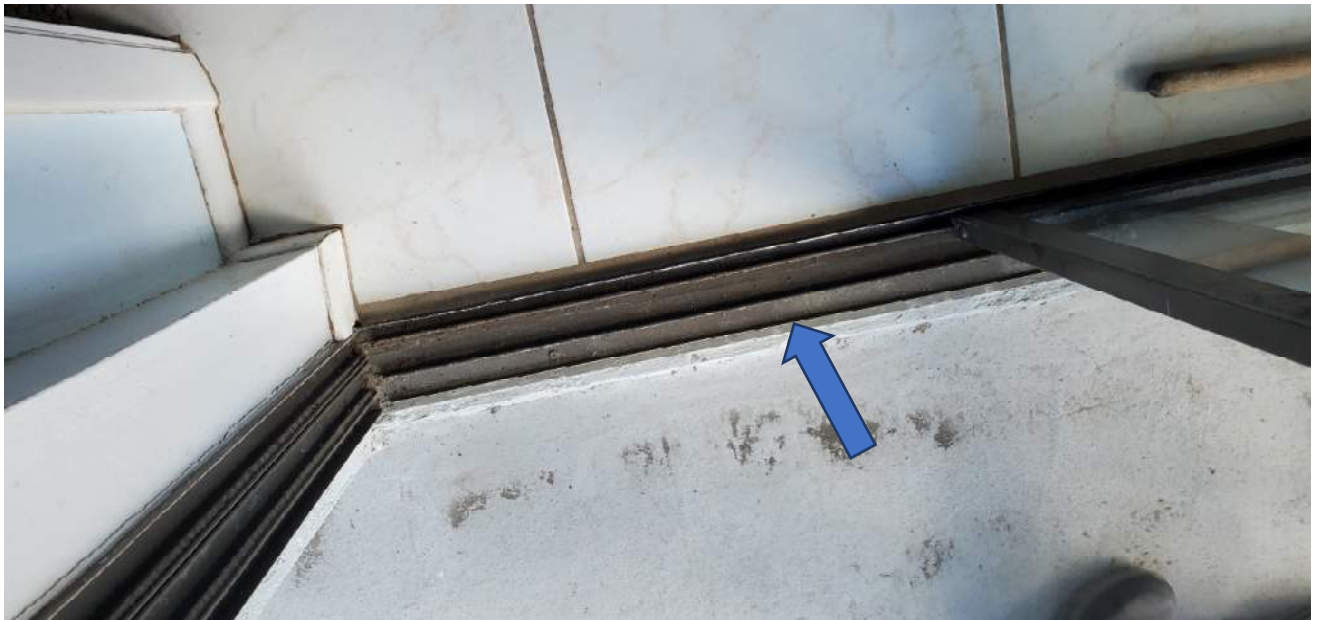
**Example view of rusting sliders.**

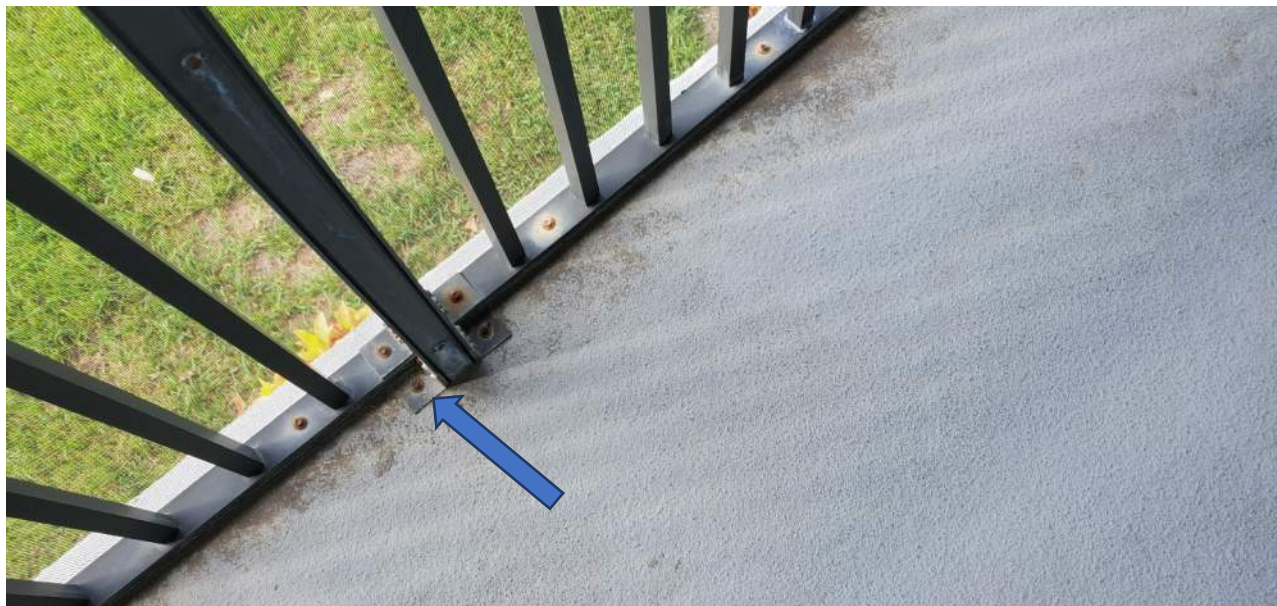
**Example view of rusting screen railing fasteners and bad coatings.**

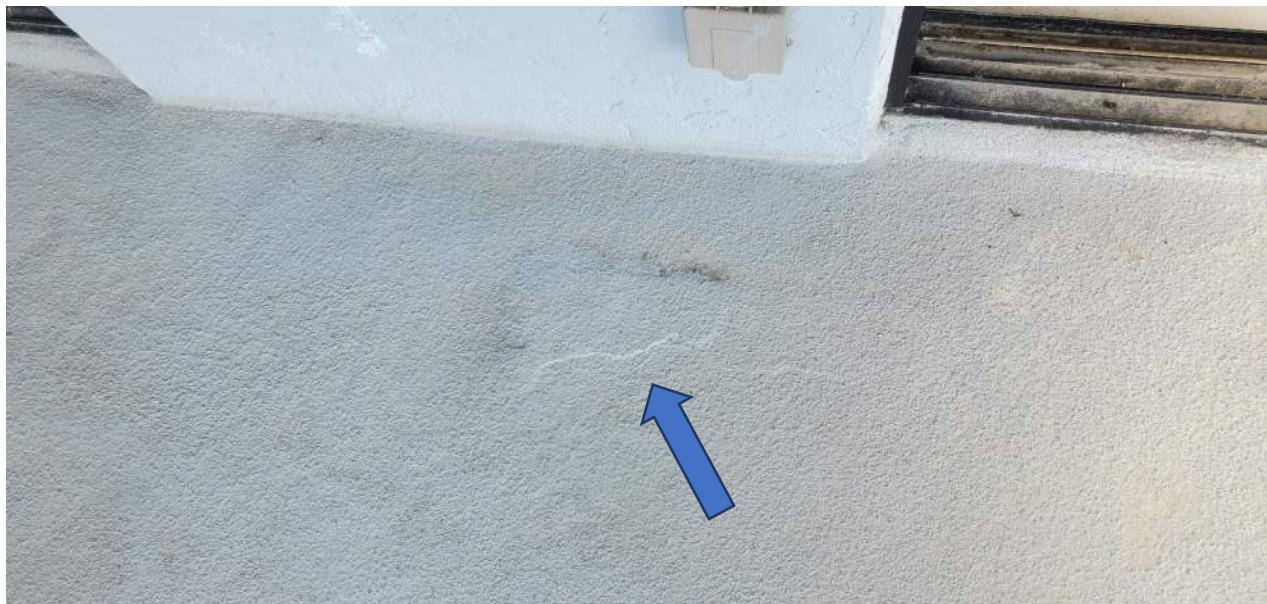
**Example view of spalling concrete due to corroding reinforcing bars**

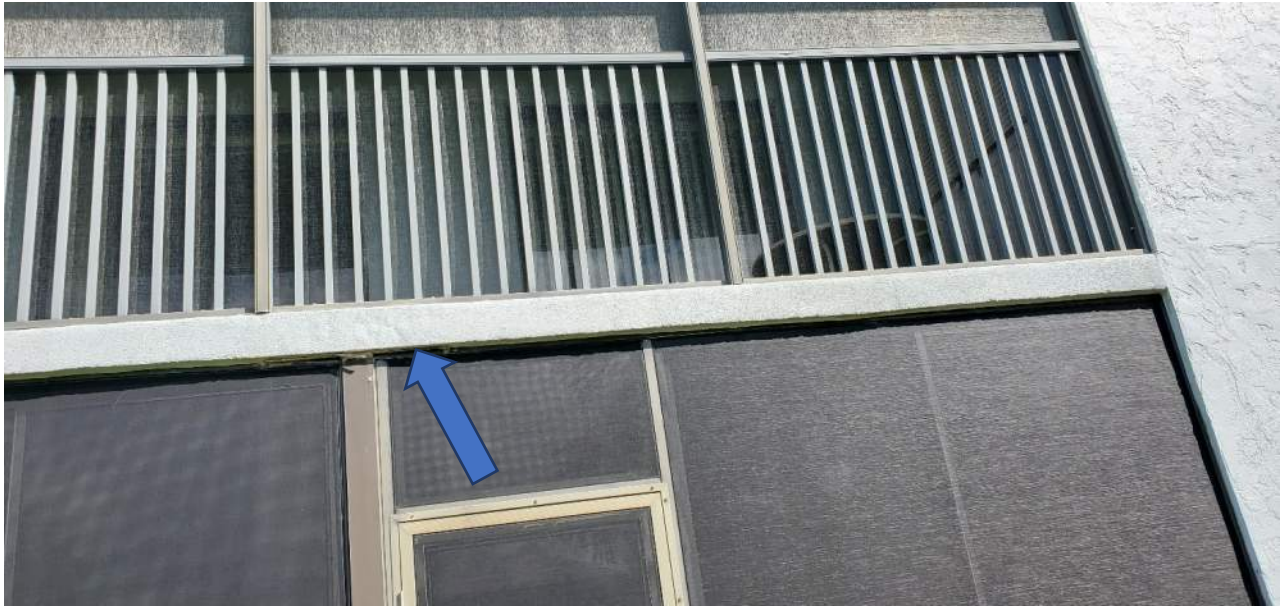
**Example view of concrete slab edge spalling**

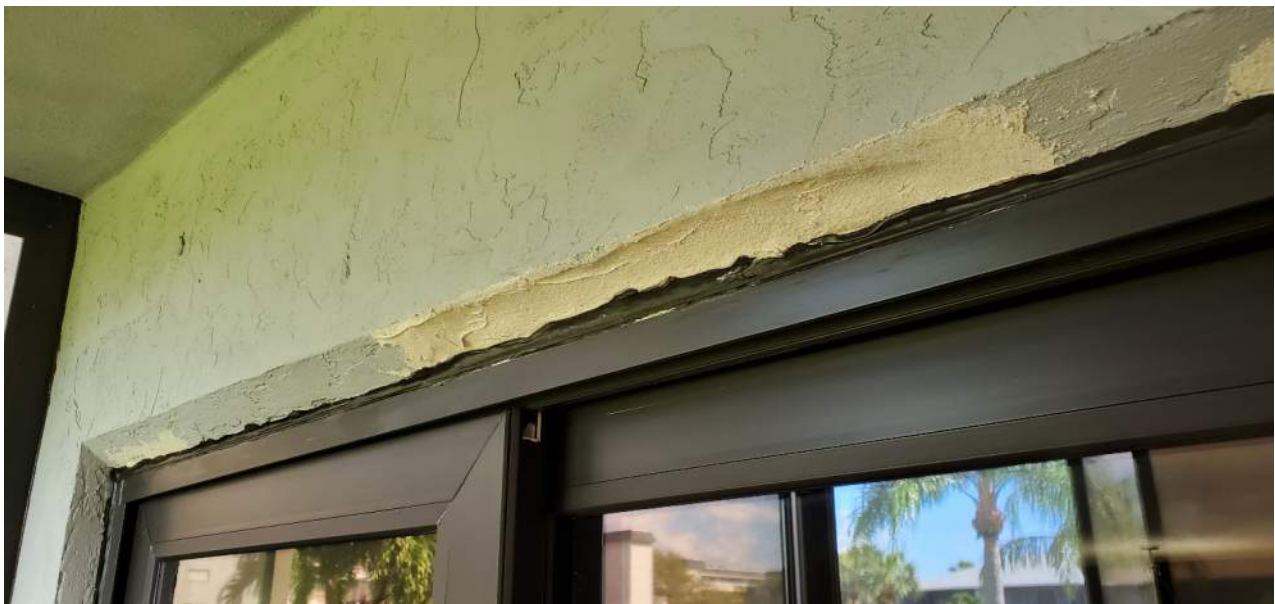
**Example view of damaged header that has been previously patched**

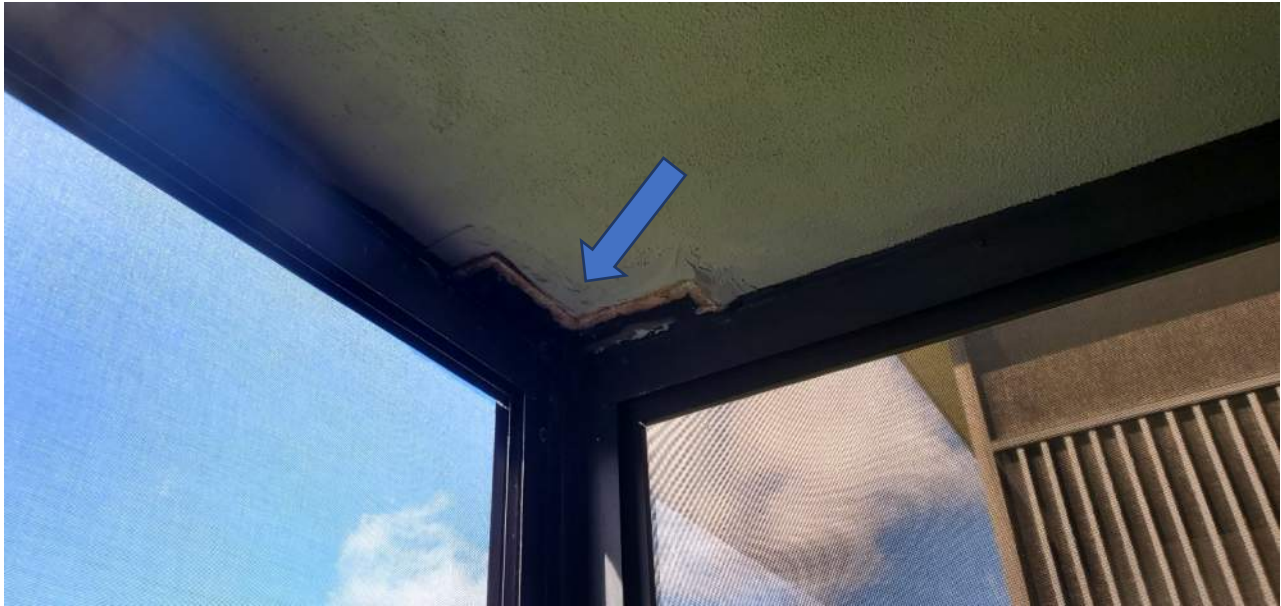
Example view of rusting bearing plate on top of column

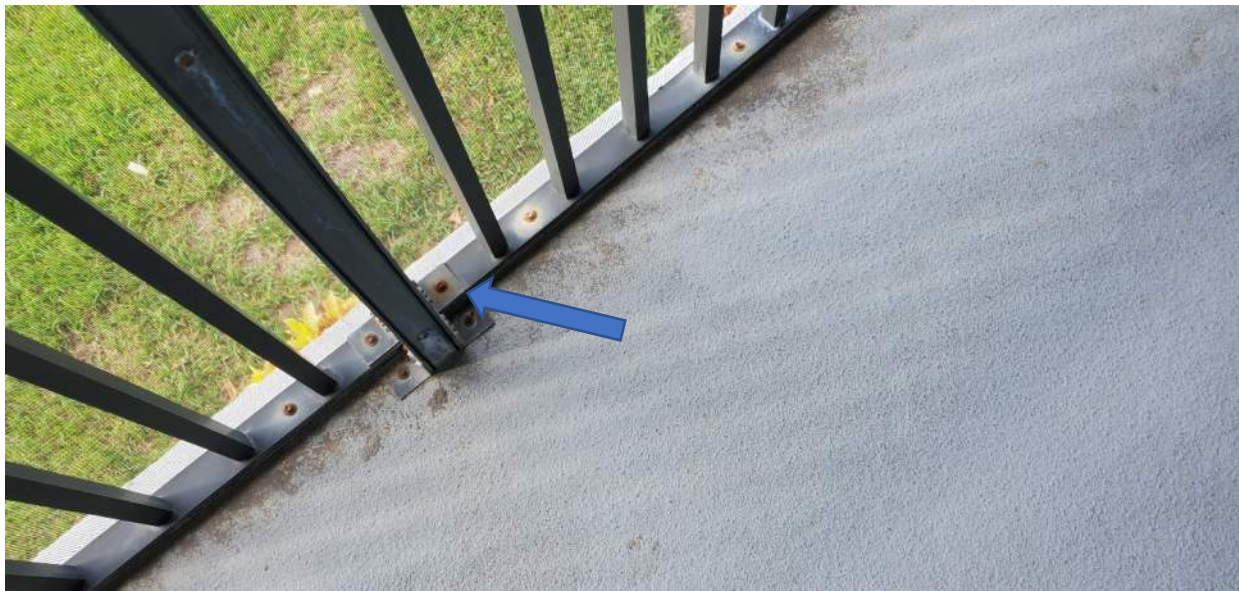
Example view of rusting railing fasteners and worn slab coatings

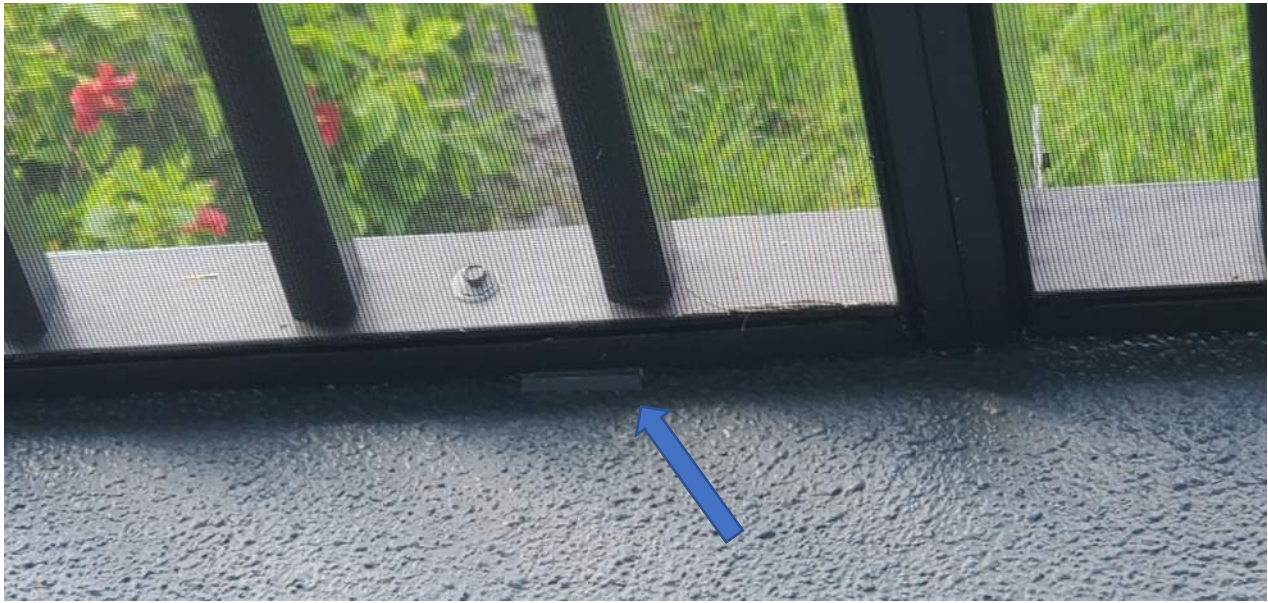
**Example view of shimmed screen enclosure**

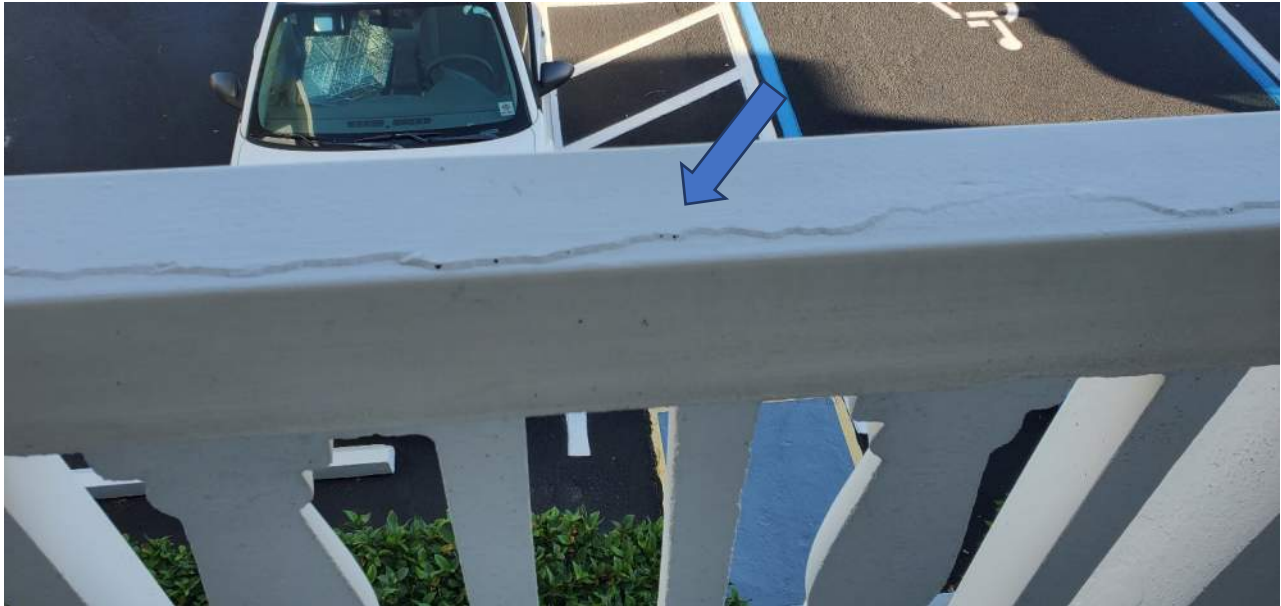
**Example view of spalling concrete railings on the walkway**

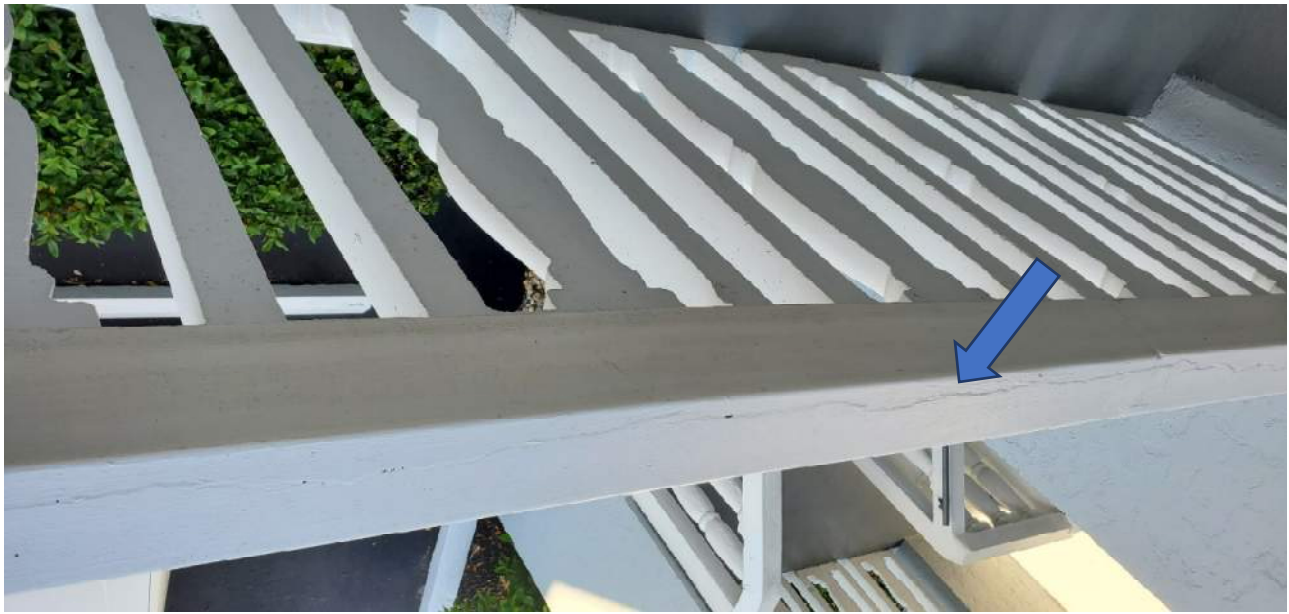
**Example view of concrete walkway railing spalling**

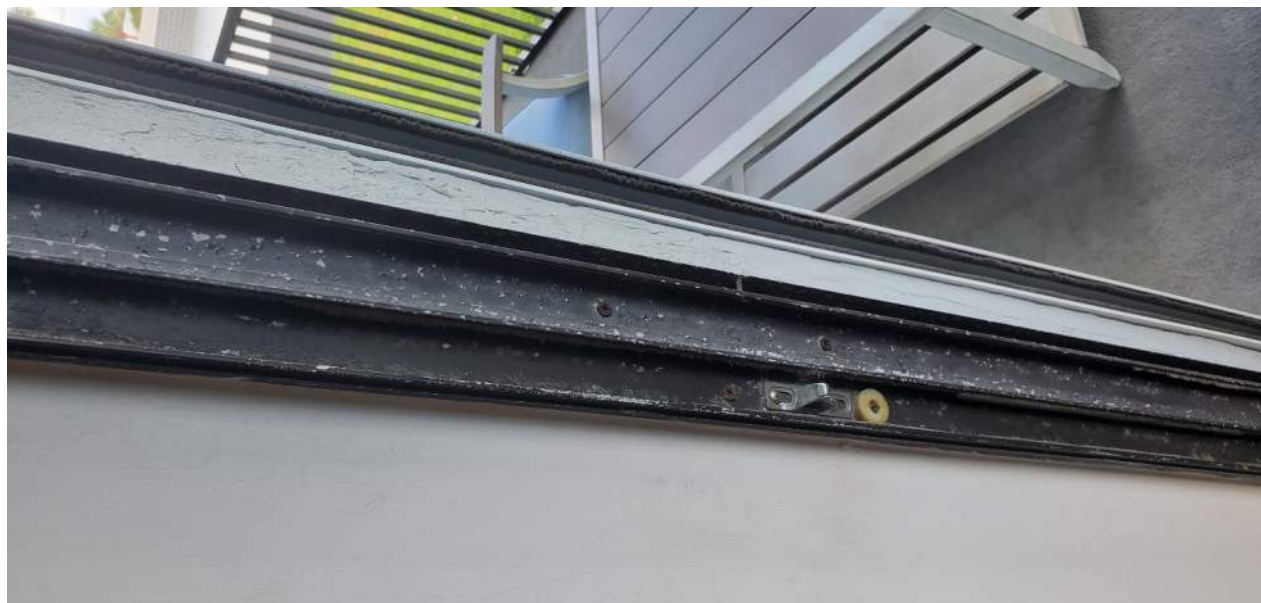
**Example view of rusting and missing sliding door fasteners**
