# Four Seasons Condominium

## Condition Survey Report Buildings 1, 2, 3, 4, 5, 6, & 7

# **Four Seasons Condominium Condition Survey Report**

Re: Buildings 1-7 Structural Condition Survey Report

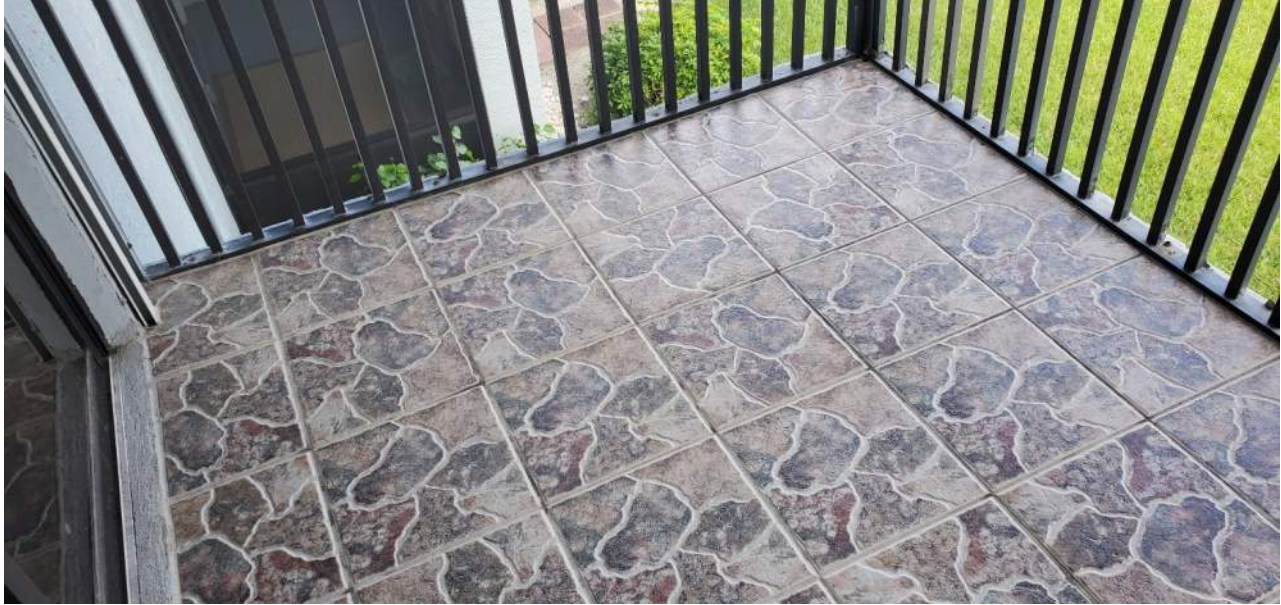
**Example view of concrete slab with tiles**

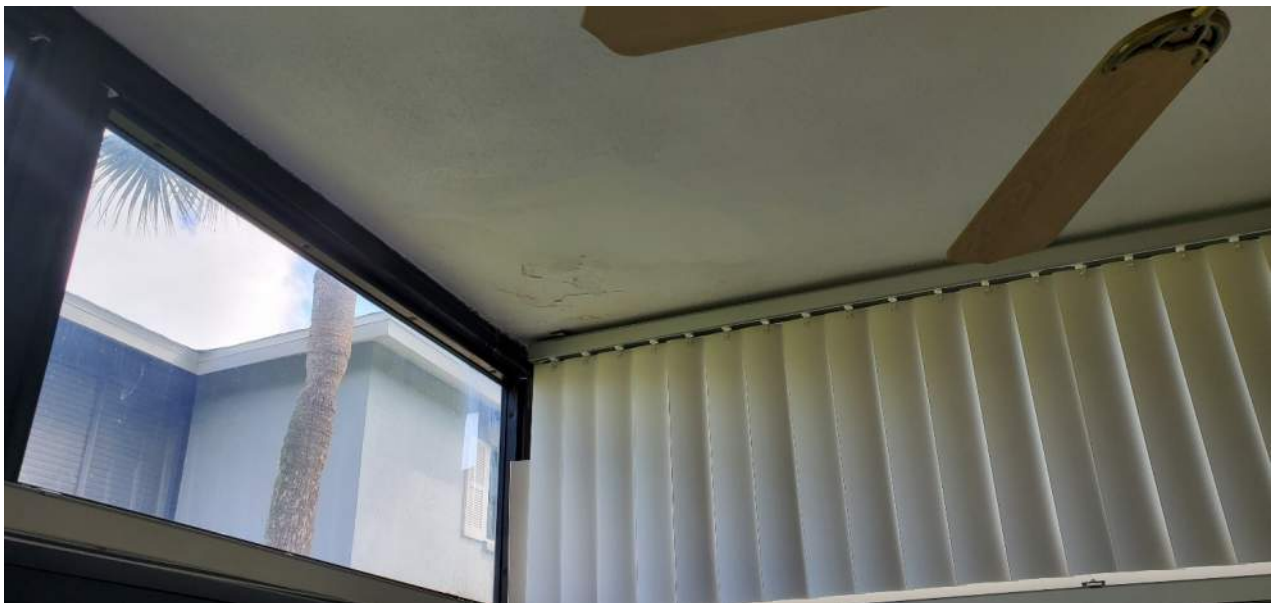
**Example view of concrete slab ceiling spall**

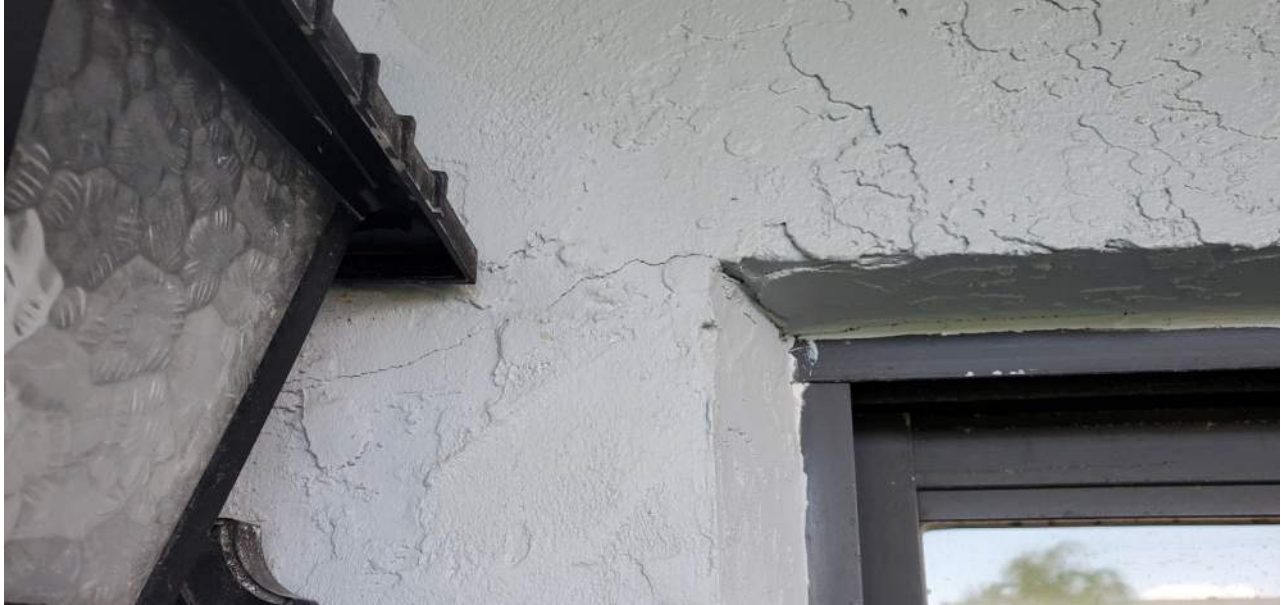
**Example view of concrete wall cracks adjacent to sliding glass door header**

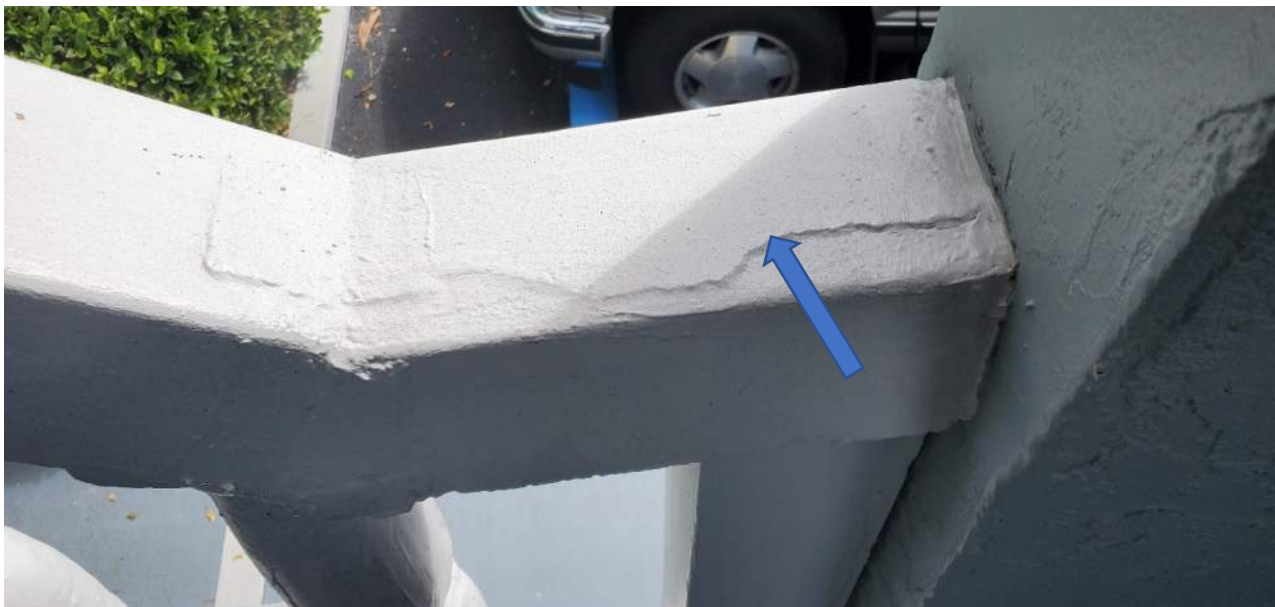
**Example view of concrete walkway stair railing spalling**

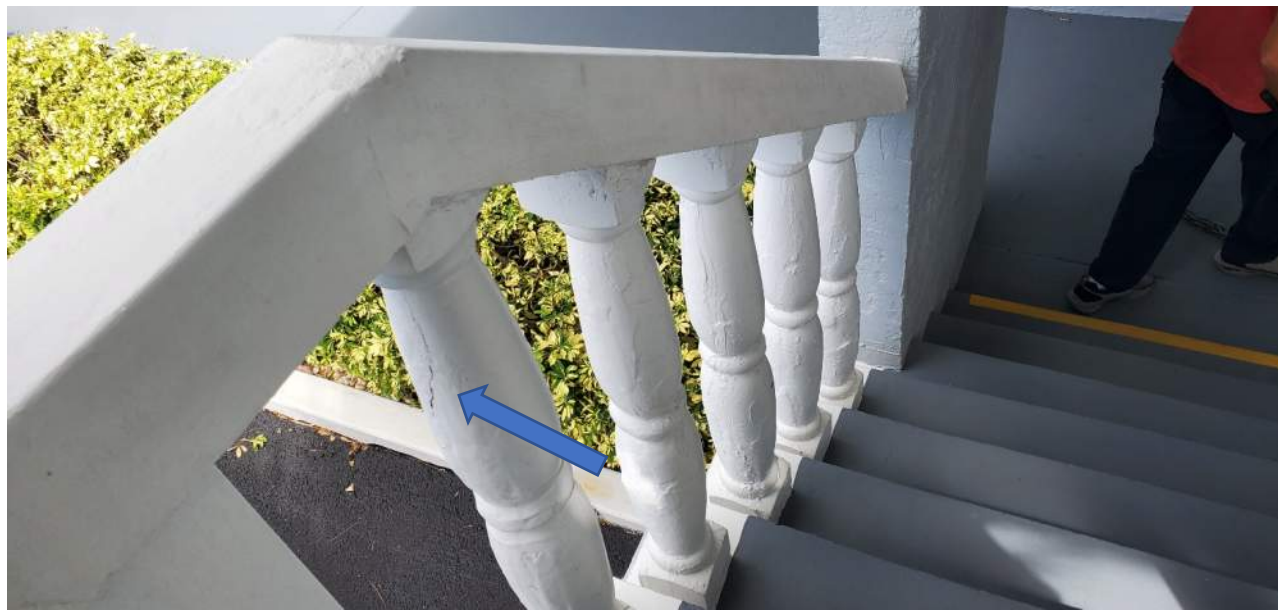
**Example view of concrete walkway stair railing pickets spalling**

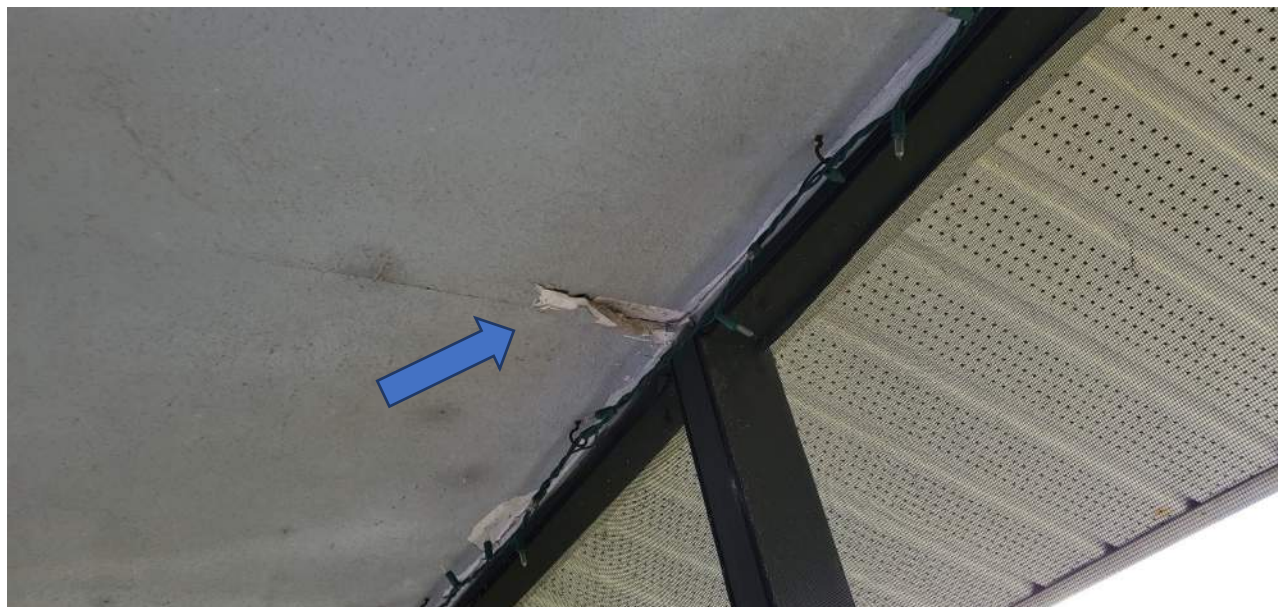
**Example view of spalled concrete ceiling**

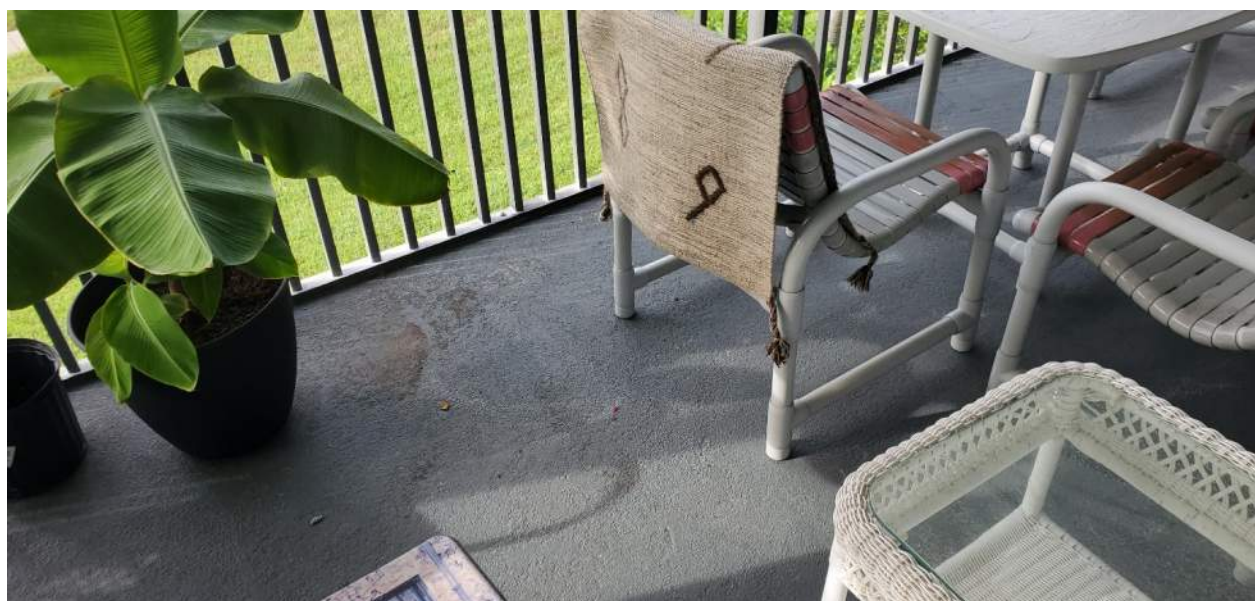
**Example view of worn protective coatings**

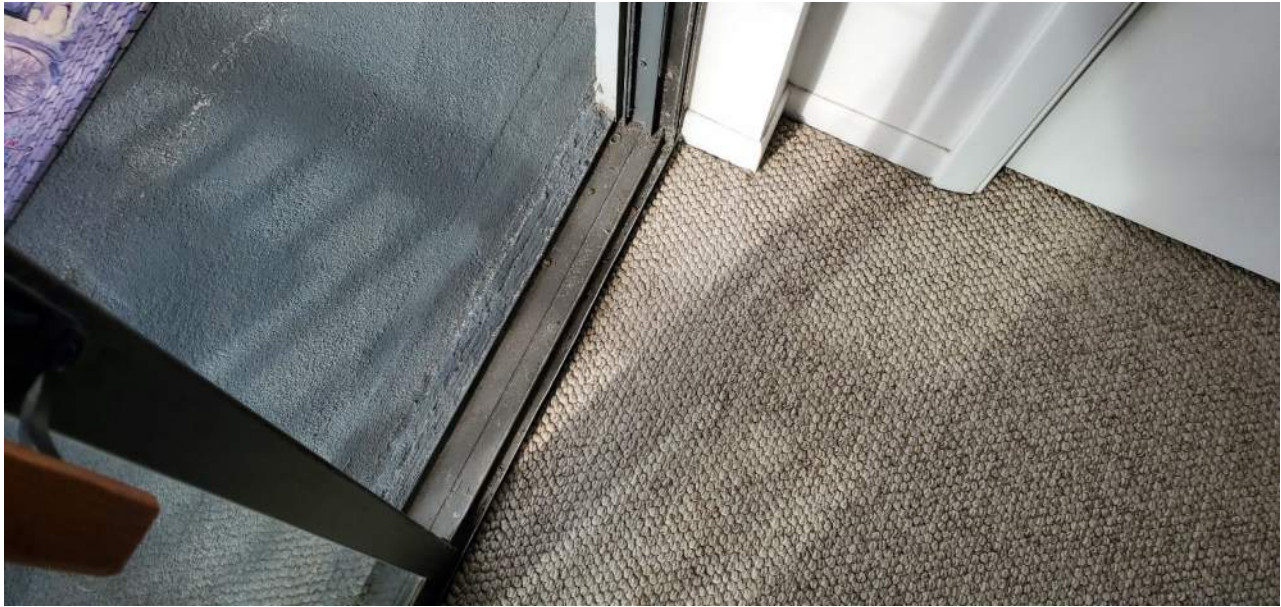
**Example view of rusting fasteners**

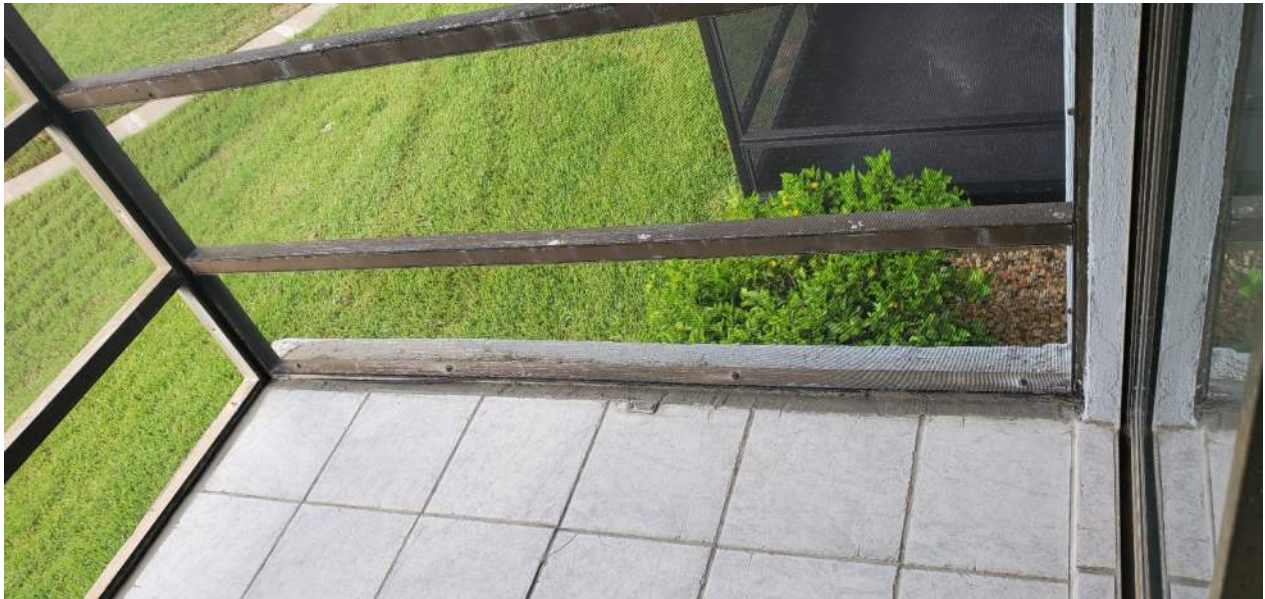
**Example view of aging screens**

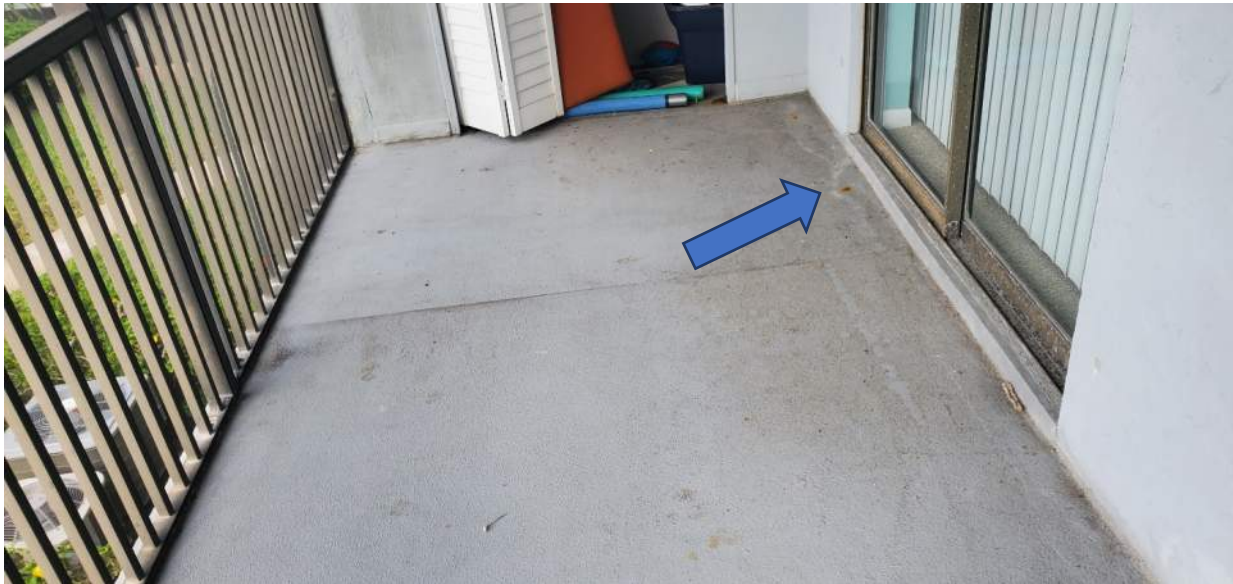
**Example view of concrete spalling by the slider**

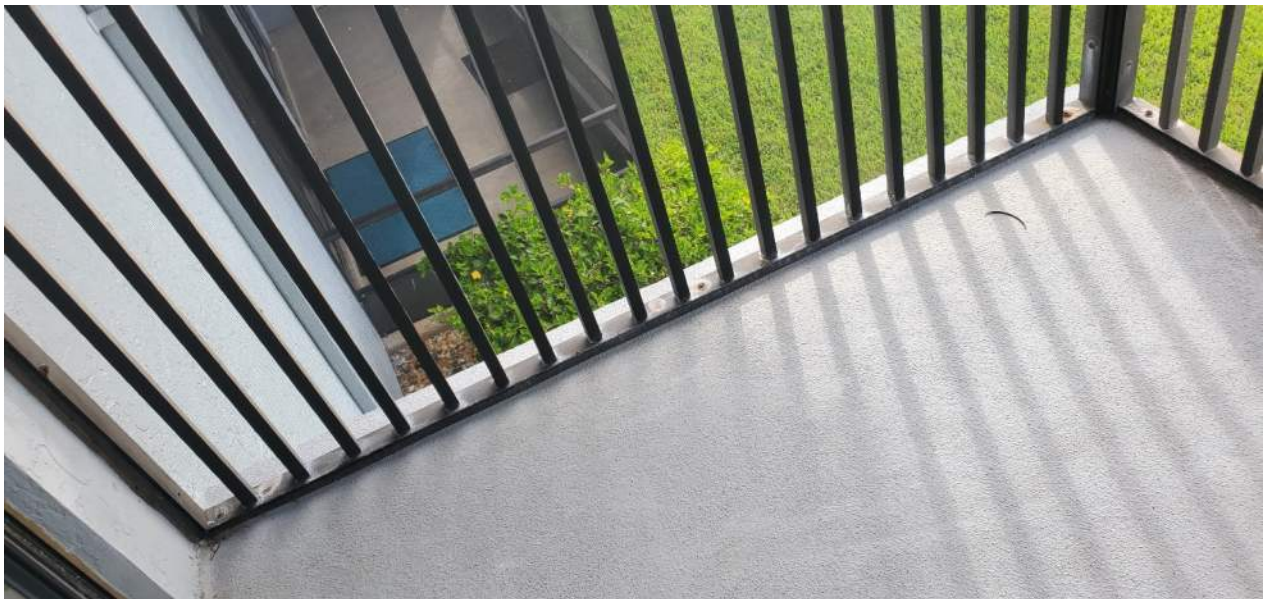
**Example view of rusting screen railing fasteners**

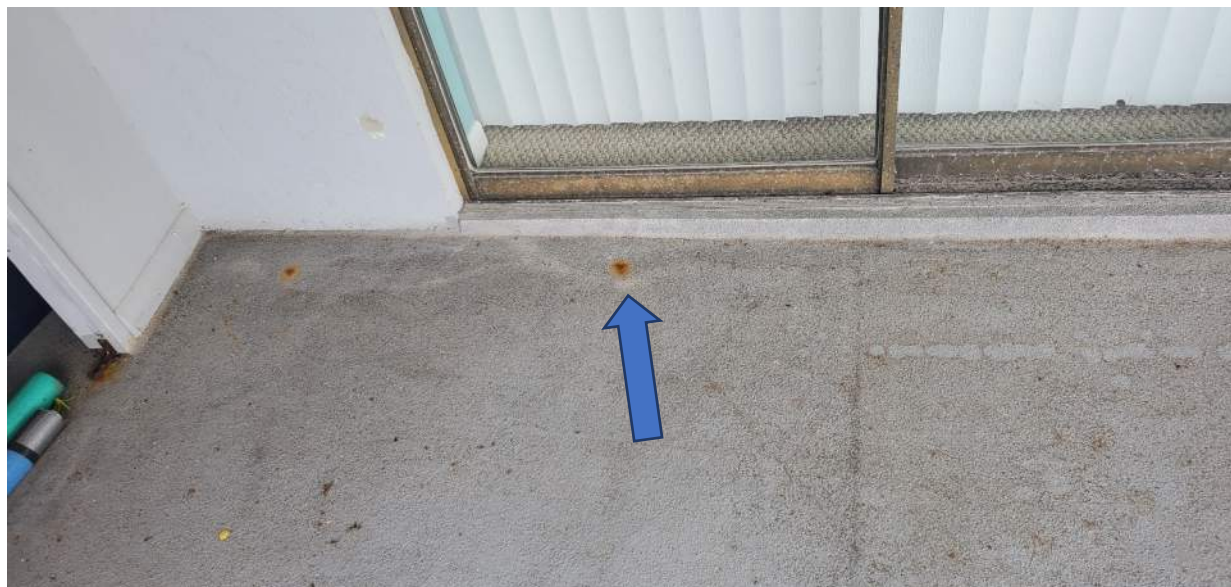
**Example view of concrete spalling and rust spots**

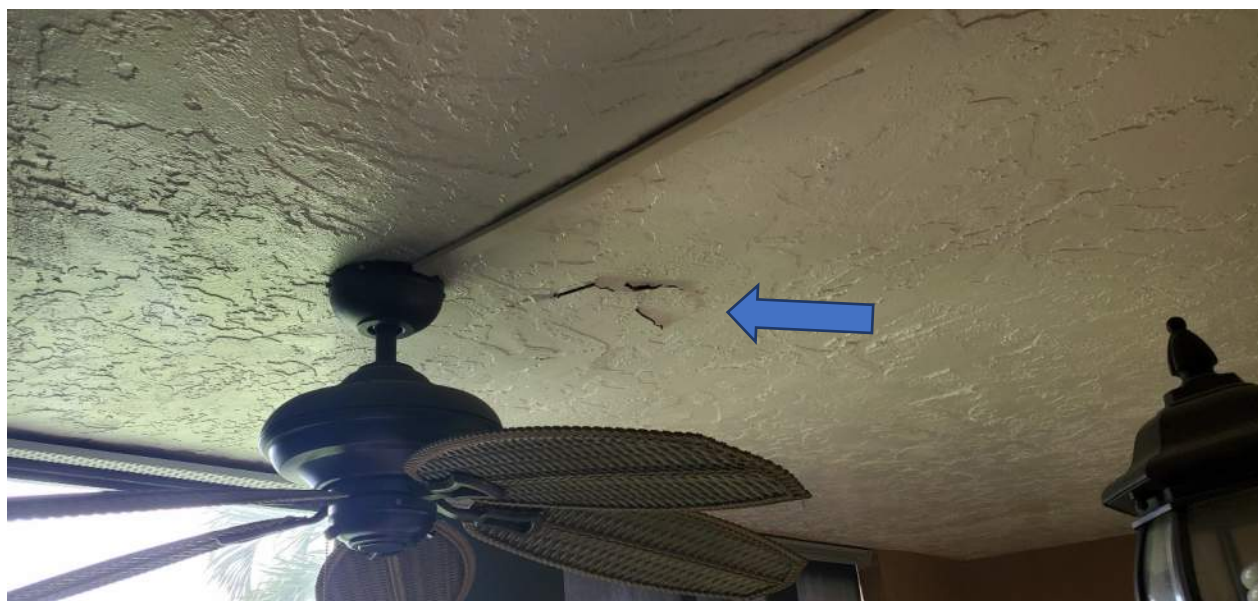
**Example view of concrete ceiling spall**

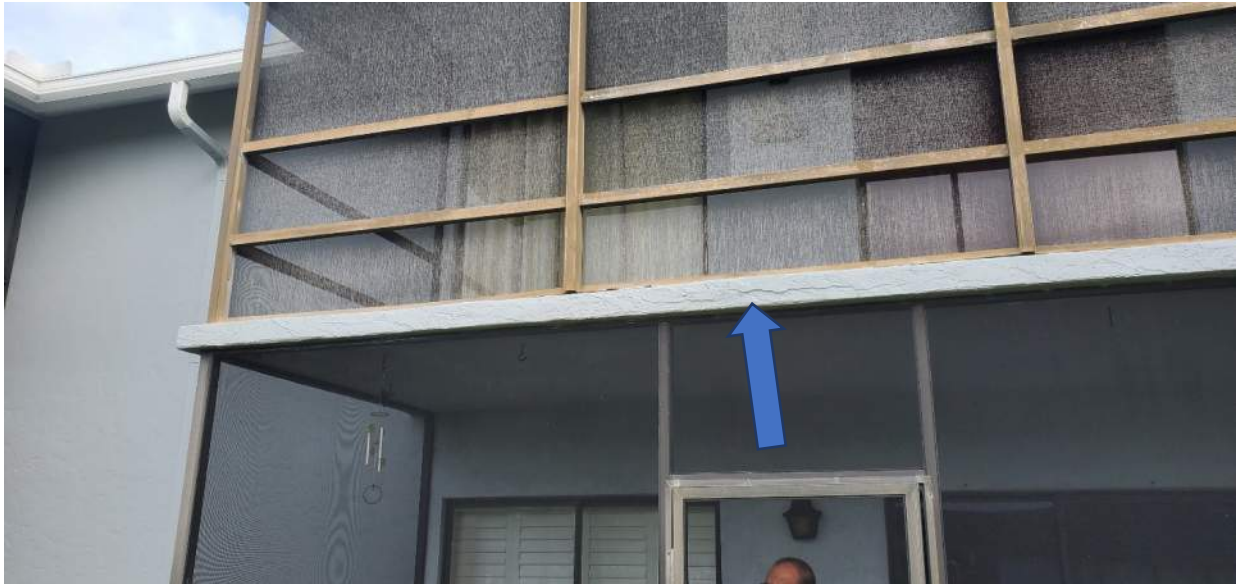
**Example view of concrete edge spalling. Note the old style non picket screens**

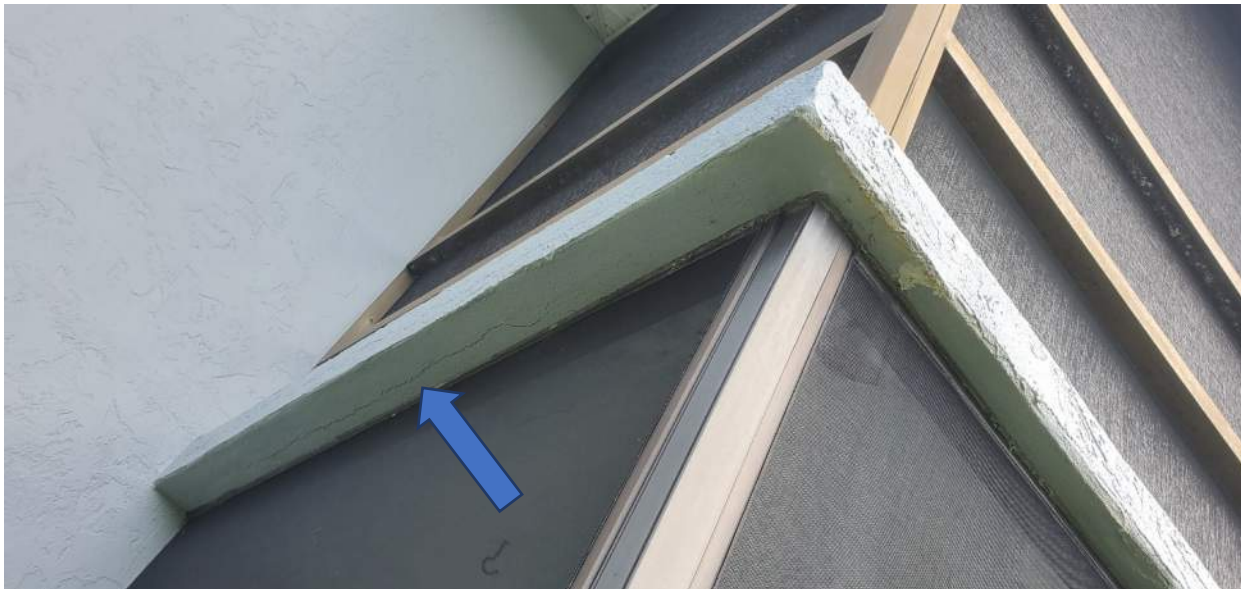
**Example view of concrete edge spalling**

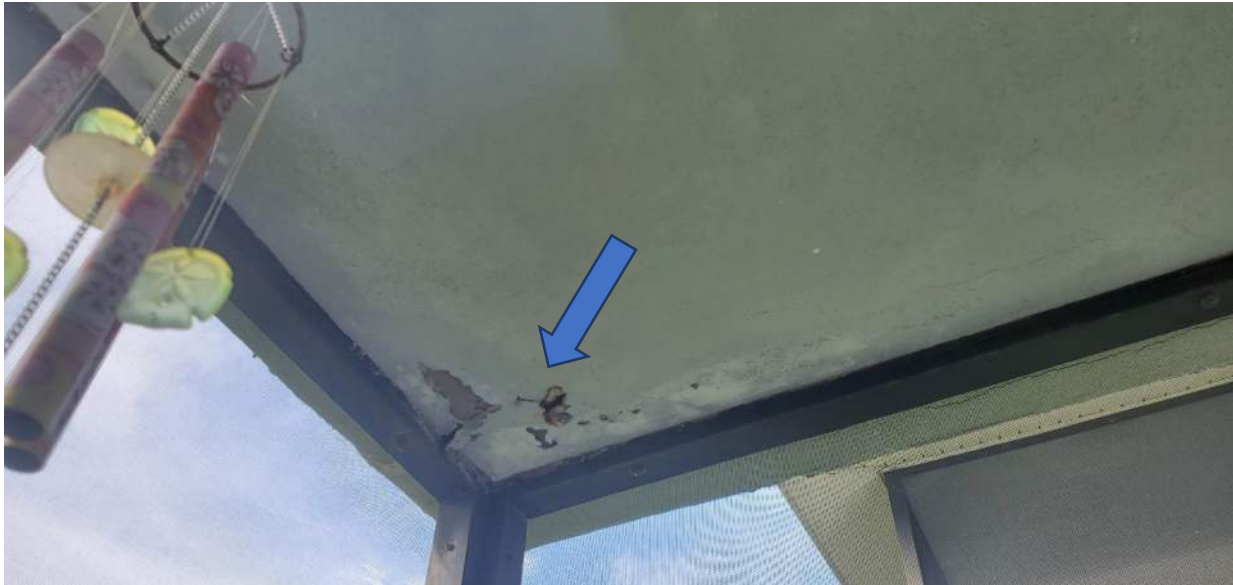
**Example view of concrete ceiling spalling**

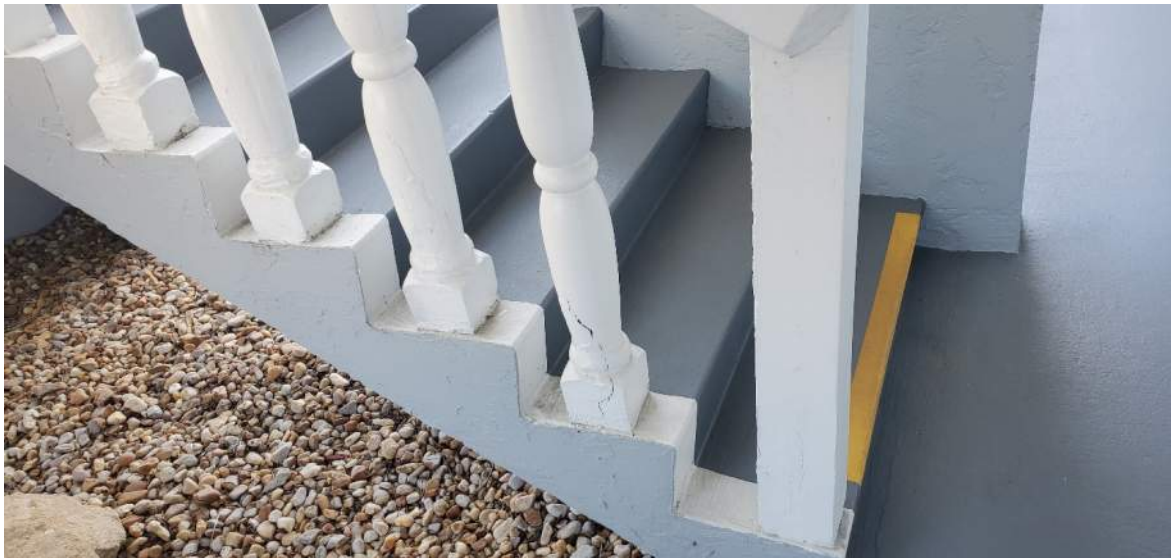
**Example view of spalling concrete stairs post**

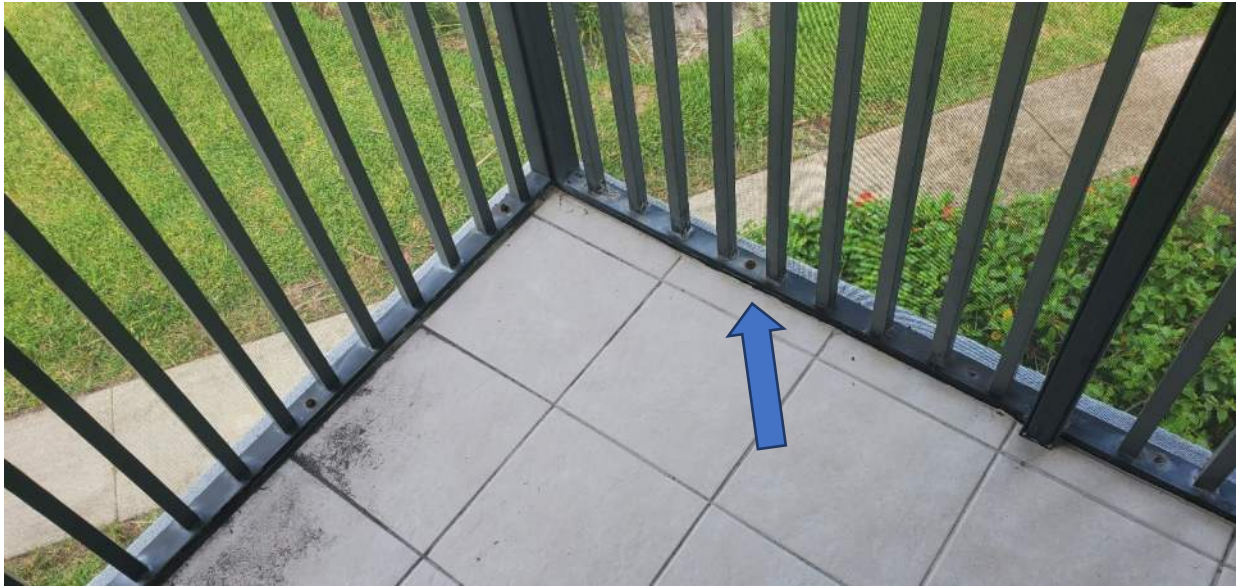
**Example view of rusting screen fasteners and tiled concrete slab**

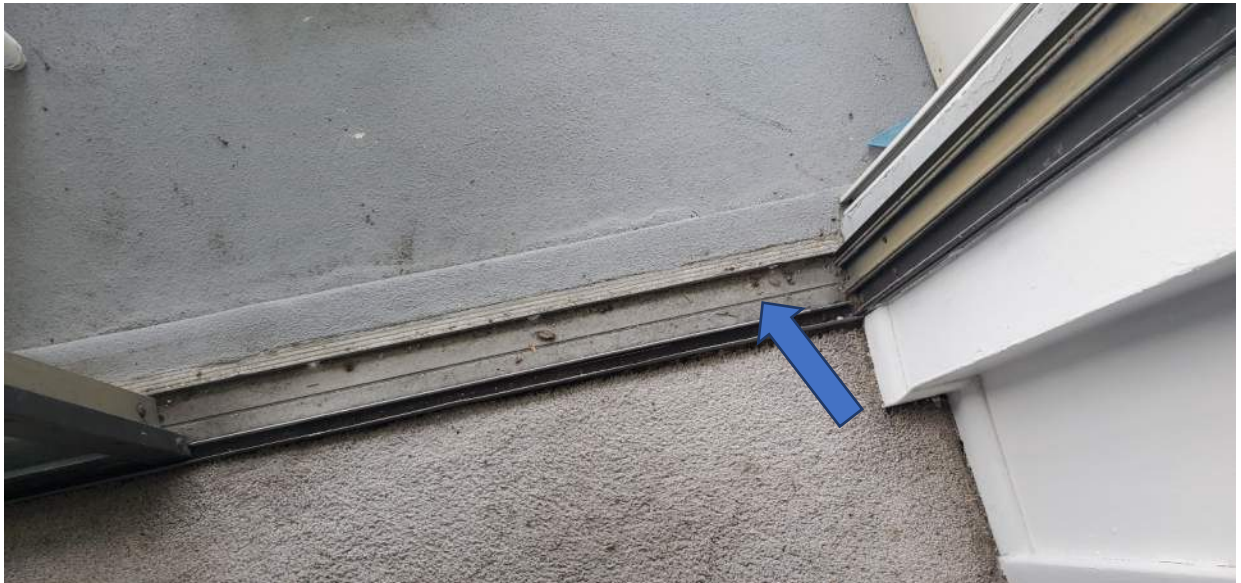
**Example view of rusting fasteners at slider**

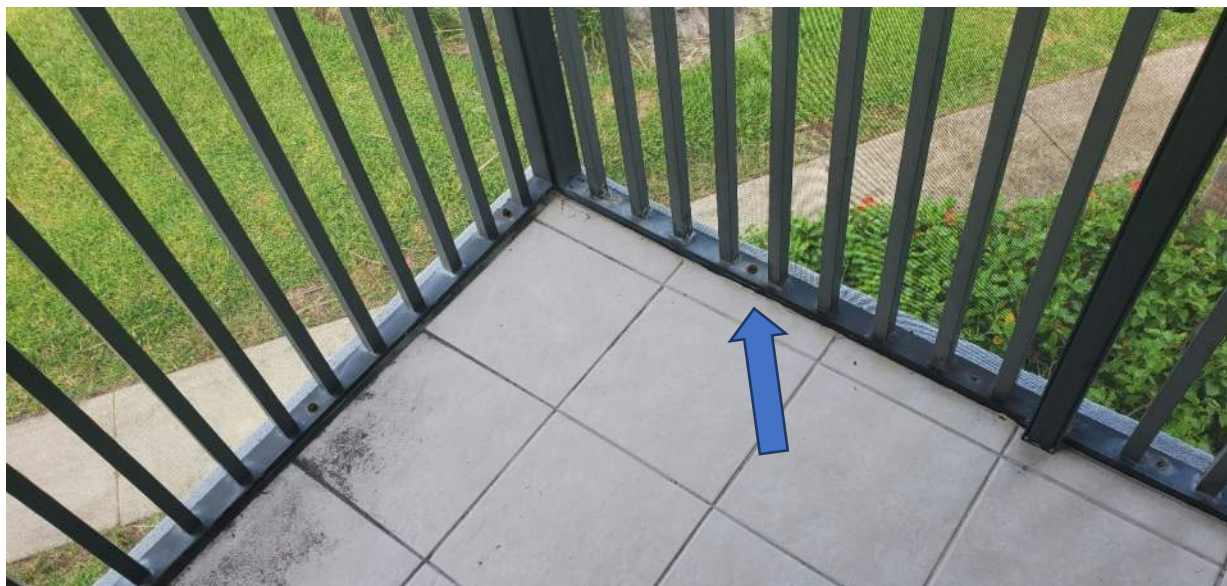
**Example view of rusting screen fasteners and tiled concrete slab**

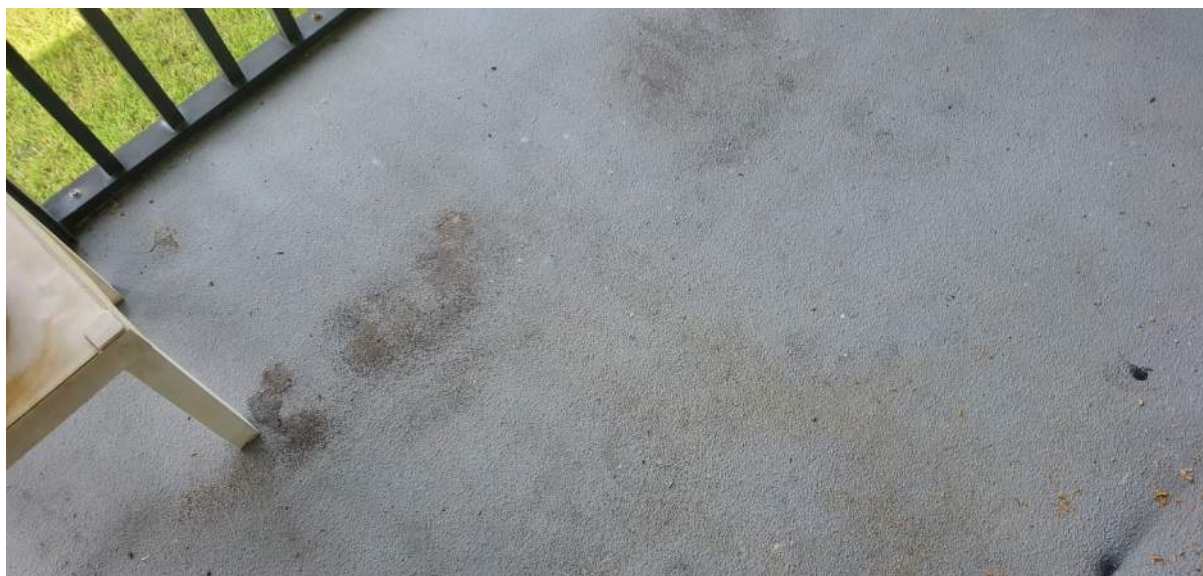
**Example view of slab with bad coatings**

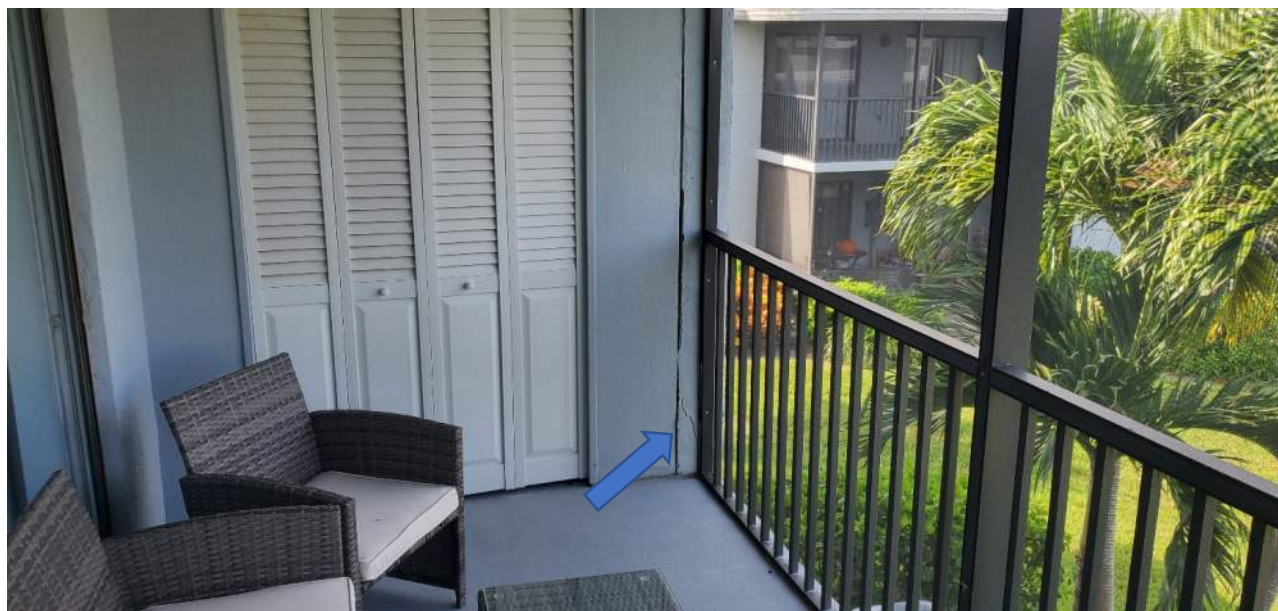
**Example view of concrete column spall**

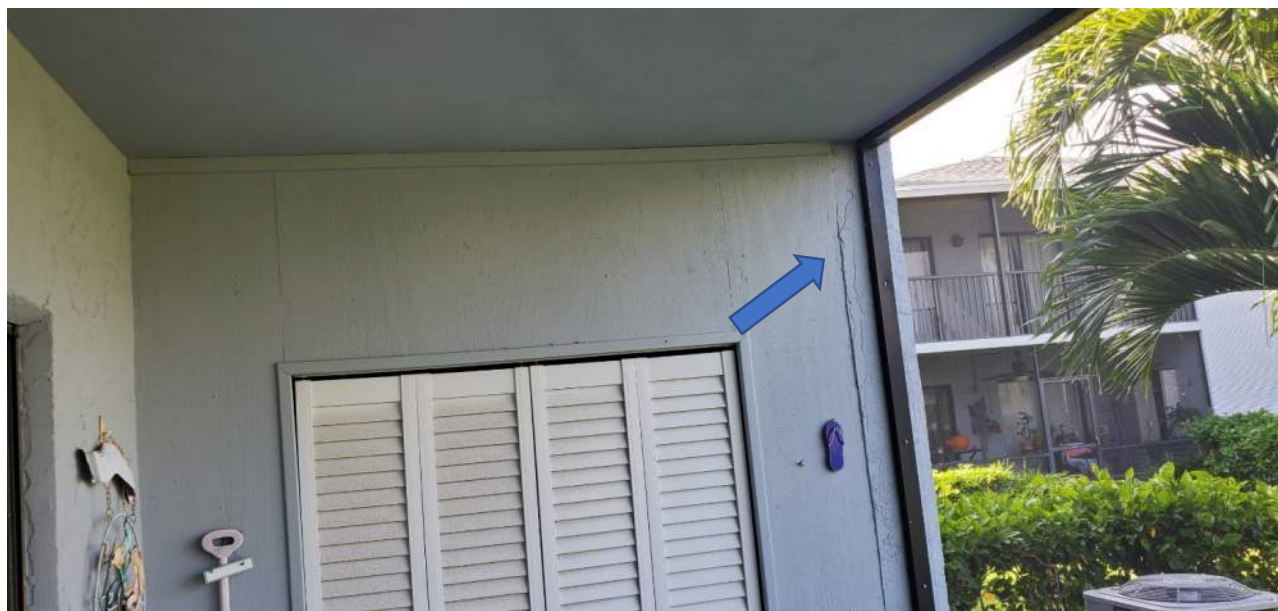
**Example view of concrete column spall**

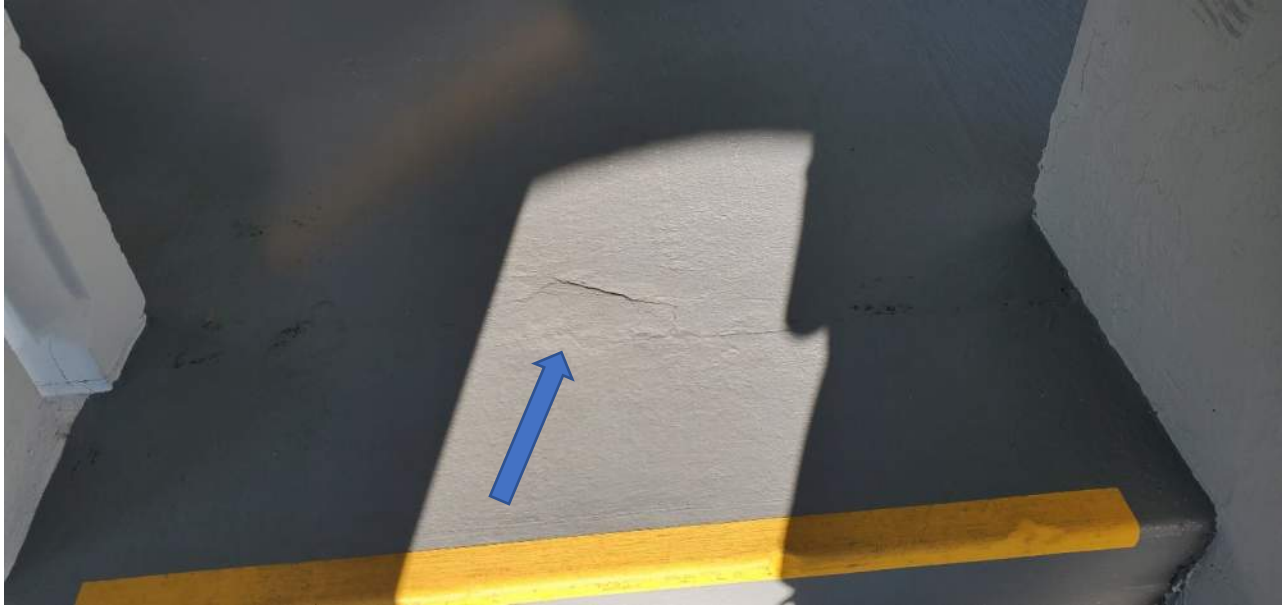
**Example view of damaged coatings on top of the stairs**

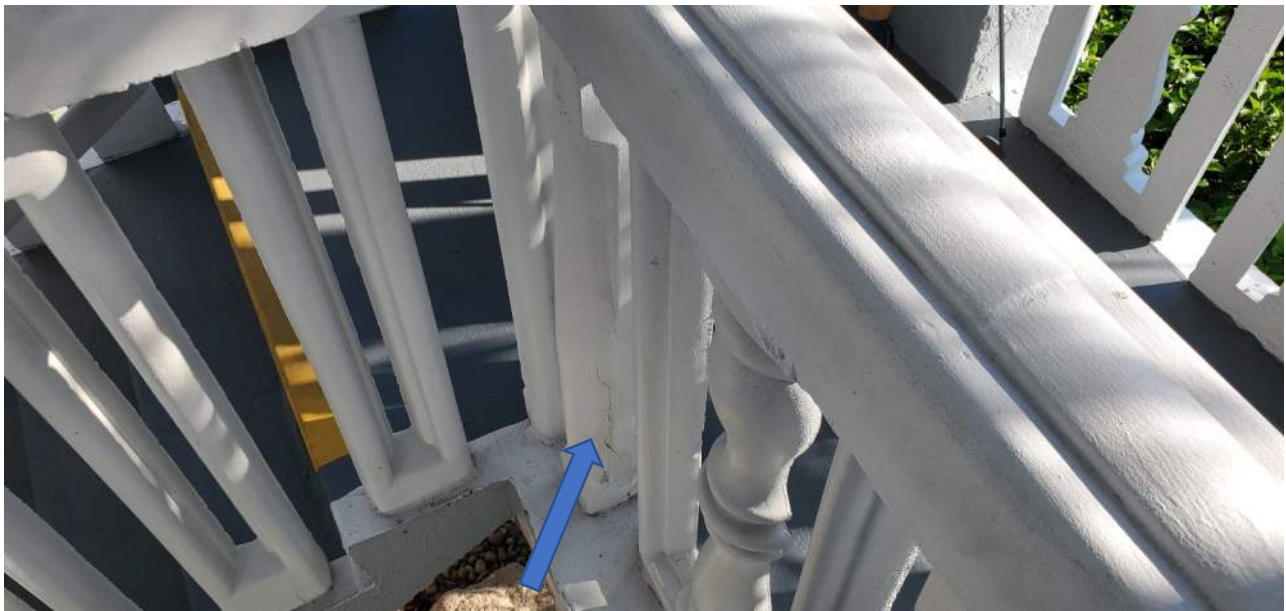
**Example view of spalling concrete railing pickets**

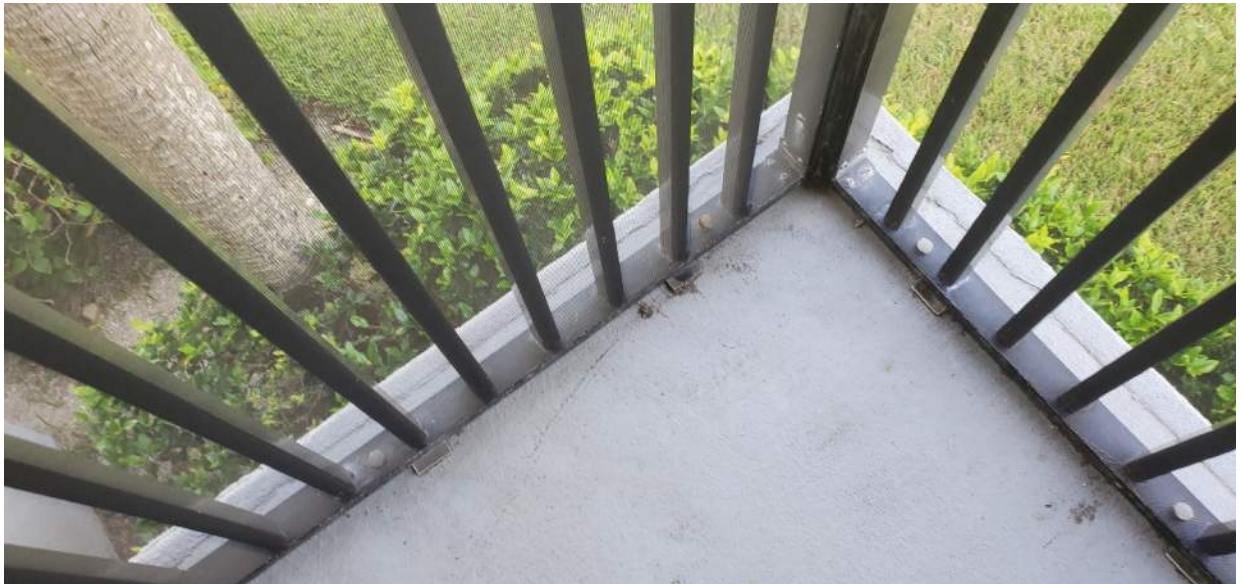
**Example view of slab edge spalls**

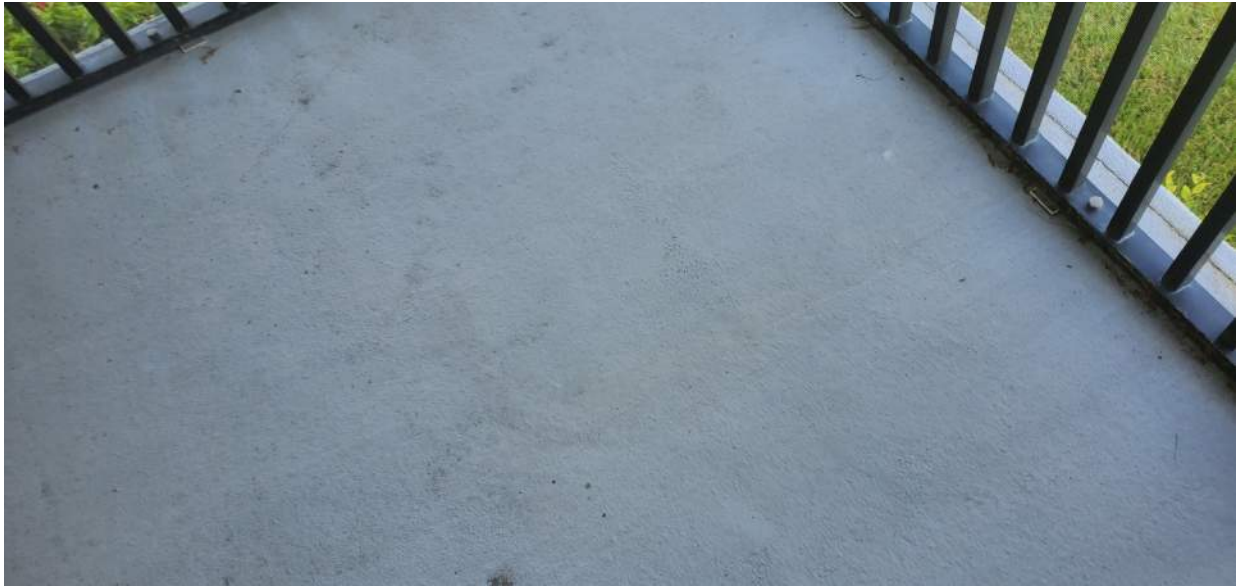
**Example view of weathered coating system**

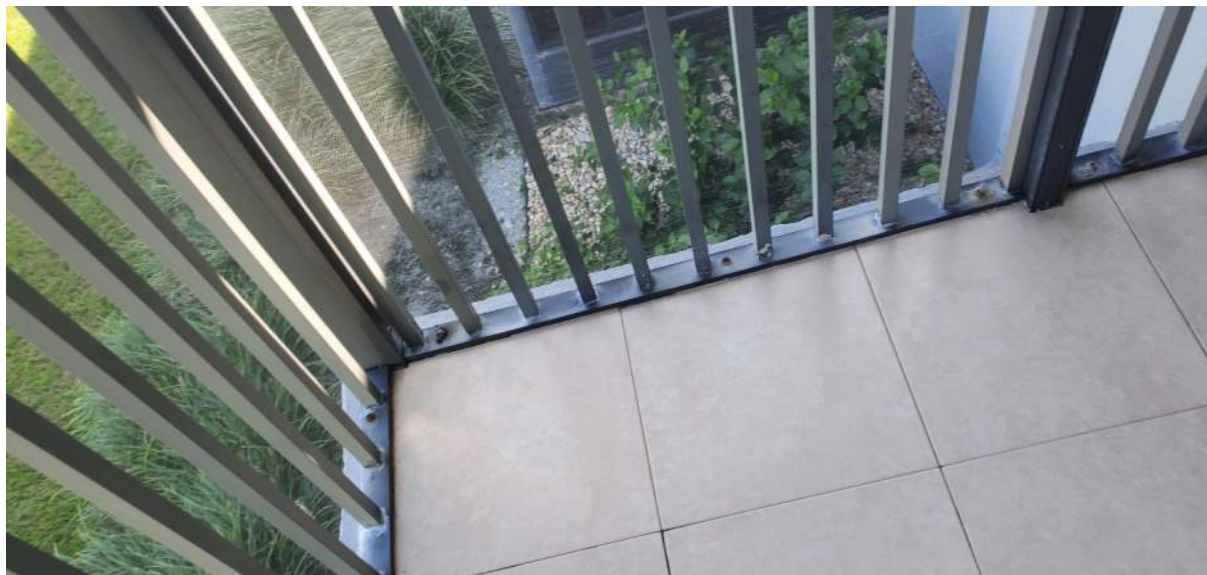
**Example view of corroding screen railing fasteners**

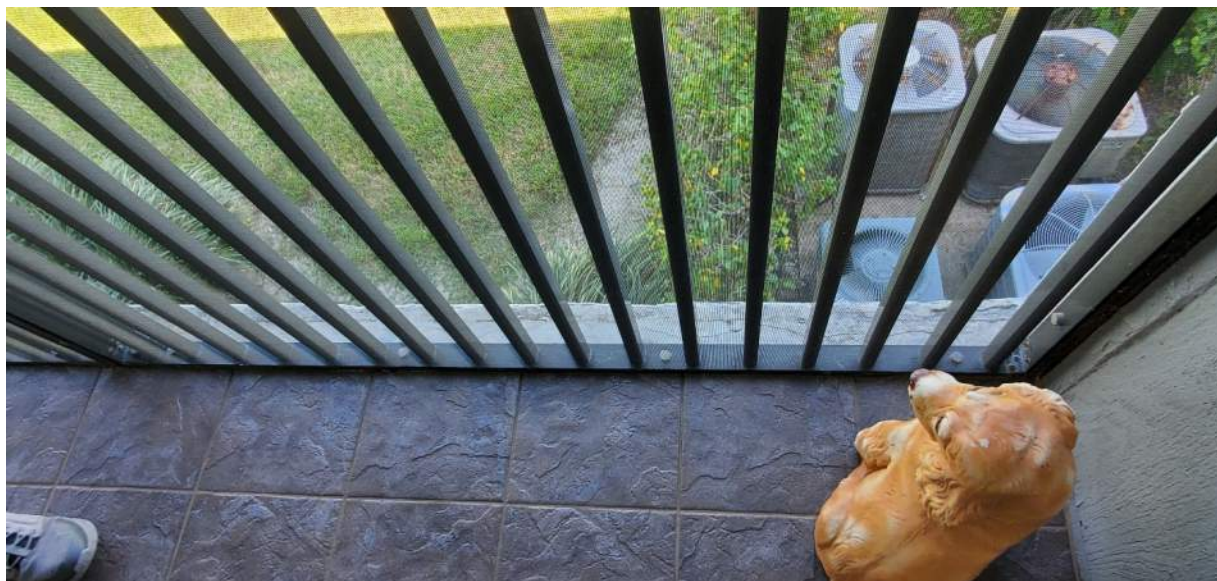
**Example view of slab edge spalls**

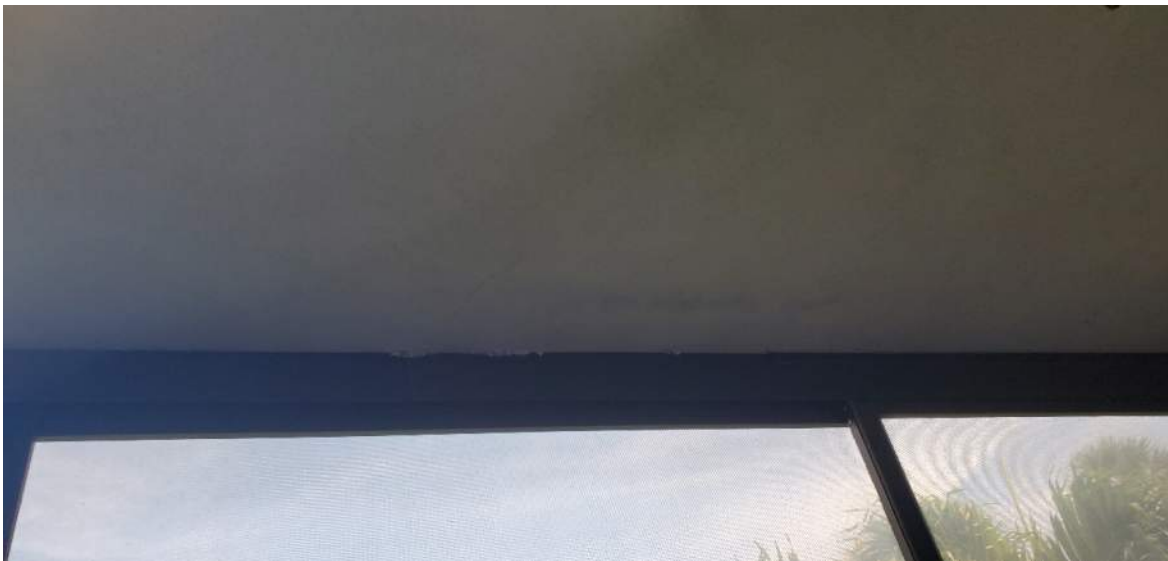
**Example view of concrete ceiling staining**

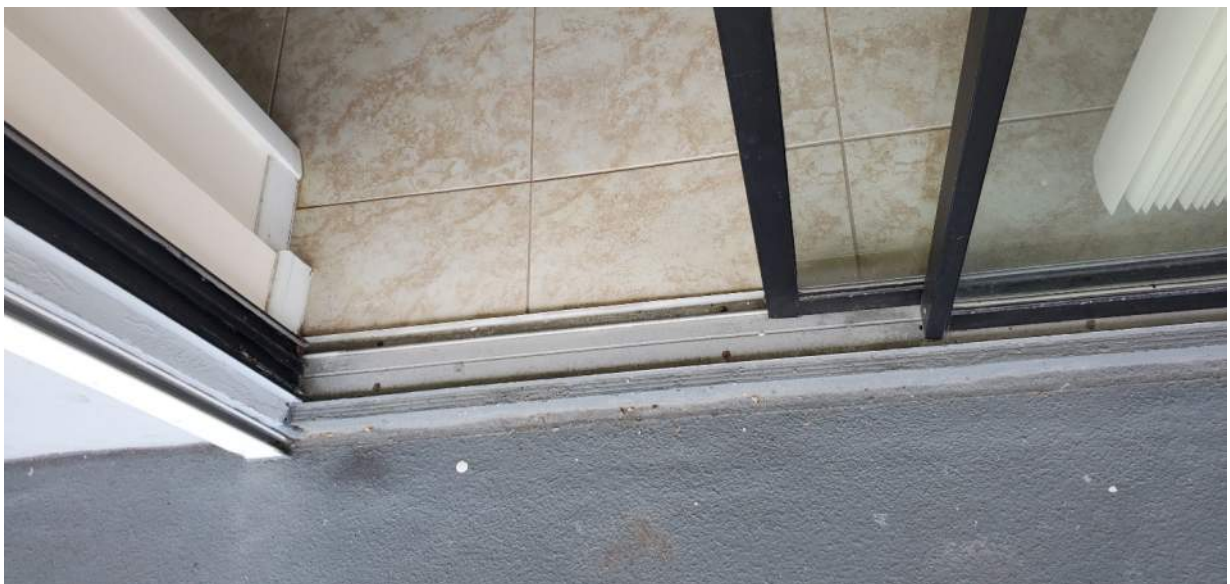
**Example view of concrete spall in front of slider**
