# Four Seasons Condominium

## Condition Survey Report Buildings 1, 2, 3, 4, 5, 6, & 7

# **Four Seasons Condominium Condition Survey Report**

Re: Buildings 1-7 Structural Condition Survey Report

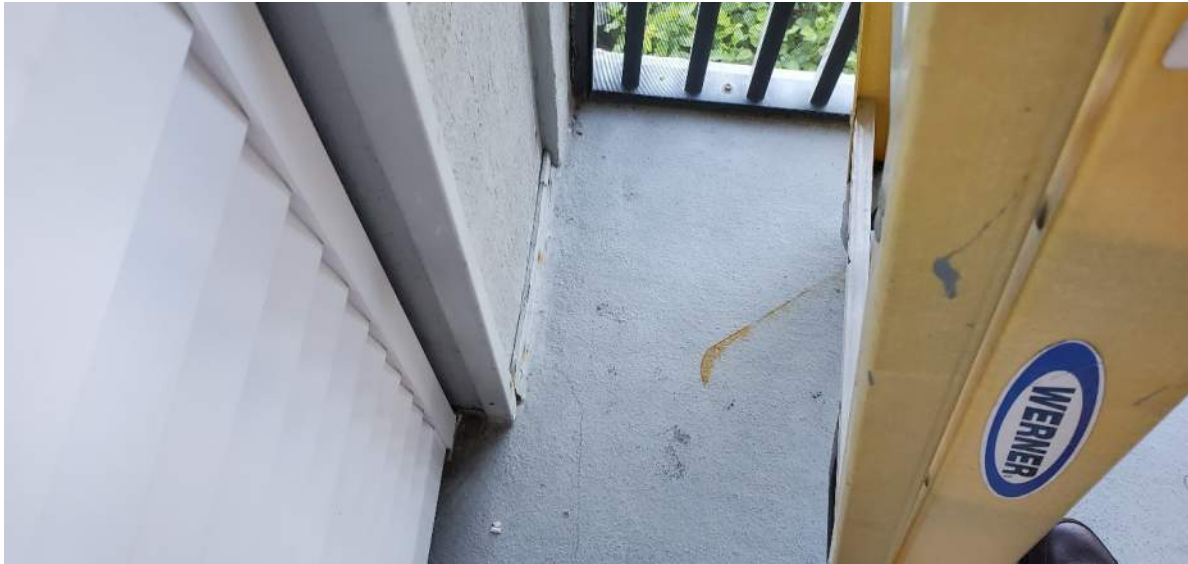
**Example view of concrete cracks**

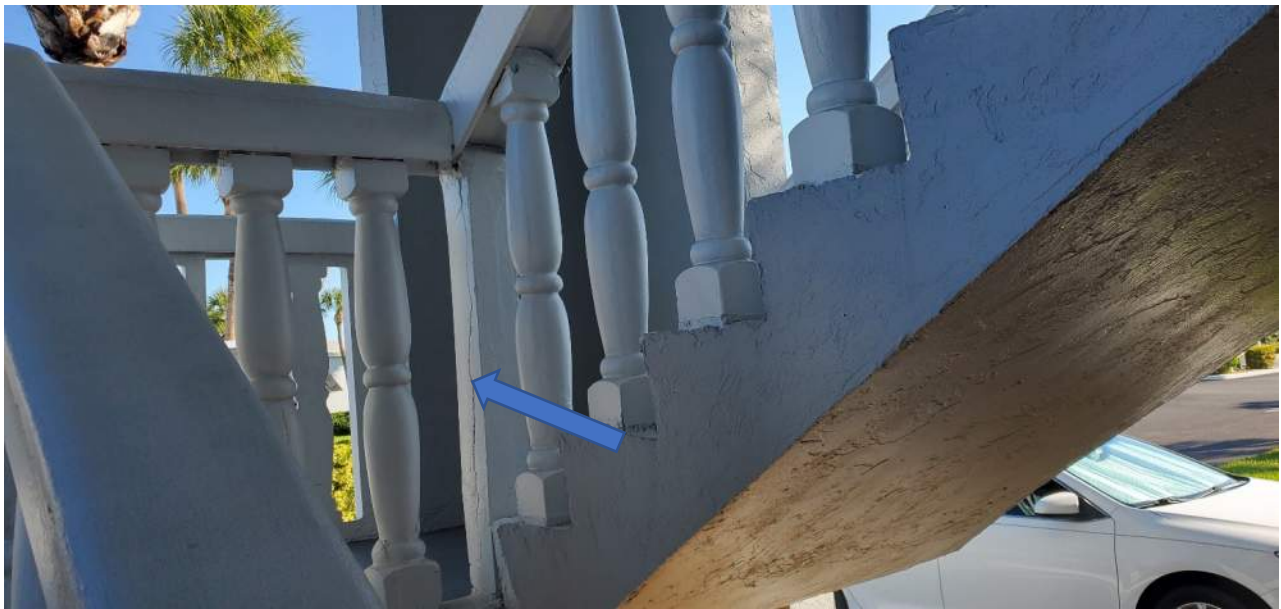
**Example view of concrete walkway stair spalling**

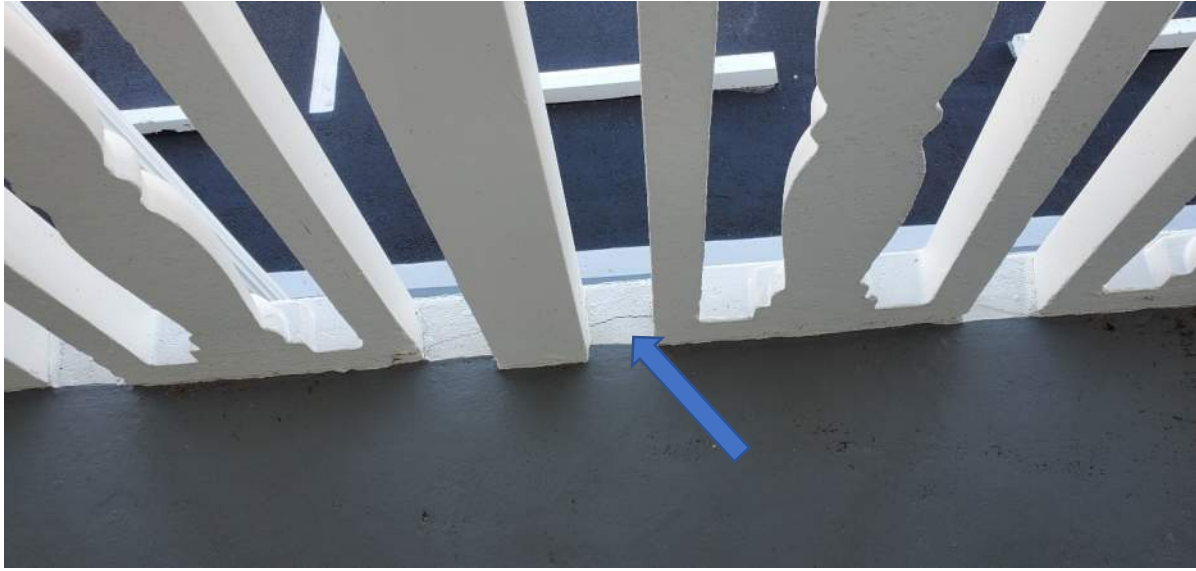
**Example view of concrete walkway edge spalling**
