Project Name Four Seasons		Permit BP-24-719	Project Description Low Slope Full Roof Replacement & Mansard Roof Replacement	
Address 3799 S Banana River Blvd	City Cocoa Beach	State FL	Zip 32931	
Roof Type Mansard Shingles/Roof Coating		Roof Manufacturer GAF	Manufacturer Rep Sean Ramsey- Regional Representative. John Torres- Roofing Inspector	
Prime Contractor Tech Systems		Contractor Contact Jim Swope		
Mechanical Erwin Air		Mechanical Contact Scott Erwin

Progress Summary Report

Site Visit Date(s) Multiple, varied and unannounced.	Keystone Inspector Curt Adamovsky	
Reporting Period Monday, January 05, 2025 through Friday, January 31, 2025.	Weather Steady winds have been present and precipitation chances vary.	Temp Typical for this month of January

FOUR SEASONS CONDOMINIUMS PROJECT REVIEW NOTES FOR THE LOW SLOPE& MANSARD ROOF REPLACEMENTS

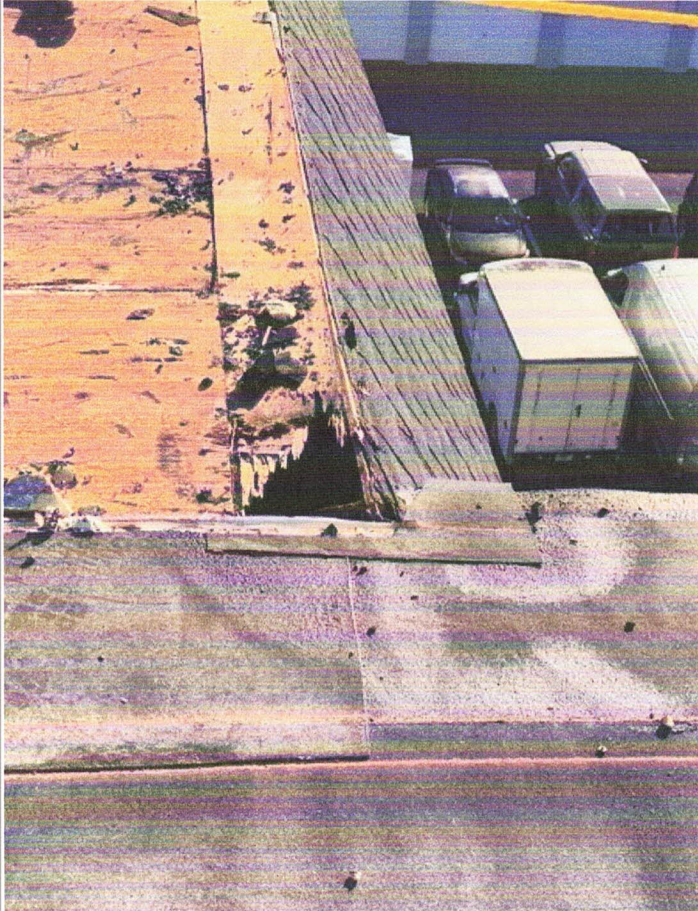
Typical deteriorated wood decking at the perimeter.

3. 3-ply 15/32" plywood (4'x8') sheets, were used to replace existing deteriorated decking, in various locations. Quantities listed below:
Building 8: Seven (7)
Building 9: Seven (7) with 20'LF of 2'x4's
Building 10: Seven (7)

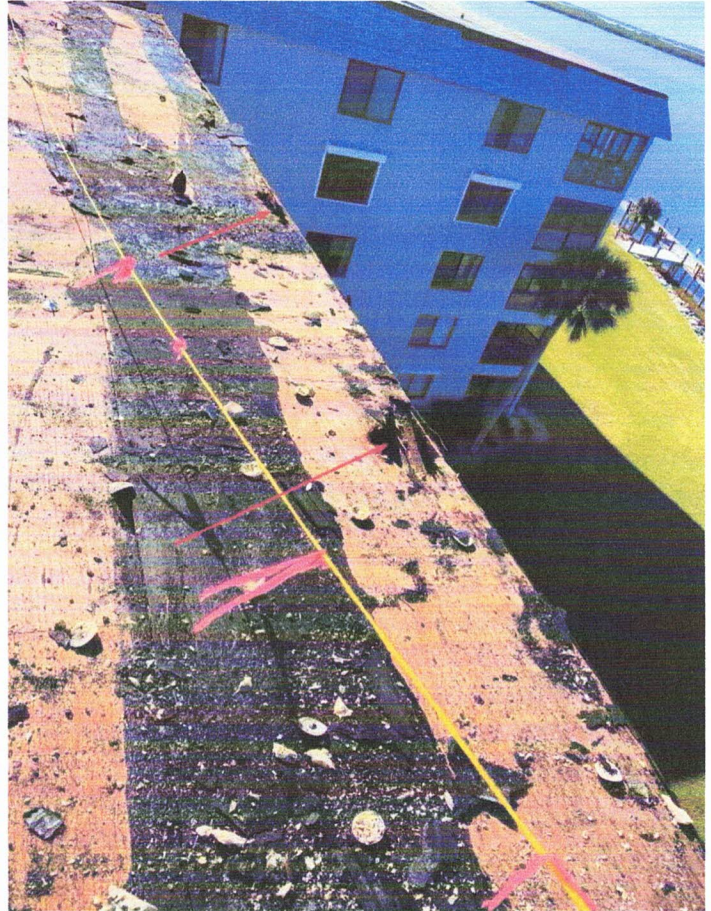
Red arrows indicate deteriorating wood decking at conditions at the perimeter.

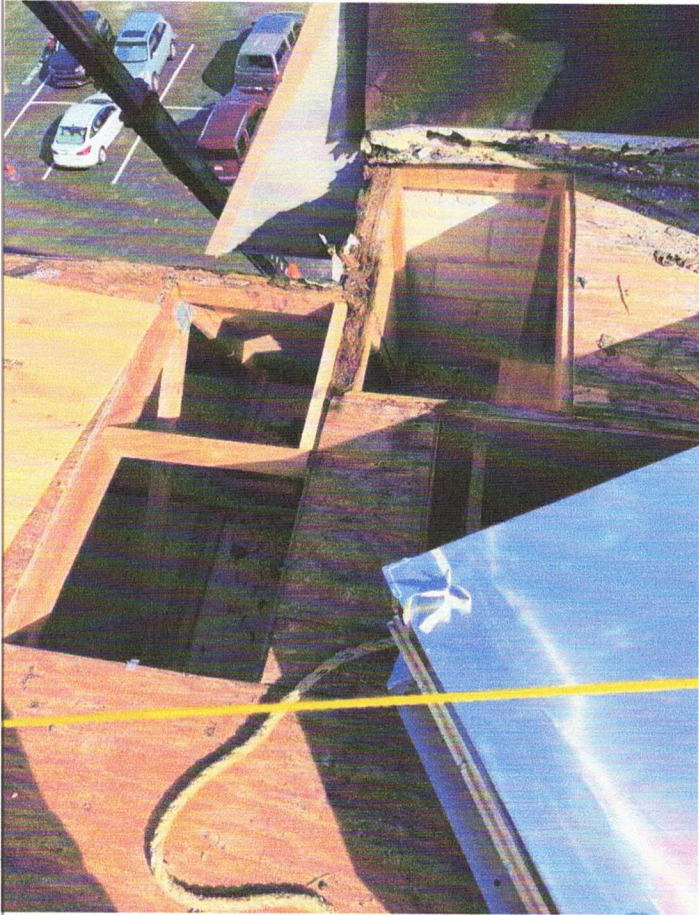
In progress wood replacement of the existing decking and framing members.

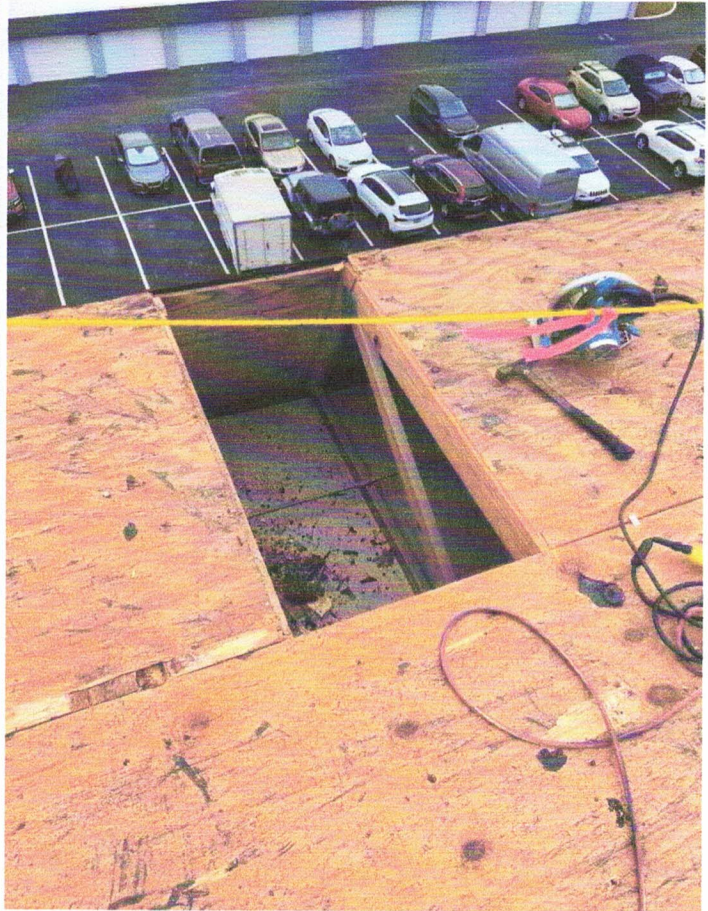
In progress wood deck replacement.

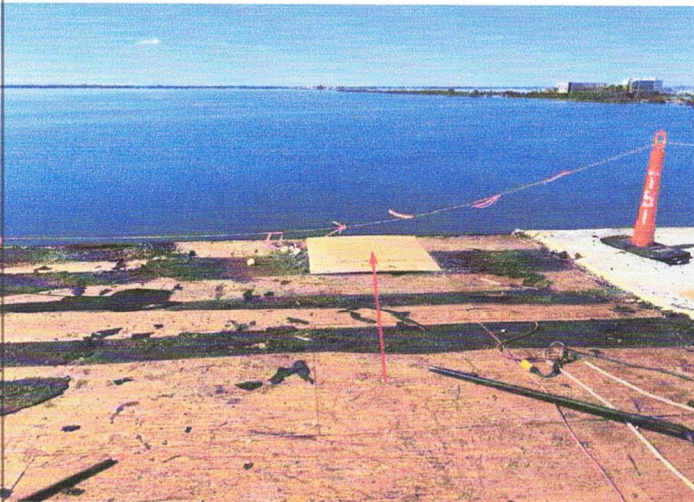
In progress new plywood sheathing installation.

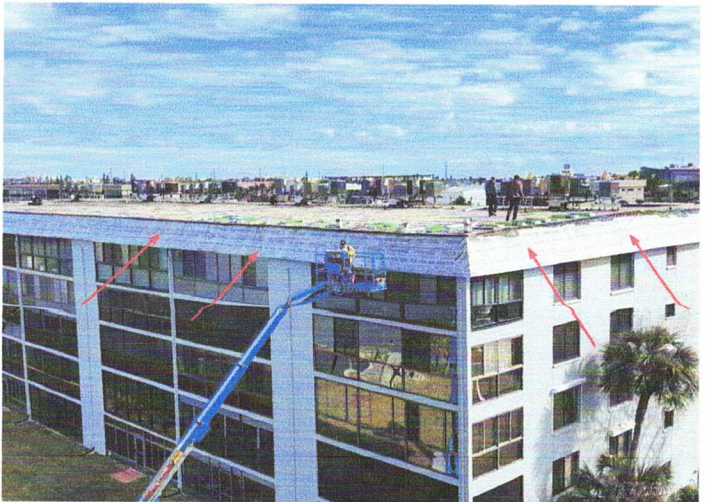
In progress installation of the self-adhering underlayment continues.

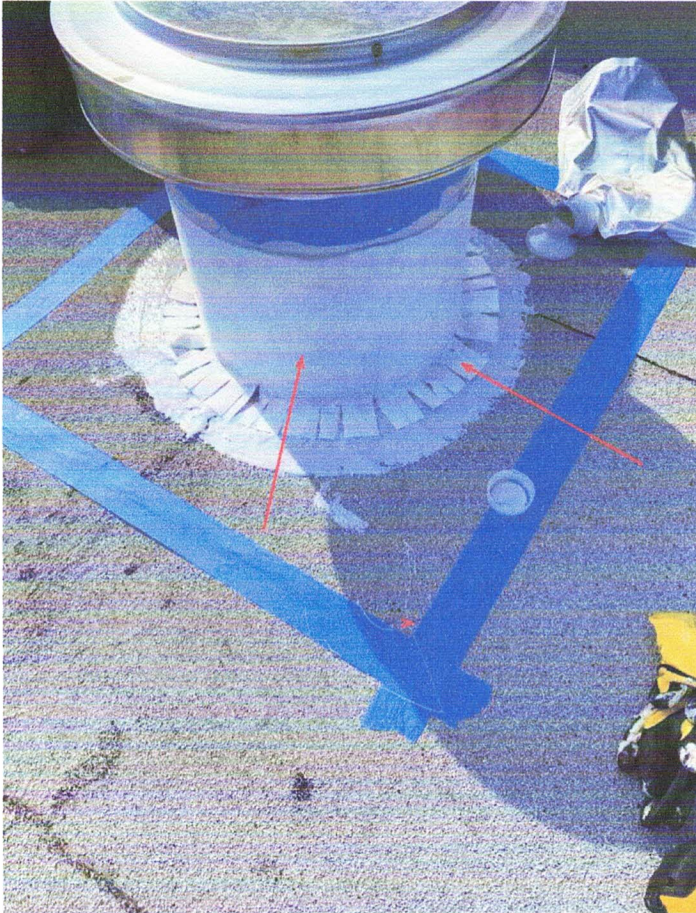
In progress installation of the liquid-applied reinforced flashing system for penetrations.

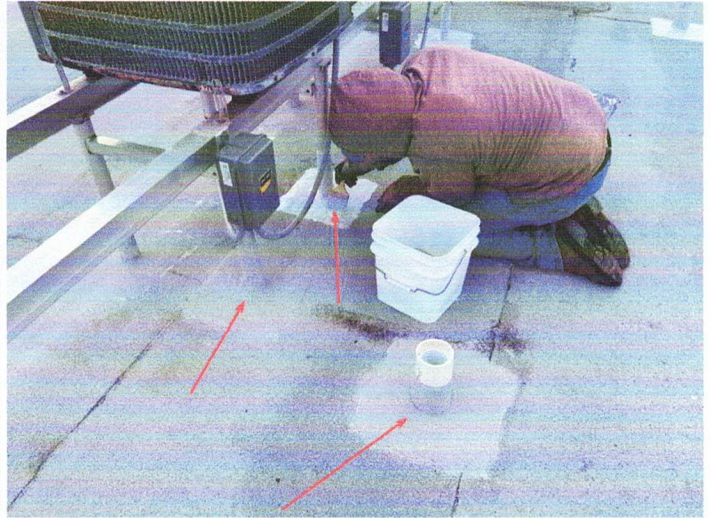
In progress installation of the liquid-applied reinforced flashing system.

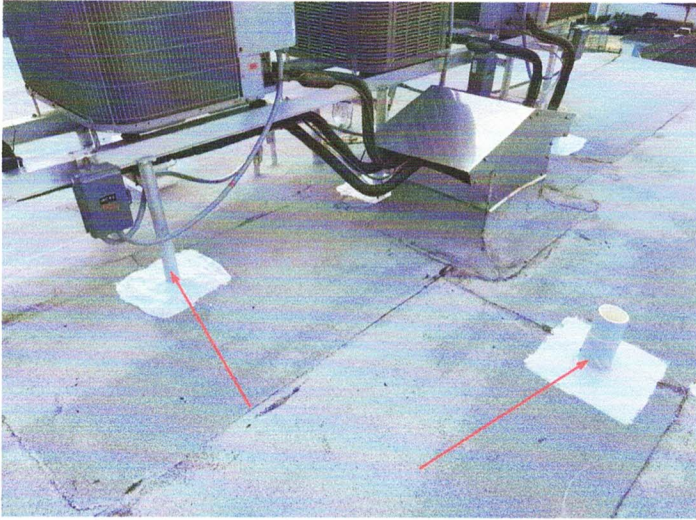
Vent stacks and mechanical stand legs being flashed to manufacturer's specifications.

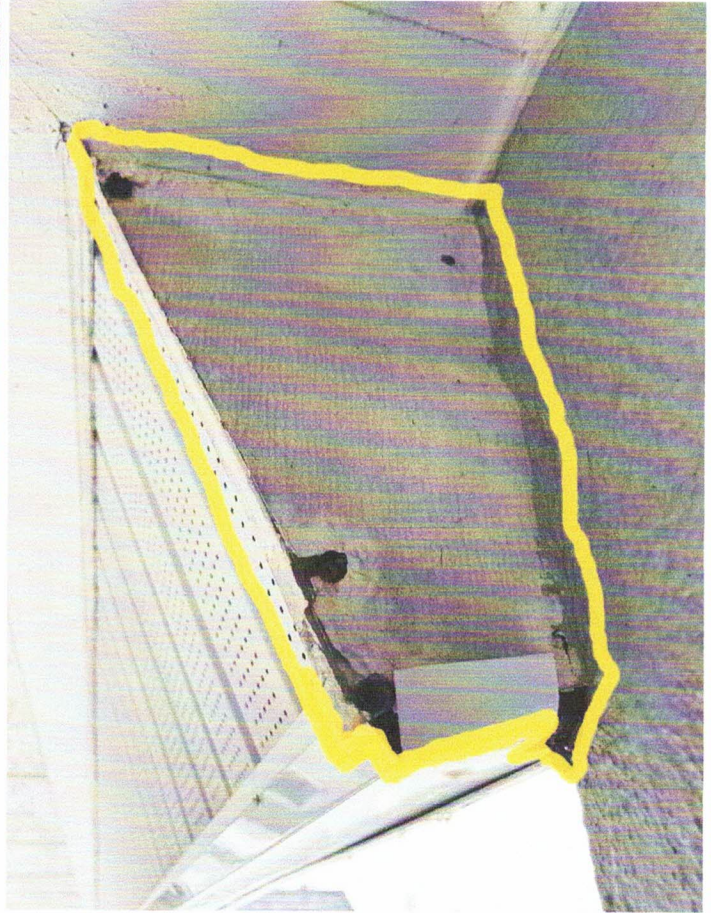
Yellow highlighted area needs new aluminum components to properly seal. This is scheduled for completion.

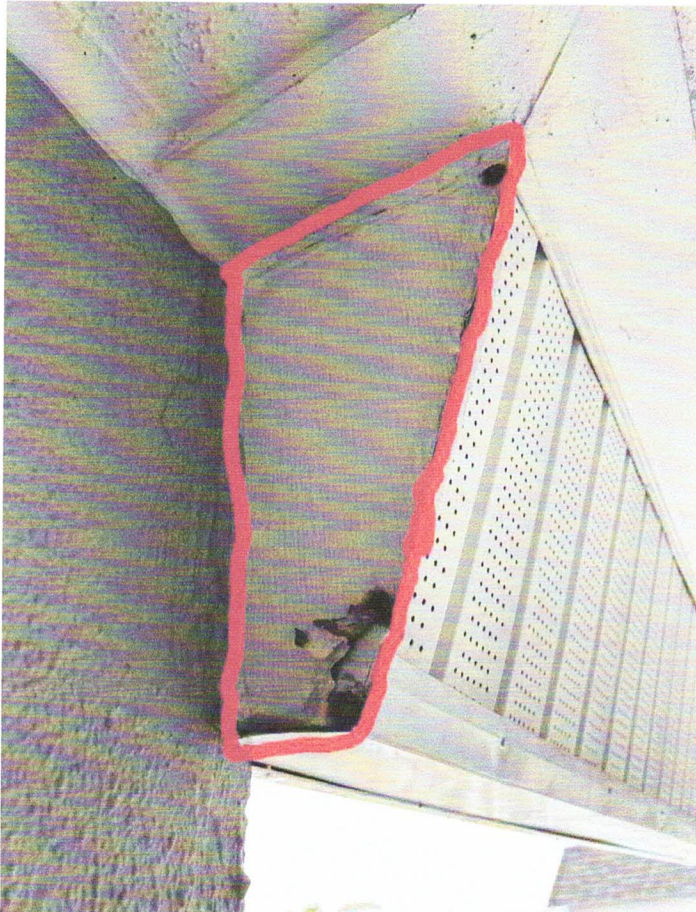
Red highlighted area indicates existing soffit end closure that will be replaced with new.

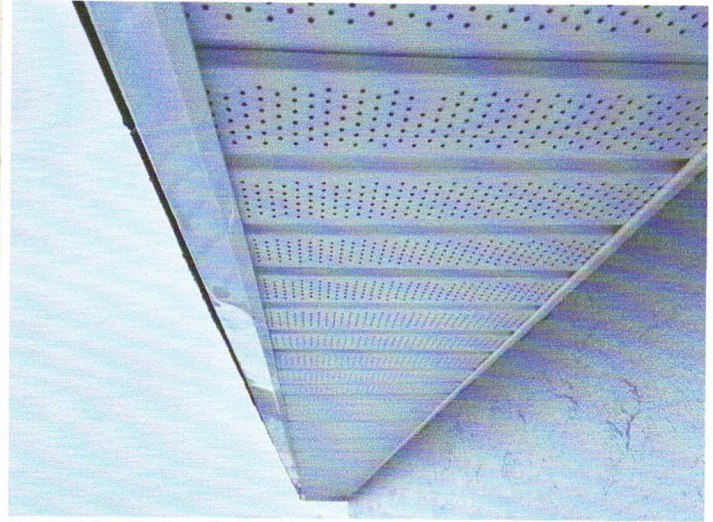
New white vented vinyl soffit assembly on the mansard.

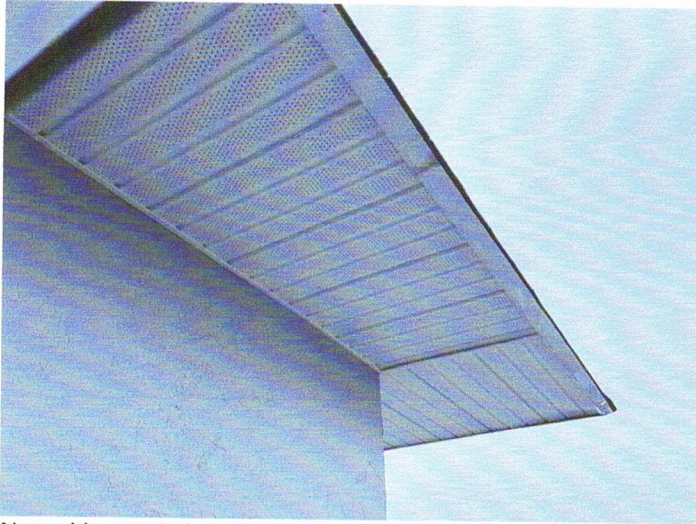
New white, vented vinyl soffit assembly on the mansard.

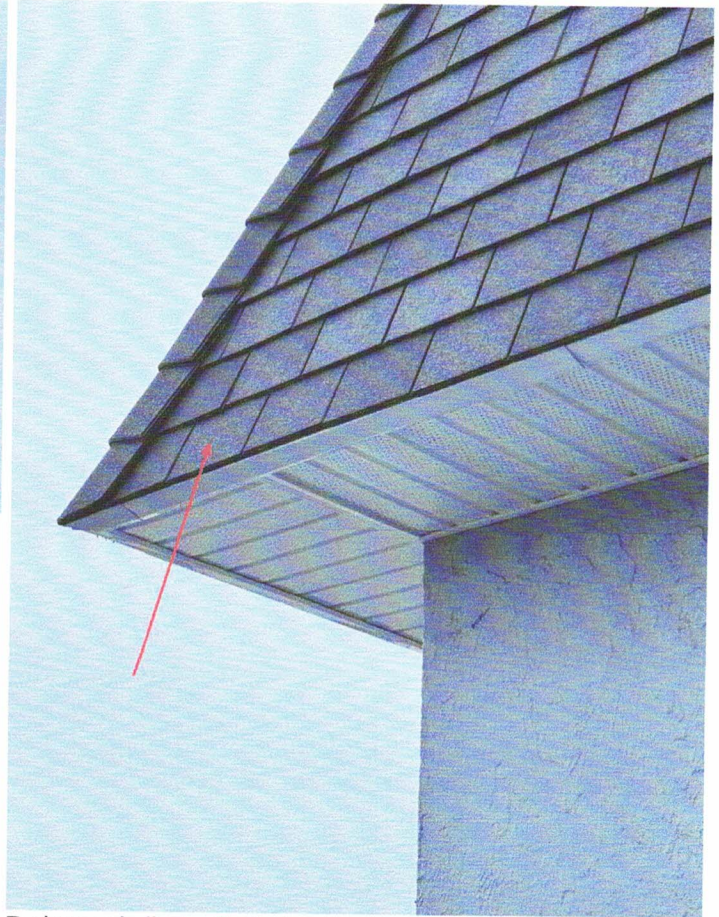
Red arrow indicator illustrates the new GAF Timberline HDZ shingles.

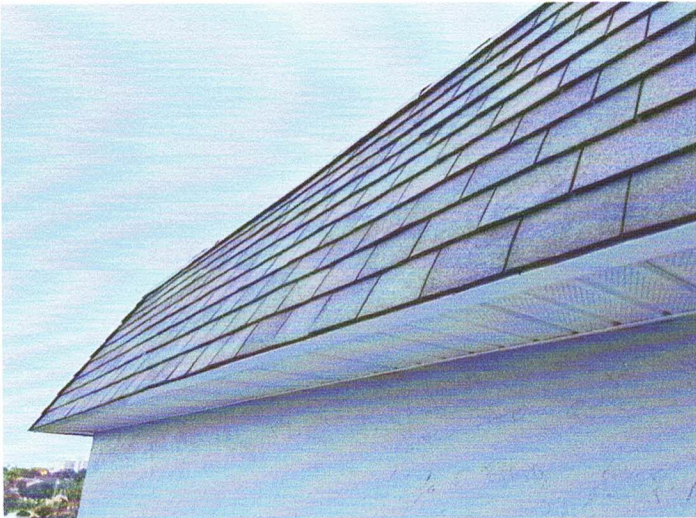
Properly installed GAF Timberline HDZ shingles installed to manufacturer's specifications.

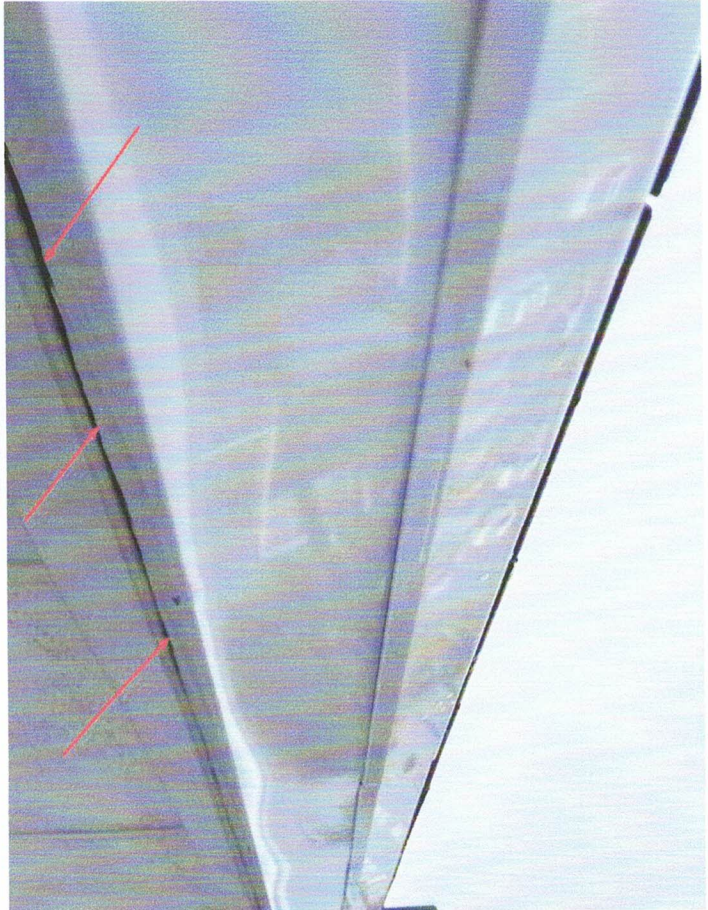
Red arrow indicators illustrates the gap shown in the metal components of the vented soffit assembly. These deficiencies were noted on building 8. They are scheduled to be corrected.

Please Note: The specified scope of work, referenced above in line item #4, has been completed, on buildings: 8, 9, 10. There are some areas need some additional attention to various details. These punch list items were discussed with Jim Swope from Tech Systems. We will re-visit these locations for completion or correction, upon notification from Jim, that the repairs have been made.

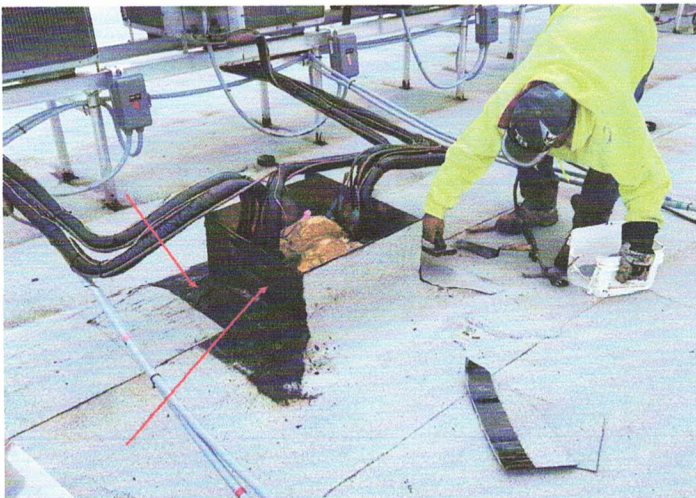
Red arrows indicate torch priming process was used in the flashing procedures.

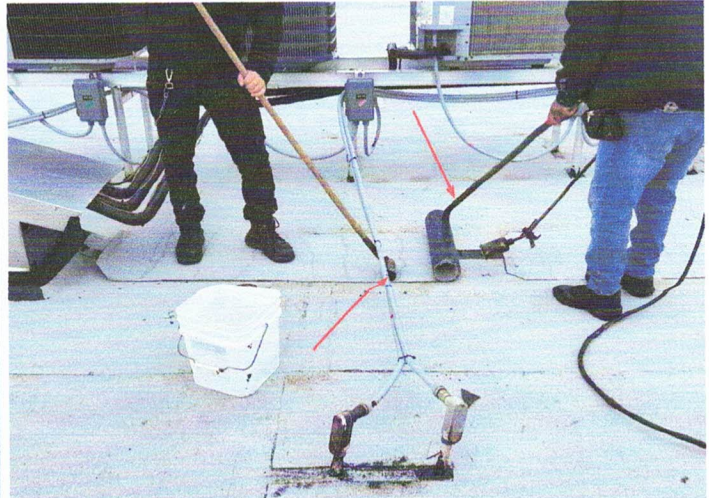
Red arrows indicate stick roller and pull stick being used during the torch operations.

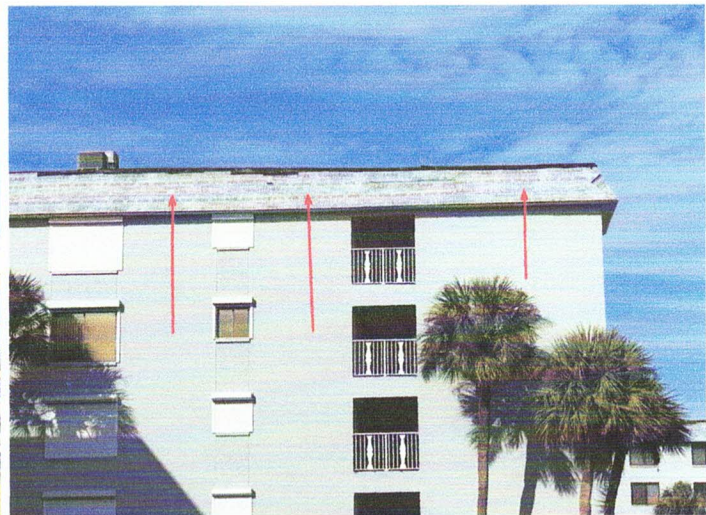
In progress installation of the self-adhering underlayment to the wood decking at conditions of the mansard.

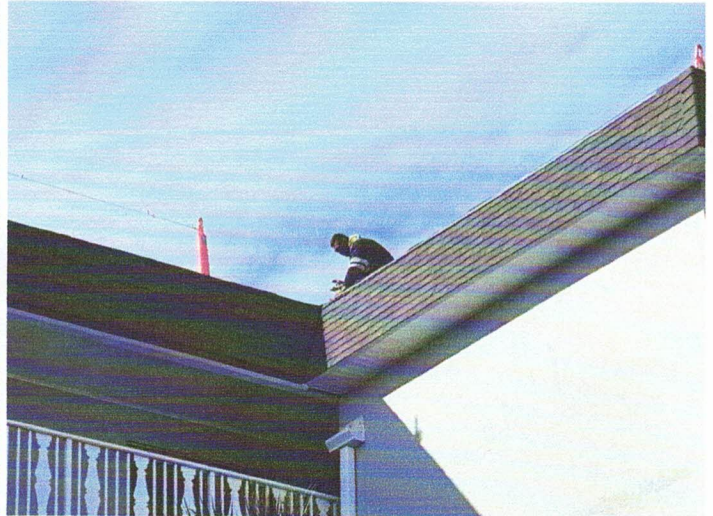
Metal cleat installation continues on the low slope perimeter roof.

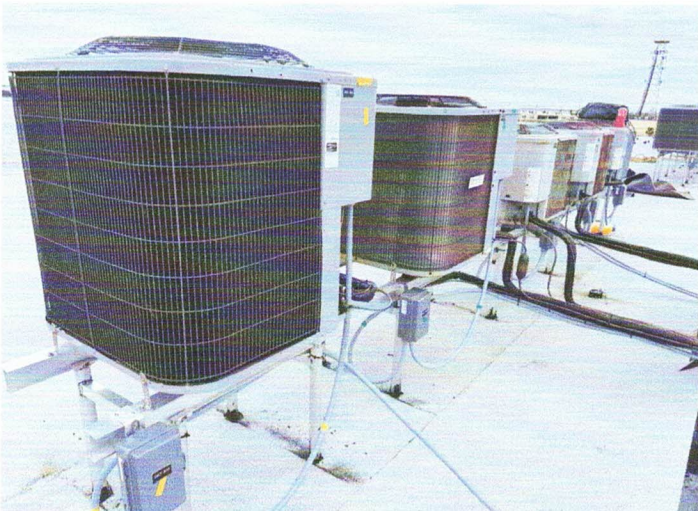
In progress installation of the GAF HW PLUS GRANULE Modified roofing.

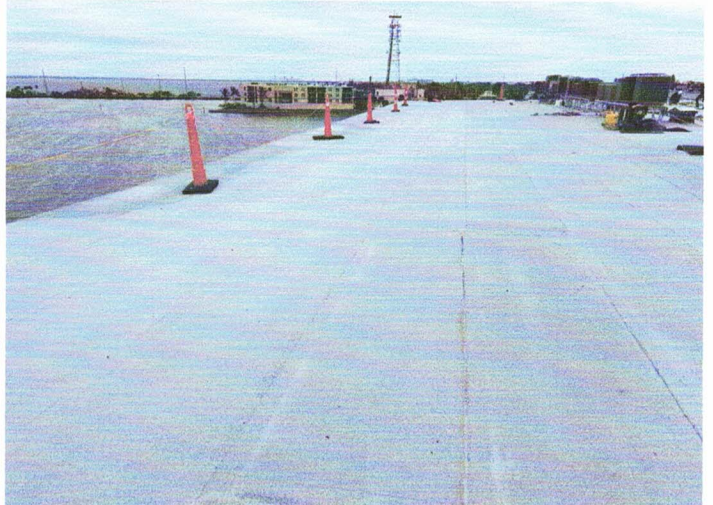
Completed roof section of the GAF granulated modified roofing.

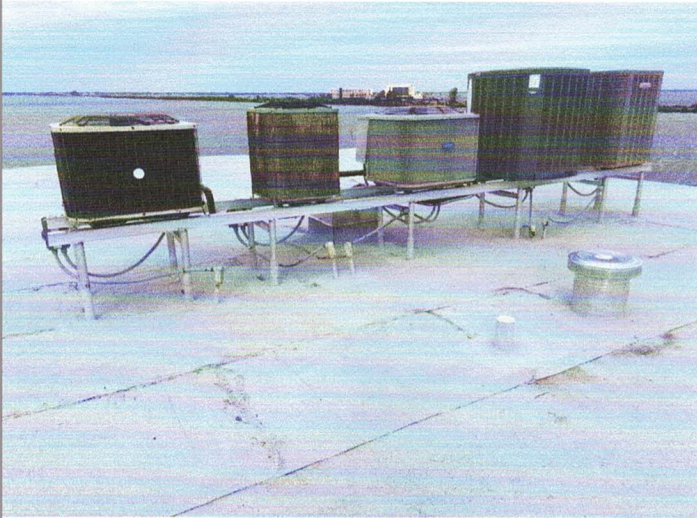
Completed GAF Modified roof system near new mechanical stands.

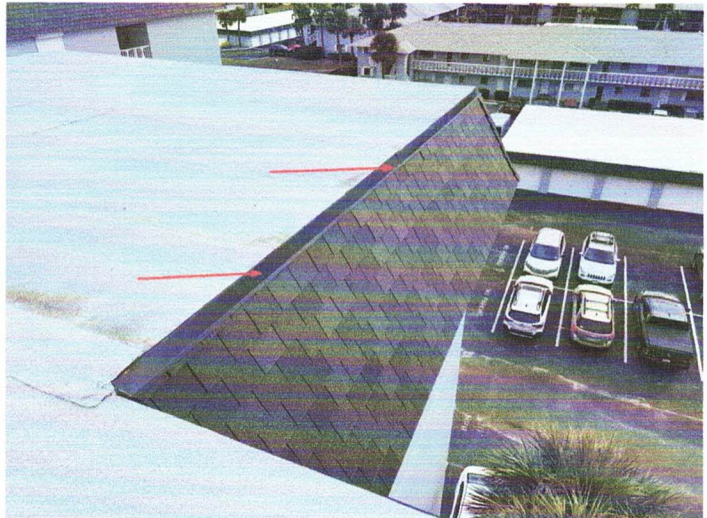
Installation of the new low slope roof edging with new white granulated modified roofing.

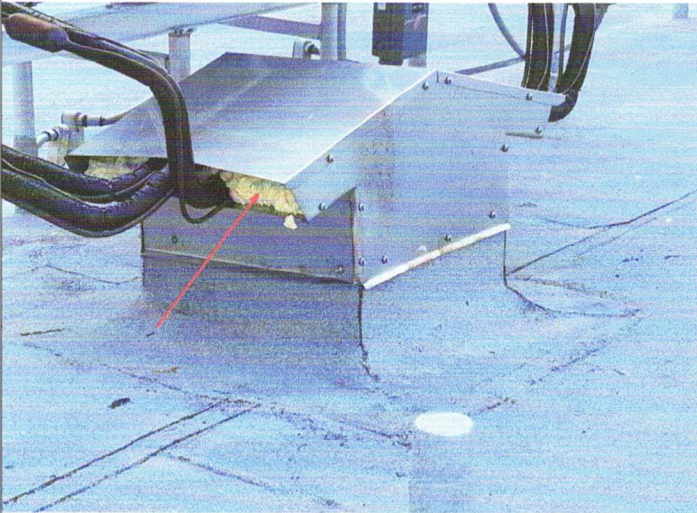
6. Installation is completed of the new 24-gauge stainless steel mechanical chase boxes. These goosenecks", have the specified removable tops and have been filled with spray polyurethane.

Spray polyurethane installed in "gooseneck" opening to seal.

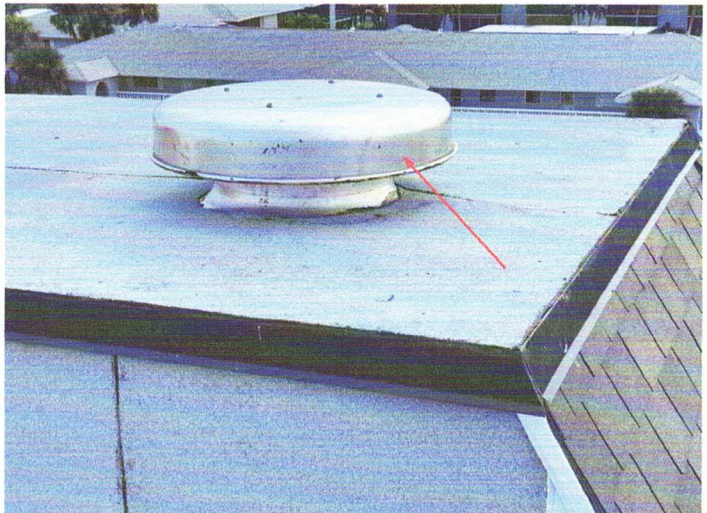
7. The elevator and trash roof vents were replaced with new 24-gauge stainless steel components and properly flashed to manufacturer's specifications.
Building 8. Completed.

New vents installed to replace existing elevator and trash roof vents.

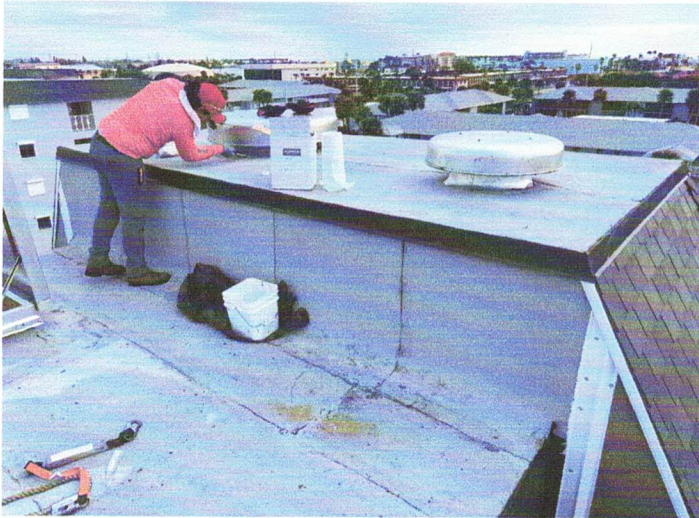
In progress liquid reinforced flashing of new rooftop vents.

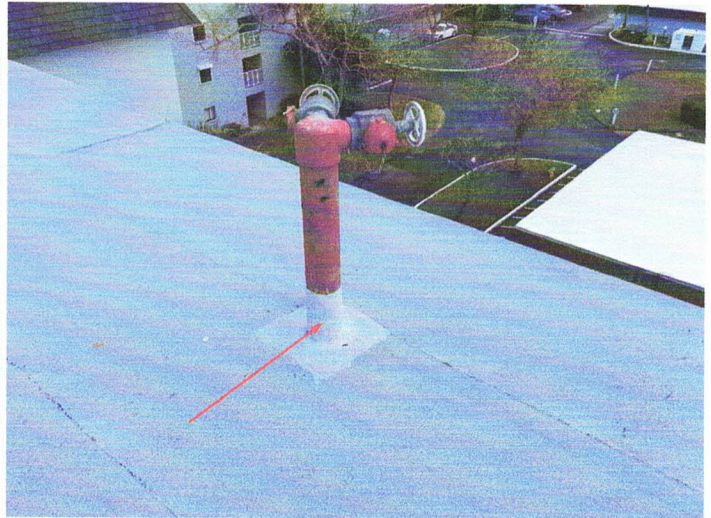
Liquid-applied reinforced flashing installed as per manufacturer specifications.

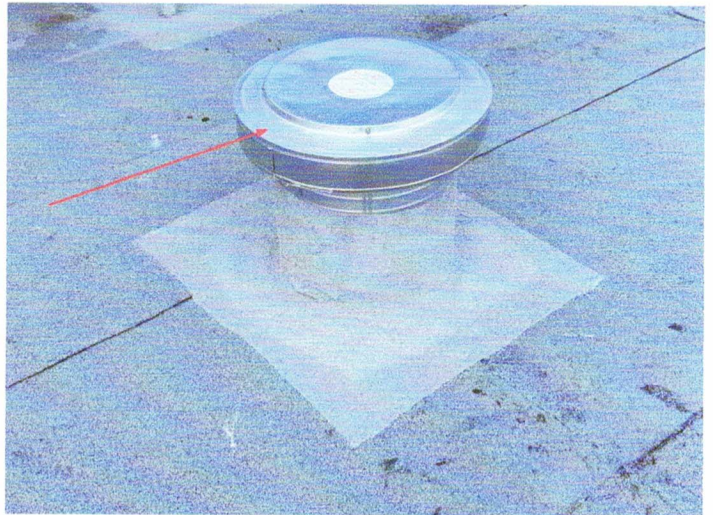
New rooftop vents properly installed and flashed.

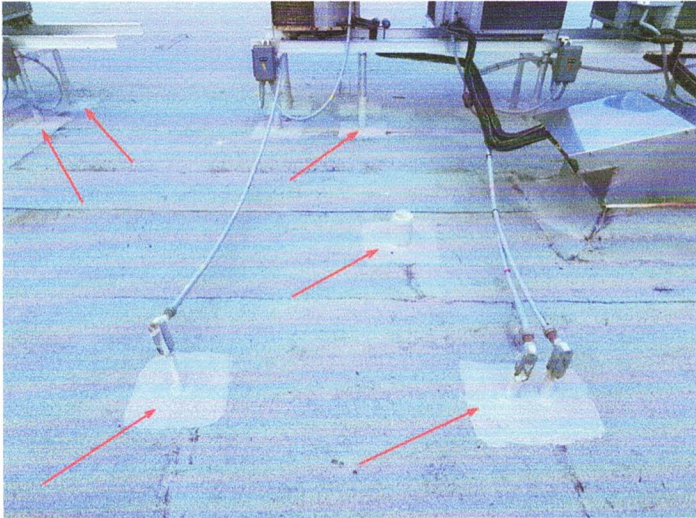
Red arrow indicates proper liquid-applied reinforced flashing system being installed.

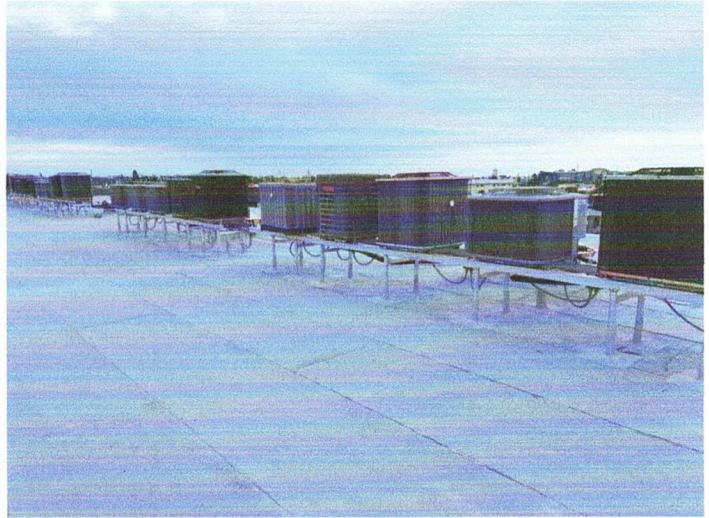
Overview of a completed GAF Modified roof system on building 8.

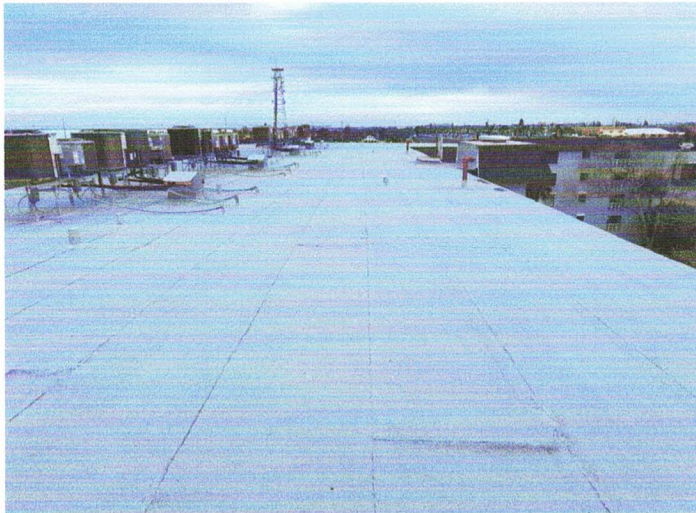
Overview of a completed GAF modified roof system on building 9.

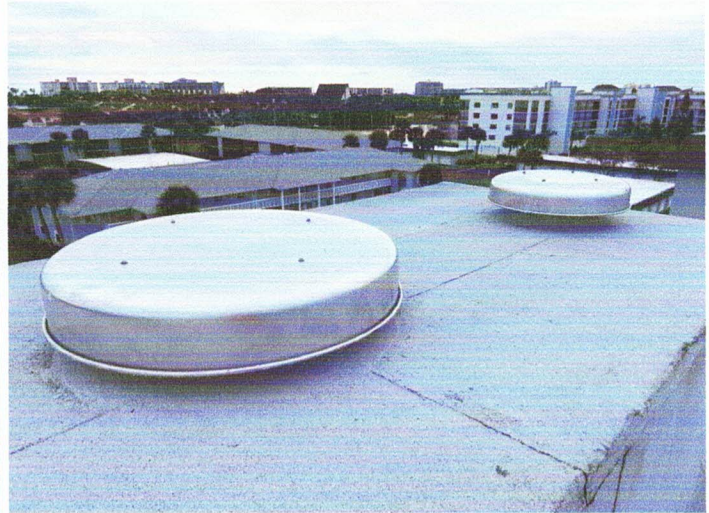
Completed installation of the new roof vents to replace existing on the elevator roof section.

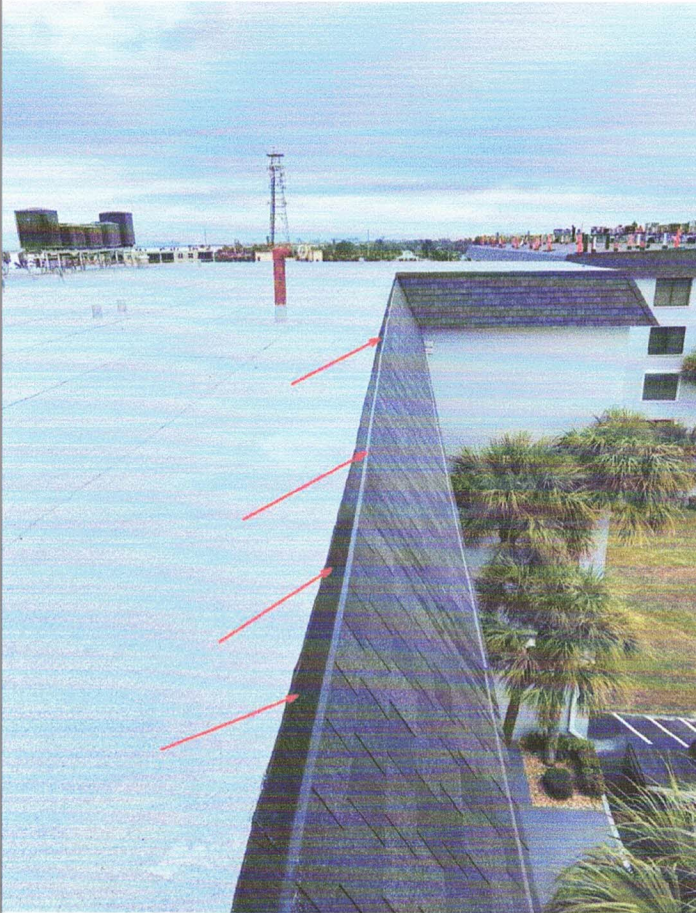
Overview of the mansard/ low slope roofing tie-in on building 9, with the transition metal noted by the red arrows.

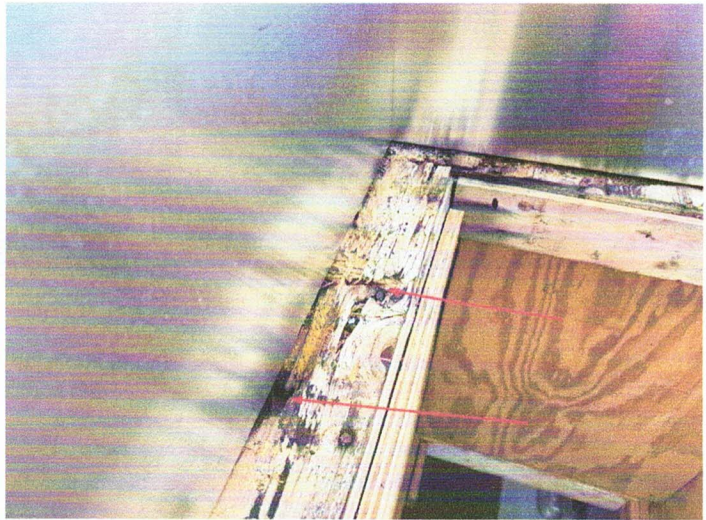
8. Some of the specified Bilco S-50 Aluminum Roof Hatches were installed over some deteriorated sheathing and some existing roofing materials. These hatches will need to be re-set on new plywood sheathing and new self-adhering underlayment, to meet project manual requirements. Deficiencies were shown to Jim Swope/ Tech Systems and will be scheduled to be corrected.

Red arrow indicators note the new aluminum roof hatch was installed directly on top of some deteriorating wood. This deficiency was shown to Jim Swope/ Tech Systems. It is scheduled to be corrected.

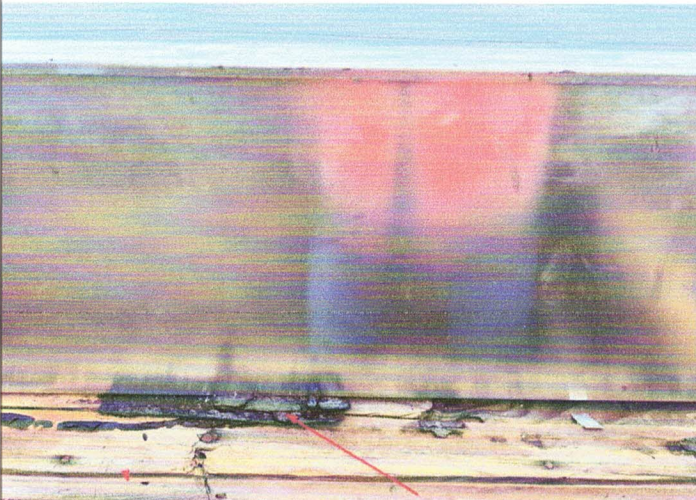
Red arrow indicates old existing roofing was not removed where the base of the new roof hatch was installed. This deficiency is scheduled to be corrected.

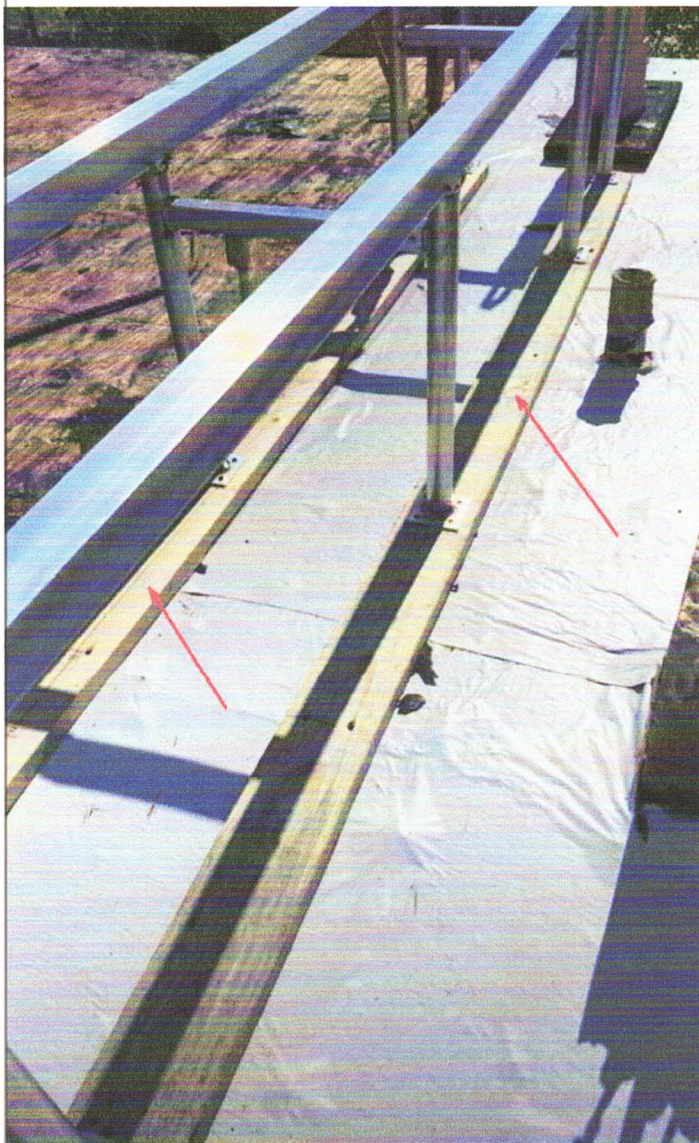
1. The contractor mechanically attached the new 2"x 6" lumber where needed, to the existing framing members. This provided additional support for the new mechanical stands.

Red arrows indicate new wood components attached to existing wood members, to provide additional support for the new aluminum legs of the mechanical stands.
