**Four Seasons Condominiums**  
**3799 S Banana River Blvd**  
**Cocoa Beach, FL 32931**  
**Equipment and Service Analysis Audit**

The Elevator Consultants

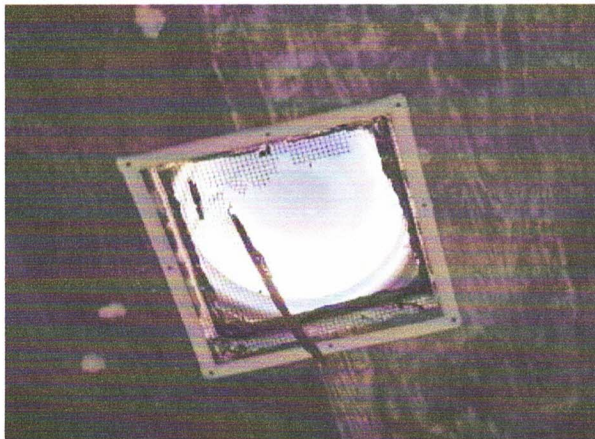
There are building related items that need to be rectified. The callback records provided to TEC by the building indicate there were four (4) callbacks in 2024 between all three (3) buildings due to corrosion/water exposure. The repair proposals provided to TEC by the building indicate four (4) proposals were provided between December of 2023 and January of 2025 for water damaged components. Due to the outside location of the hoistways, the proper equipment should be installed at each building to help prolong the lifecycle of the pit equipment and to prevent major repairs/costs in the future due to water exposure. The elevator pits at all three (3) buildings lacked a sump pump pits and sump pumps which should be installed. The vent screen at the top of the hoistway of Building 8 was damaged and needs to be repaired.

Repair vent screen at top of hoistway of Building 8

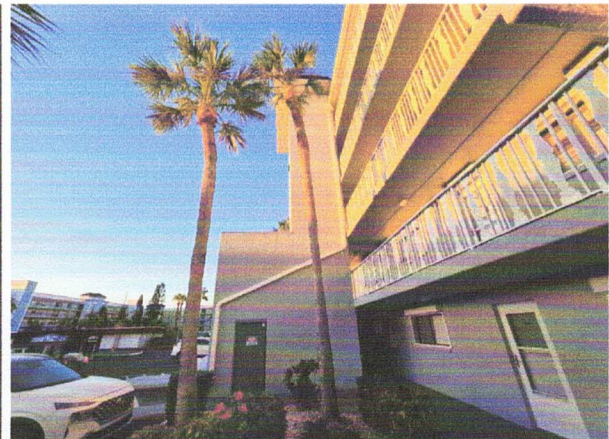
The door operation systems on all three (3) elevators were in fair condition due to the age of the equipment, usage and deferred maintenance. The door operators need more maintenance for smooth and quite operation. The hoistways at all three (3) buildings are located outside with all landings exposed to the elements. The hoistway door equipment and pits at all three (3) buildings have evidence of past

Hoistways located outside, recommend pit sump pumps

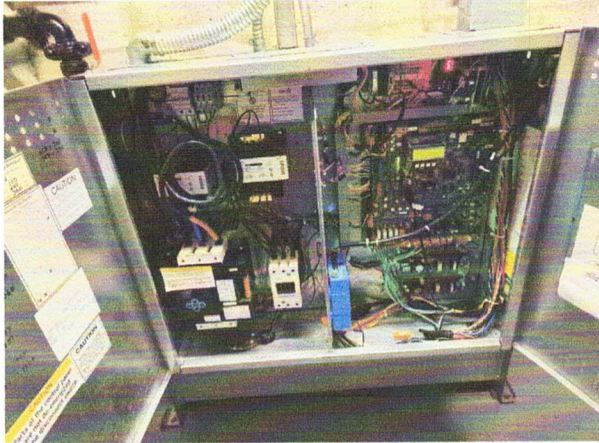
The control systems on all three (3) elevators were in fair condition due to the age of the equipment, usage and deferred maintenance. All three (3) elevators lack the proper elevator identification on the elevator related equipment which are code violations. The elevator identifications need to be properly posted. The battery backup systems on all elevators have been removed which are code violations. The battery backup systems need to be re-installed to proper working order. A contactor inside the controller cabinet at Building 9 needs to be repaired. The building informed TEC that the elevators are programmed to park at the top landing. At the time of TEC's onsite visit, the elevators at Buildings 9 and 10 were not parking at the top landing.

ThyssenKrupp TAC32 control system

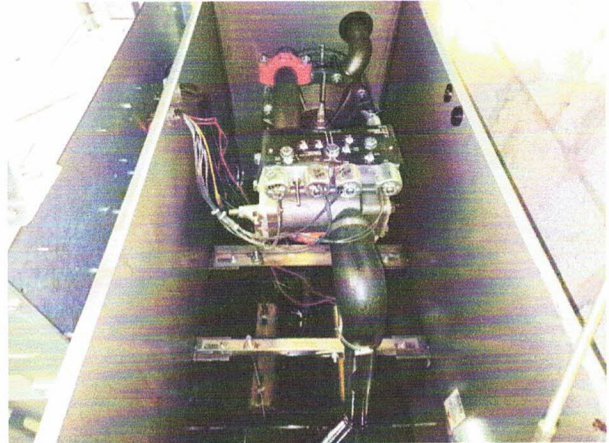
The hydraulic pump unit assemblies were in fair condition due to the age of the equipment, usage and deferred maintenance. The elevators at Buildings 9 and 10 were traveling approximately 15% slower than the rated speeds of the elevators. The valves need to be adjusted by TK Elevator without negatively impacting the ride quality of the elevators. The original inground hydraulic jack unit assemblies were retained during the modernizations. According to information provided to TEC by the building, the jack assembly at Building 9 was replaced in 2018 and the jack assembly at Building 10 was replaced in 2013. The reason for replacing the jack unit assemblies was not able to be determined from the documentation available onsite. The condition of all three (3) jack units was not able to be determined due to the jack units being in the ground.

ThyssenKrupp submersible hydraulic pump unit assembly

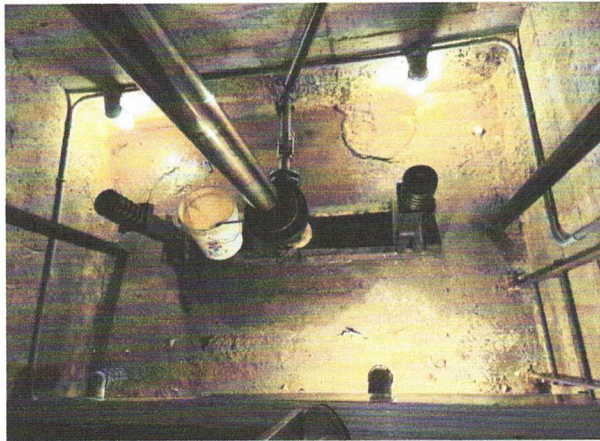
Inground hydraulic jack unit assembly

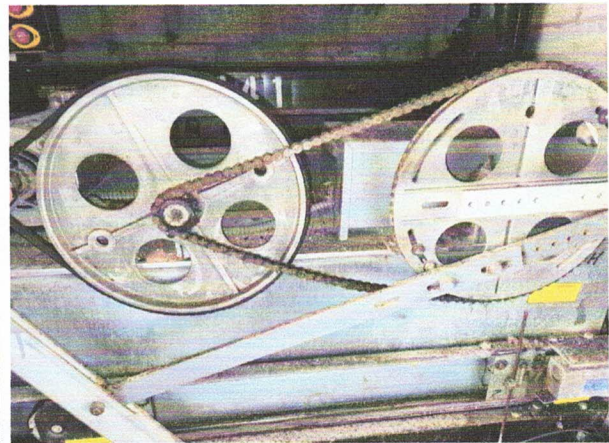
GAL MOVFR II door operation system

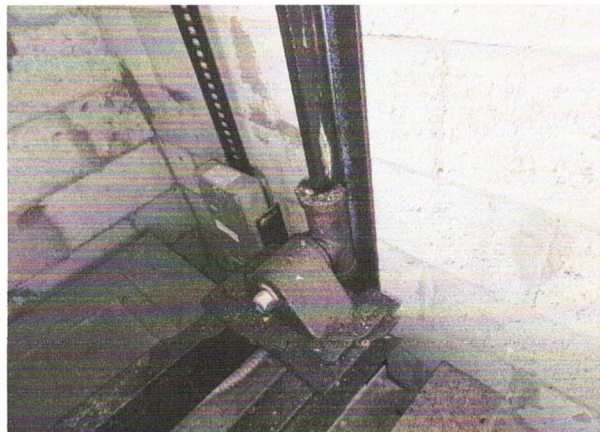
water exposure and will require increased maintenance for proper working order of the equipment. The hoistway doors at Buildings 8 and 9 need to have escutcheon sleeves installed in the hoistway doors at all landings. The original slide guide assemblies at all three (3) buildings were retained during the modernizations and were in fair condition due to the age of the equipment and usage.

Original slide guide assemblies

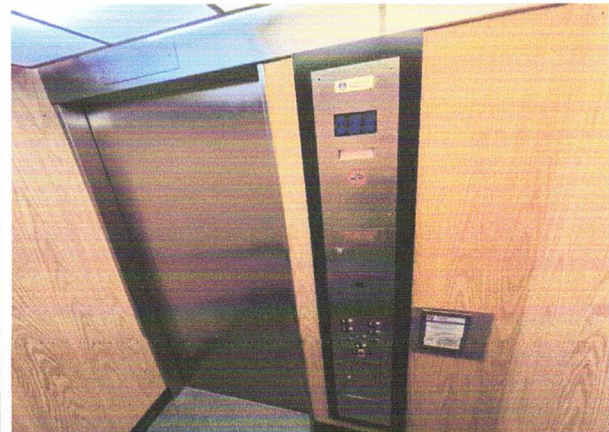
The fixtures at Buildings 8 and 9 were in poor condition and were not ADA compliant. The emergency alarms at both buildings were not working and the phone at Building 8 was not working. The non-working alarms and phone are code violations which need to be repaired. The position indicator in the cab and on the hall fixtures at Building 9 were not operational and need to be repaired. The fixtures at Building 10 were ADA compliant, all buttons were operational and the emergency phone dialed out to TK Elevator.

Stainless-steel cab fixtures

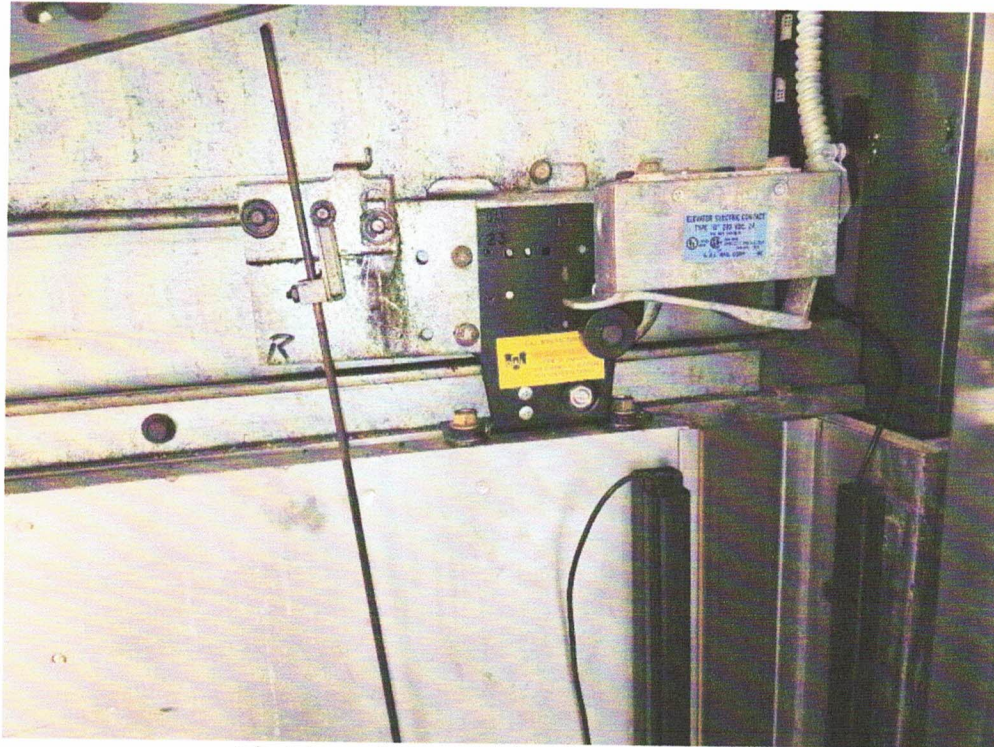
All three (3) elevators are equipped with mechanical door restrictors and CEDES door protection systems. The door restrictors at Buildings 8 and 10 were not operational which are code violations, safety hazards for passengers and liabilities for the building. The door restrictors need to be properly adjusted. The door restrictor at Building 9 was in good working order. The door protection systems were in good working order on all elevators. The car top of all three (3) elevators were dirty and need to be cleaned. The car top at Building 9 had an open junction box with exposed wiring which is a code violation and safety hazard. The wiring needs to be properly insulated and the junction box cover need to be re-installed.

Adjust door restrictor at Building 8 for proper operation
