# Four Seasons Condominium

## Condition Survey Report Buildings 1, 2, 3, 4, 5, 6, & 7

# **Four Seasons Condominium Condition Survey Report**

Re: Buildings 1-7 Structural Condition Survey Report

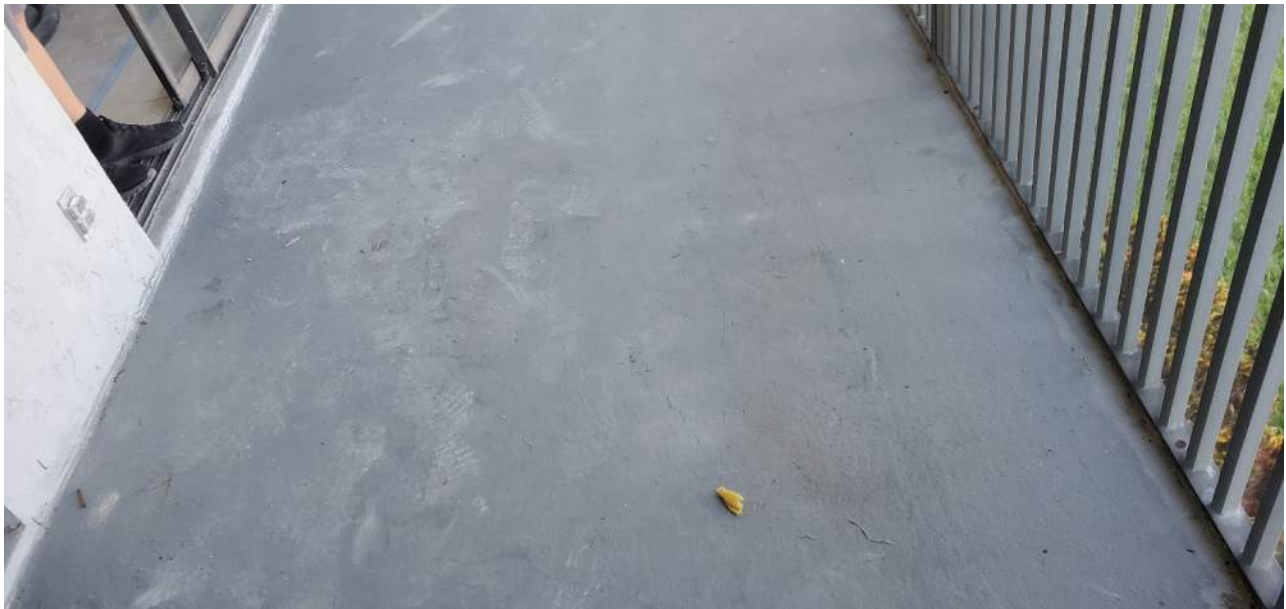
**Example view of concrete balcony slab needing new coatings**

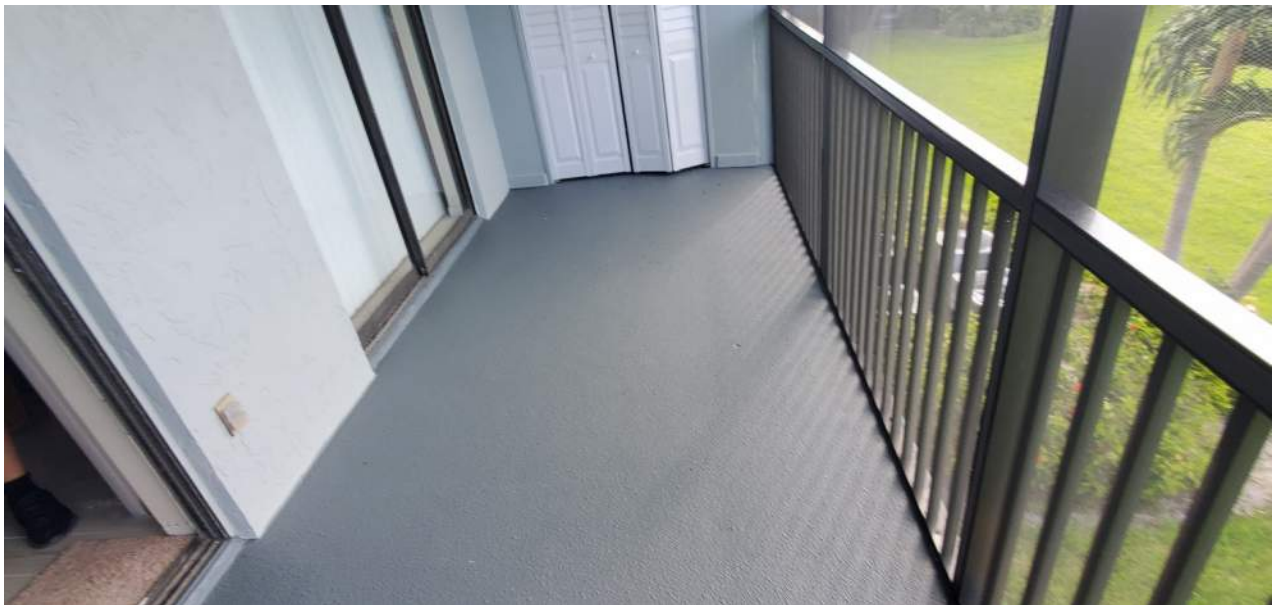
**Example view of unit 208. This slab was torn off about a year ago and a new slab was formed and poured with complete new waterproofing coatings.**

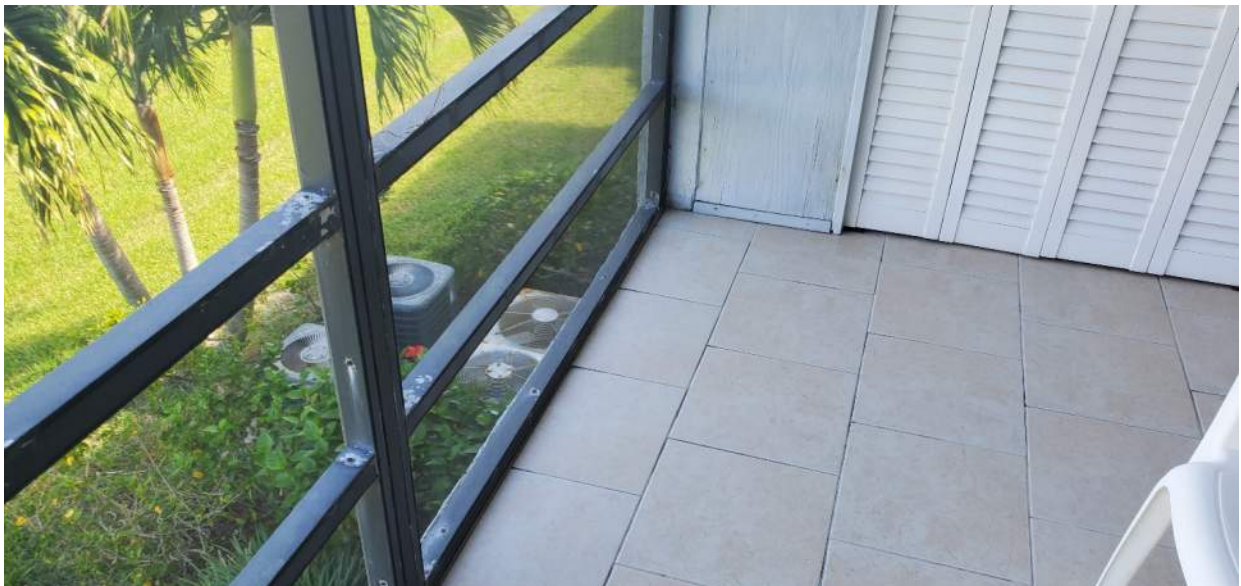
**Example view of peeling screen railings and tiled slab.**  
**Note the old style type screens without pickets**

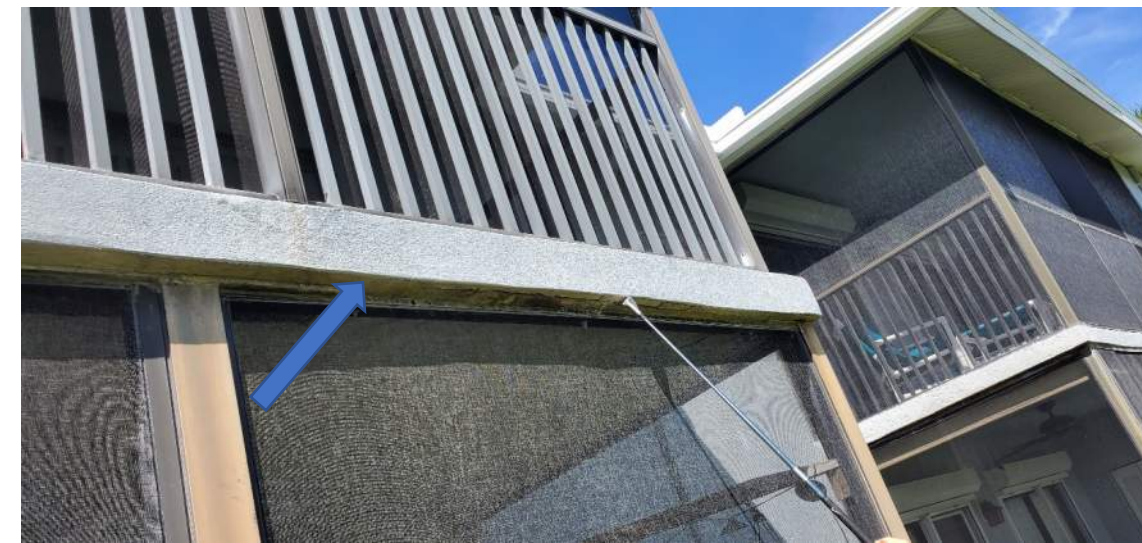
**Example view of concrete beam spalling**

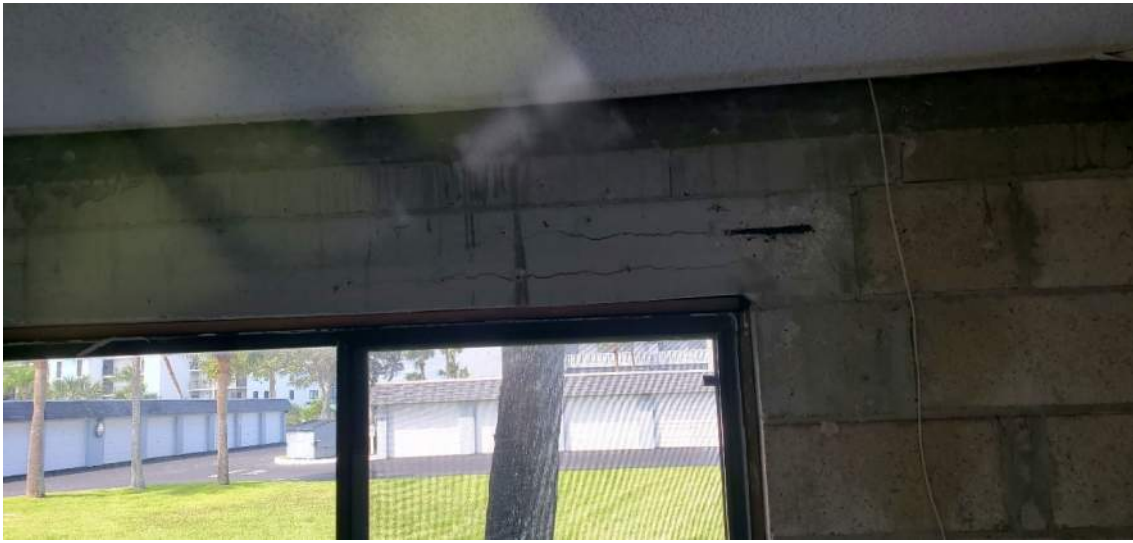
**Example view of concrete Header beam spalling**

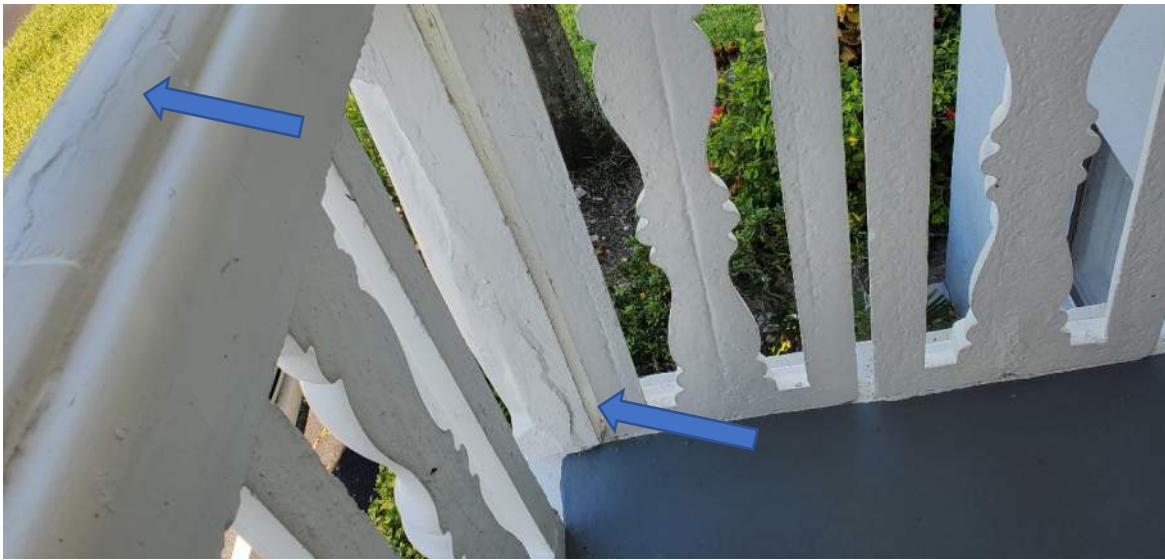
**Example view of spalling concrete railings**

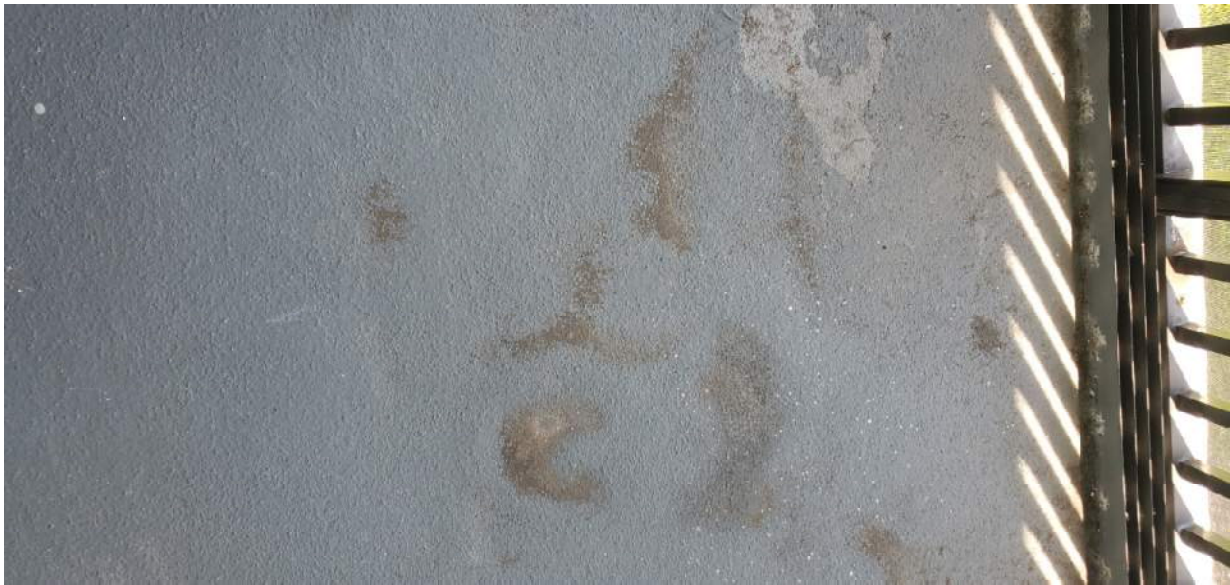
**Example view of slab with bad coatings**

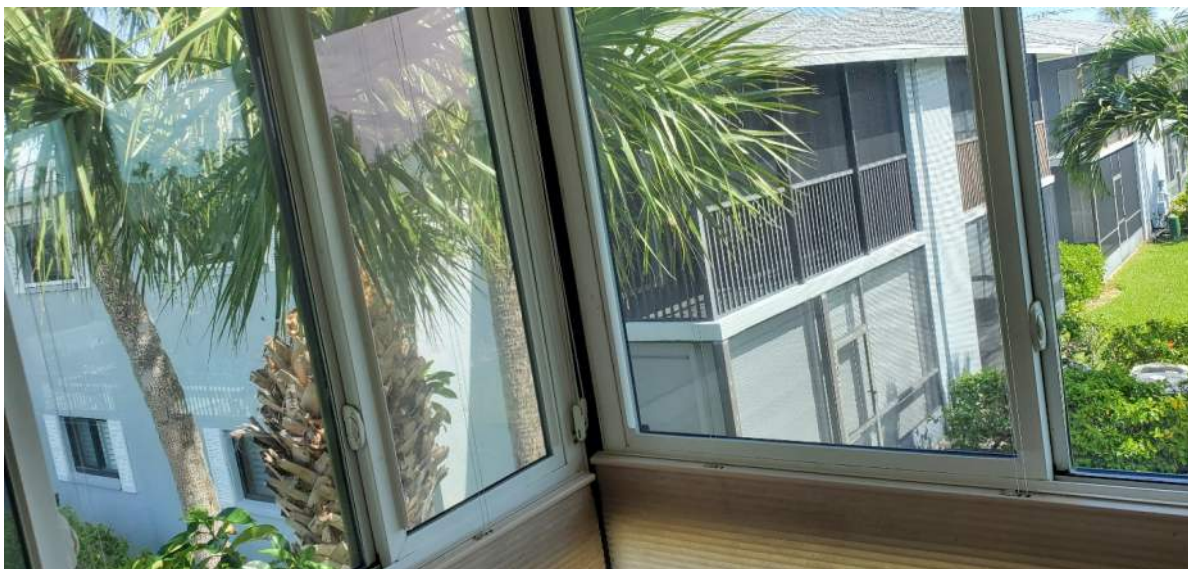
**Example view of porch with glass enclosure**
