# Four Seasons Condominium

## Condition Survey Report Buildings 1, 2, 3, 4, 5, 6, & 7

# **Four Seasons Condominium Condition Survey Report**

Re: Buildings 1-7 Structural Condition Survey Report

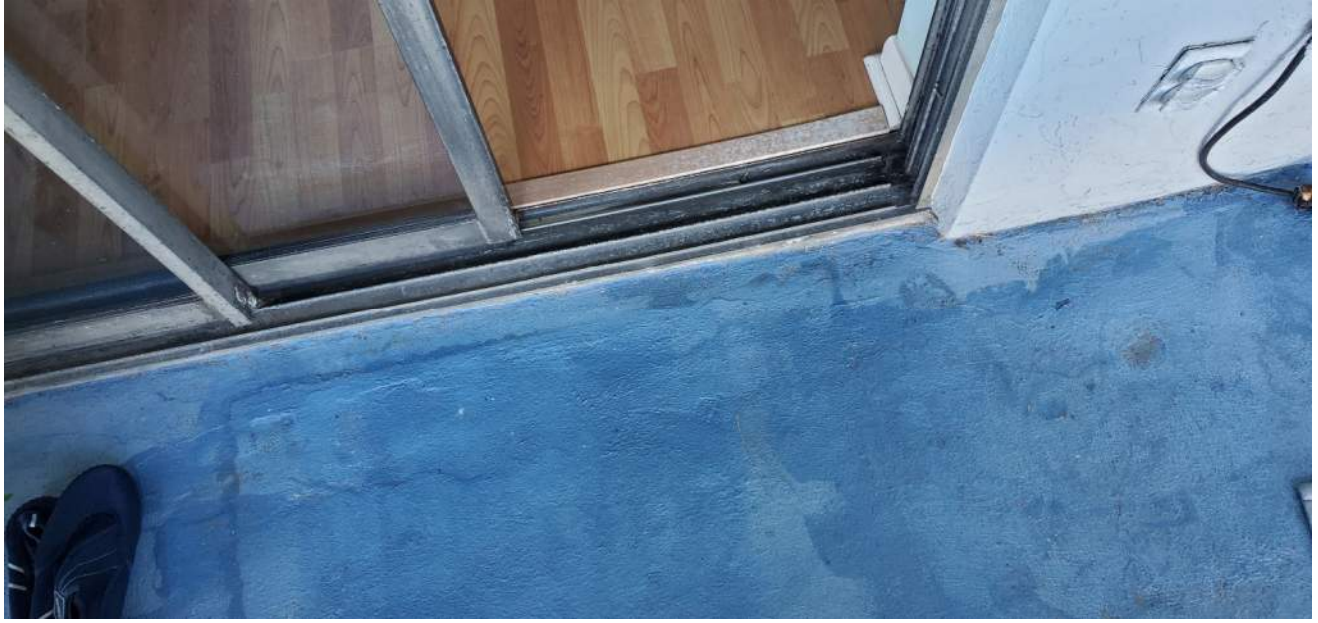
**Example view of old sliders and old floor coatings**

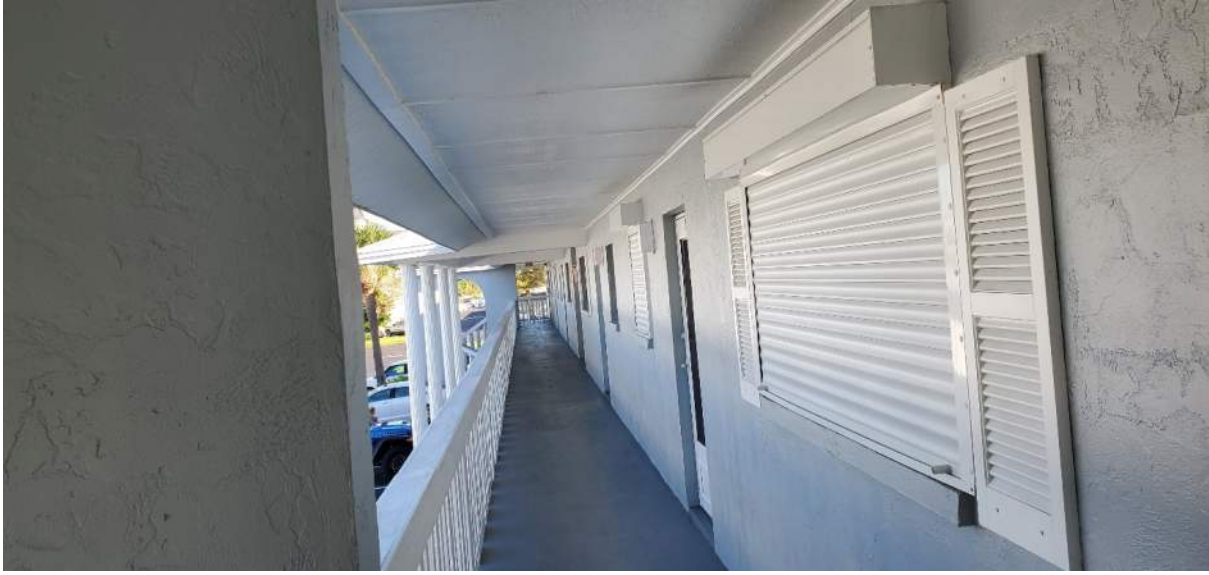
**Example view of walkway**
